## *Tests & QC at Aachen Production Site*

- ◆ Updates
- ◆ HV Tests
- ◆ Cosmics data taking & Noise

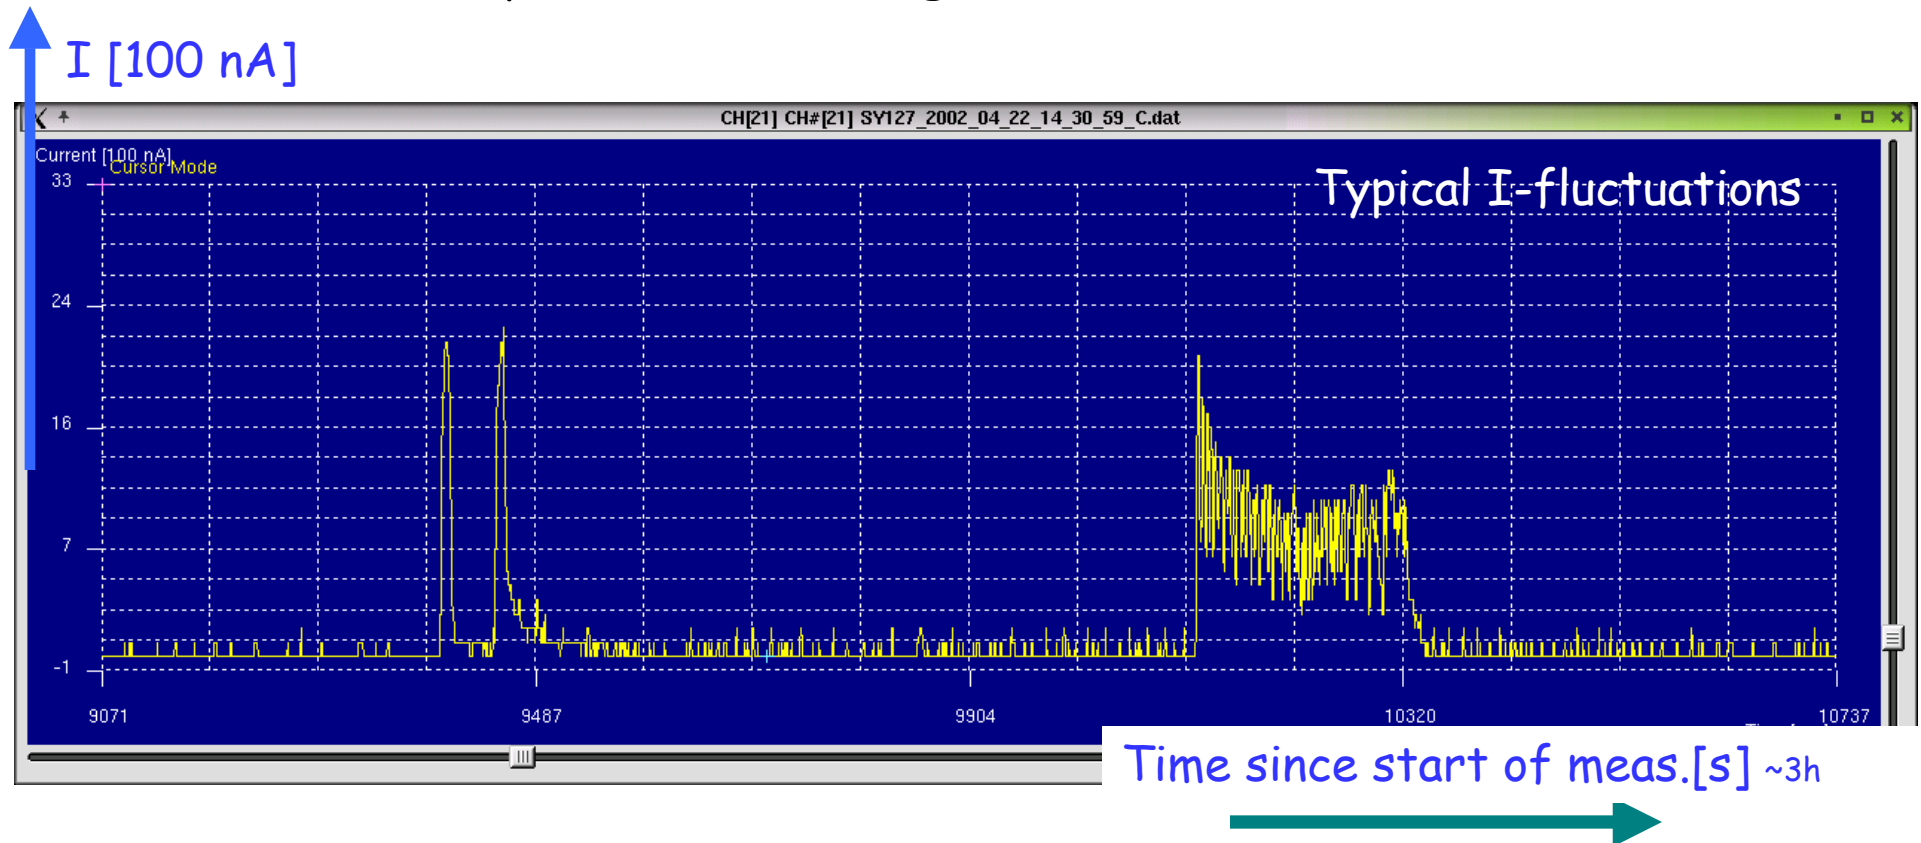
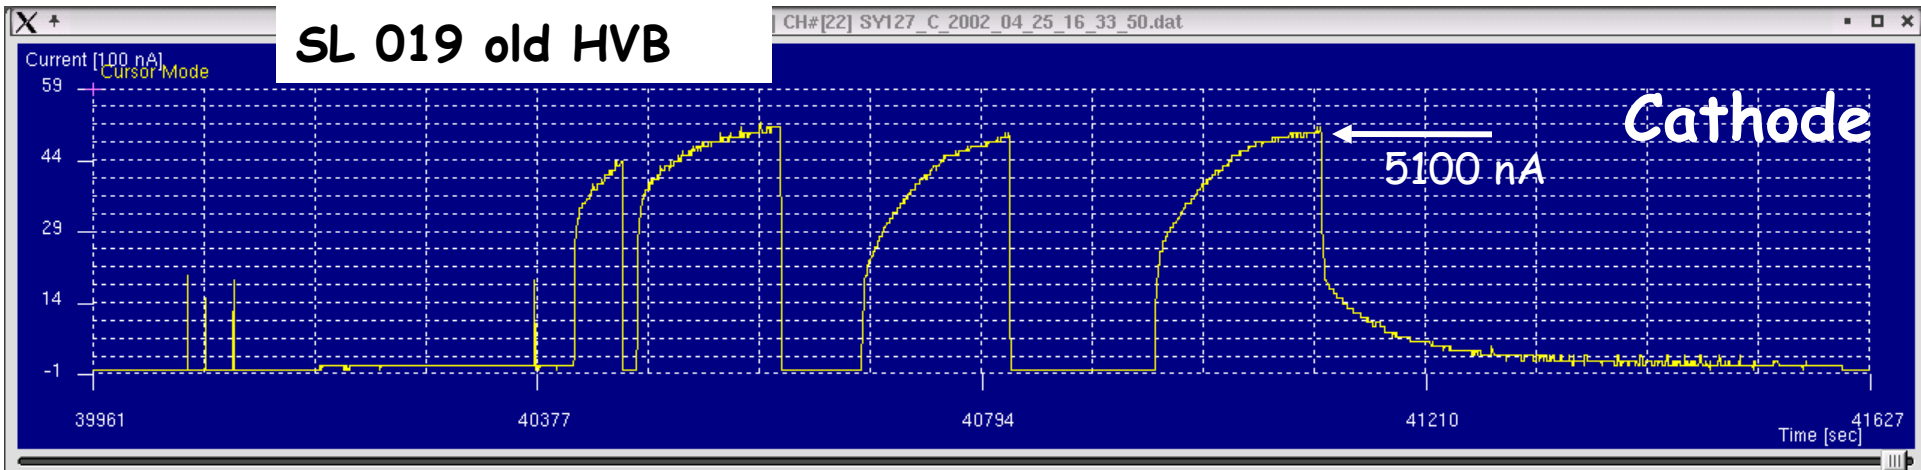
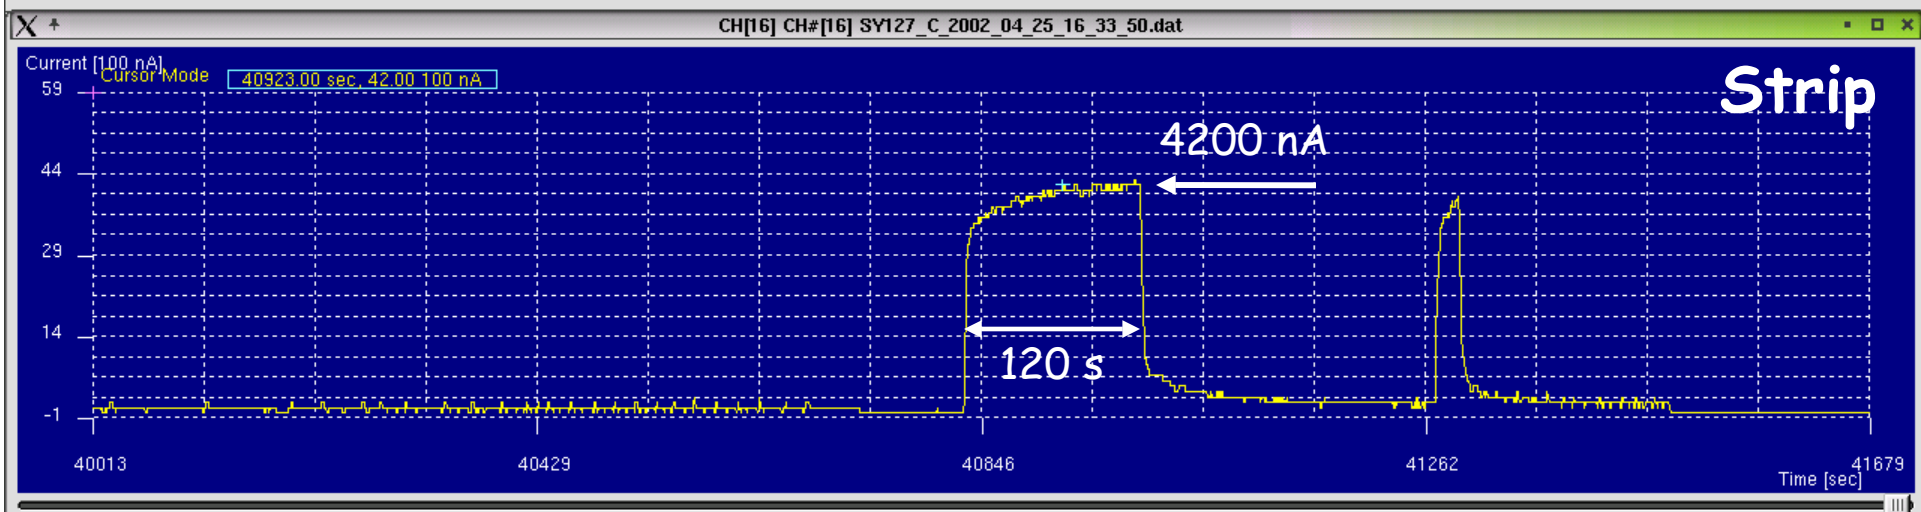
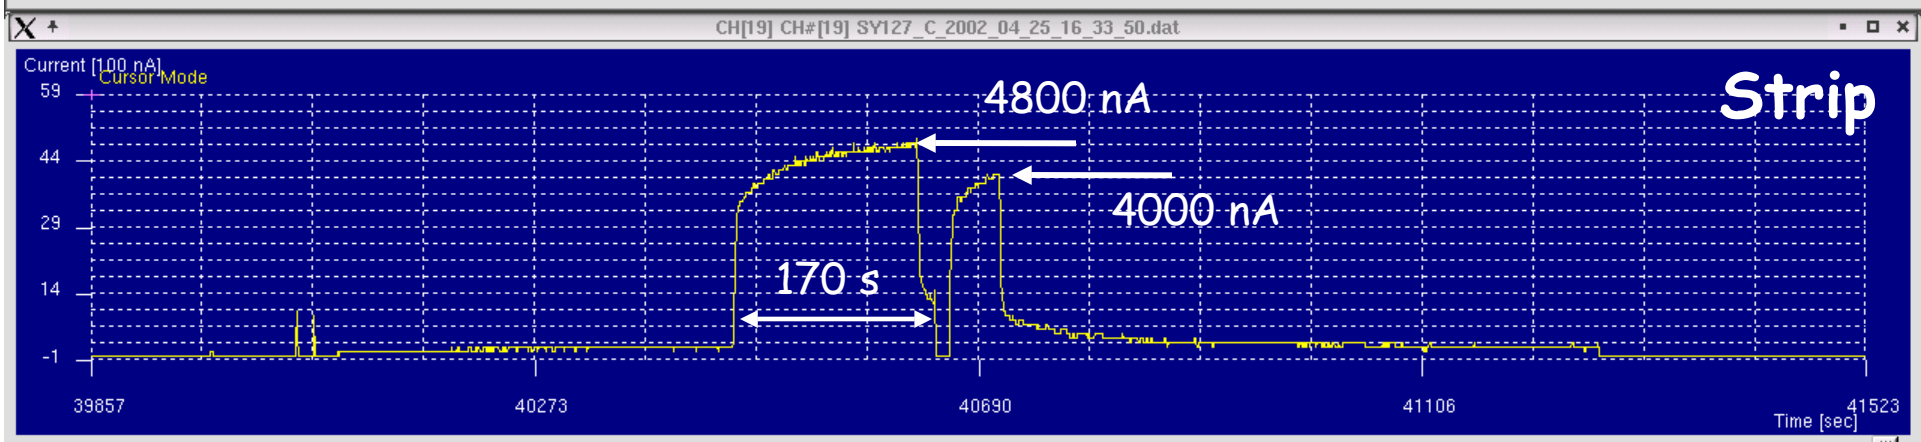
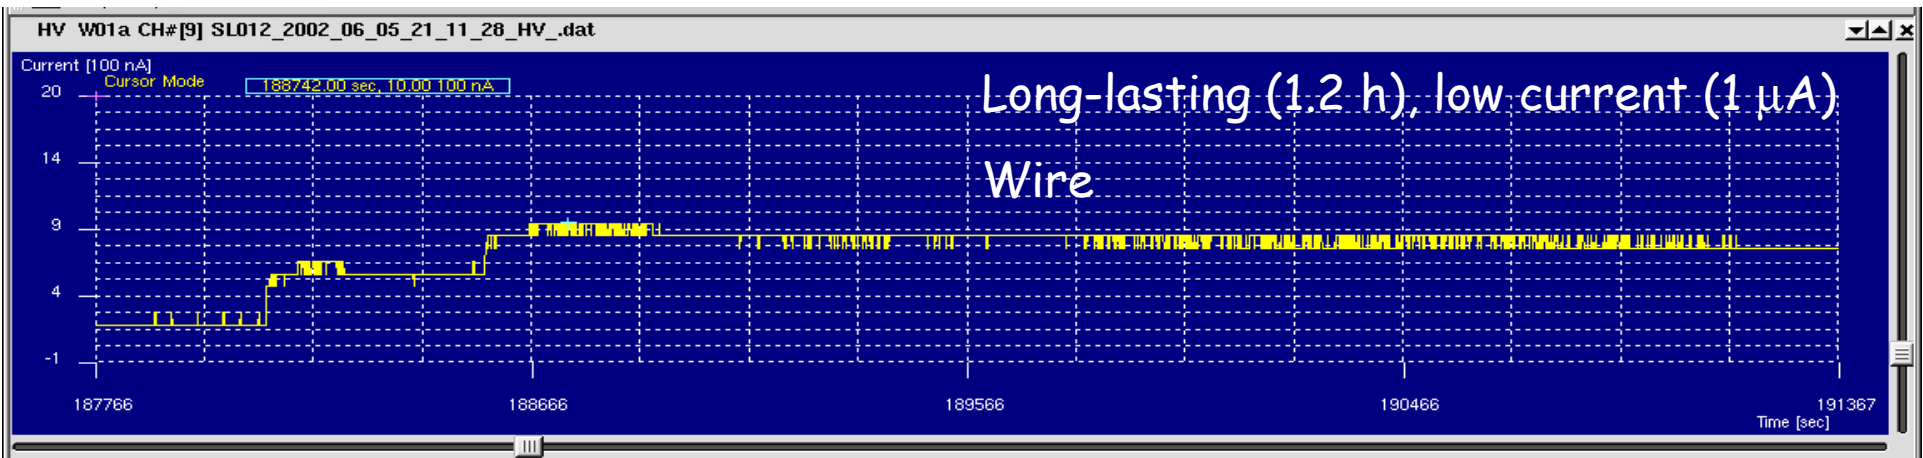
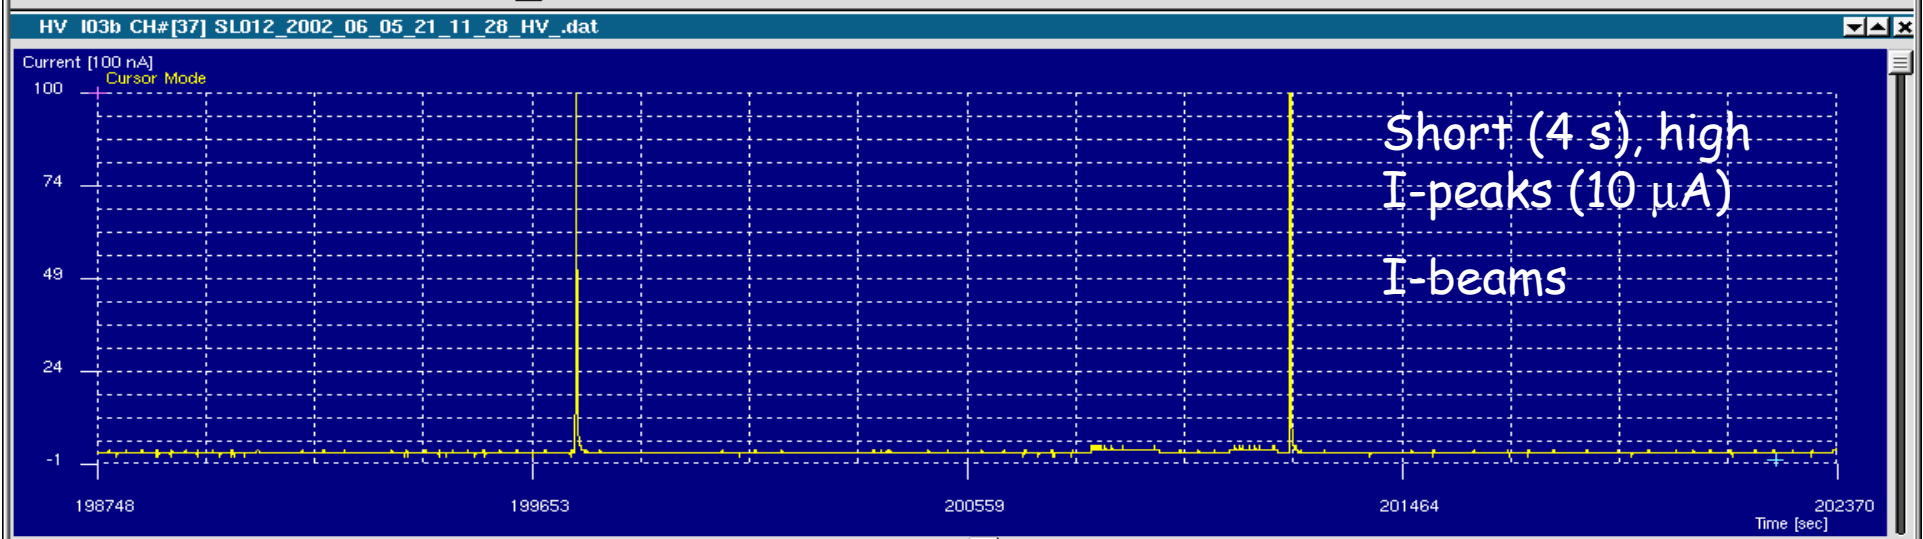
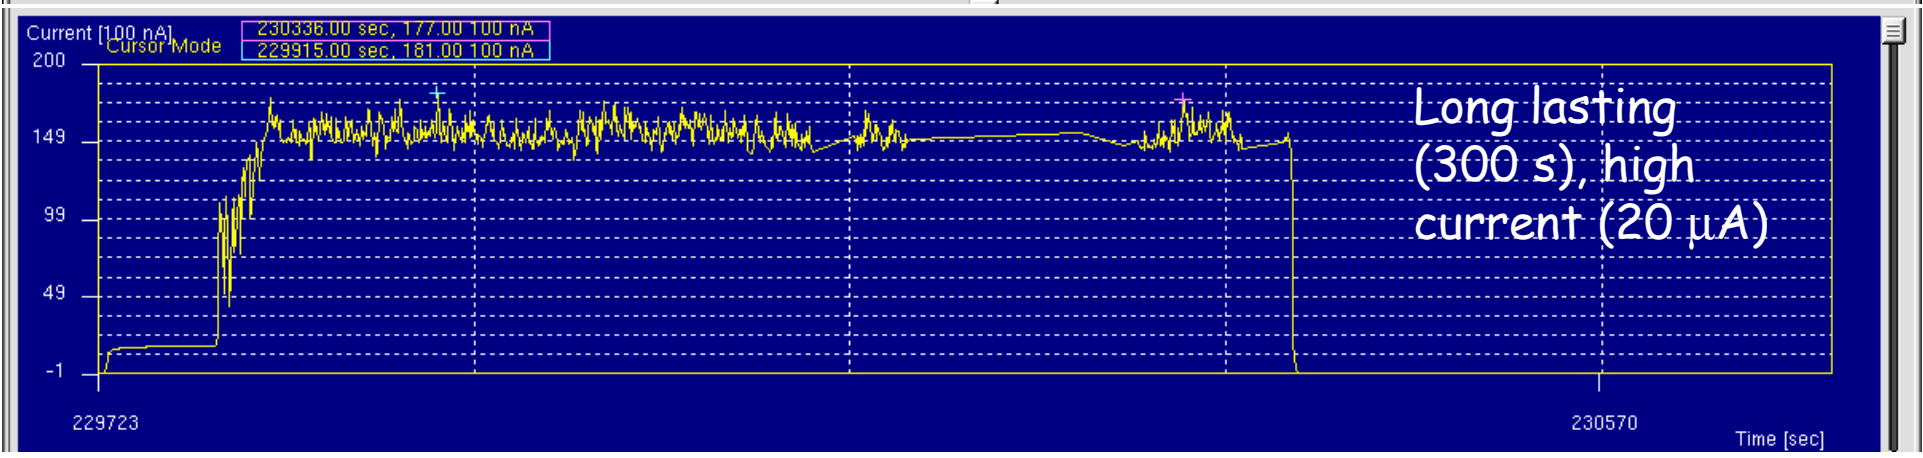
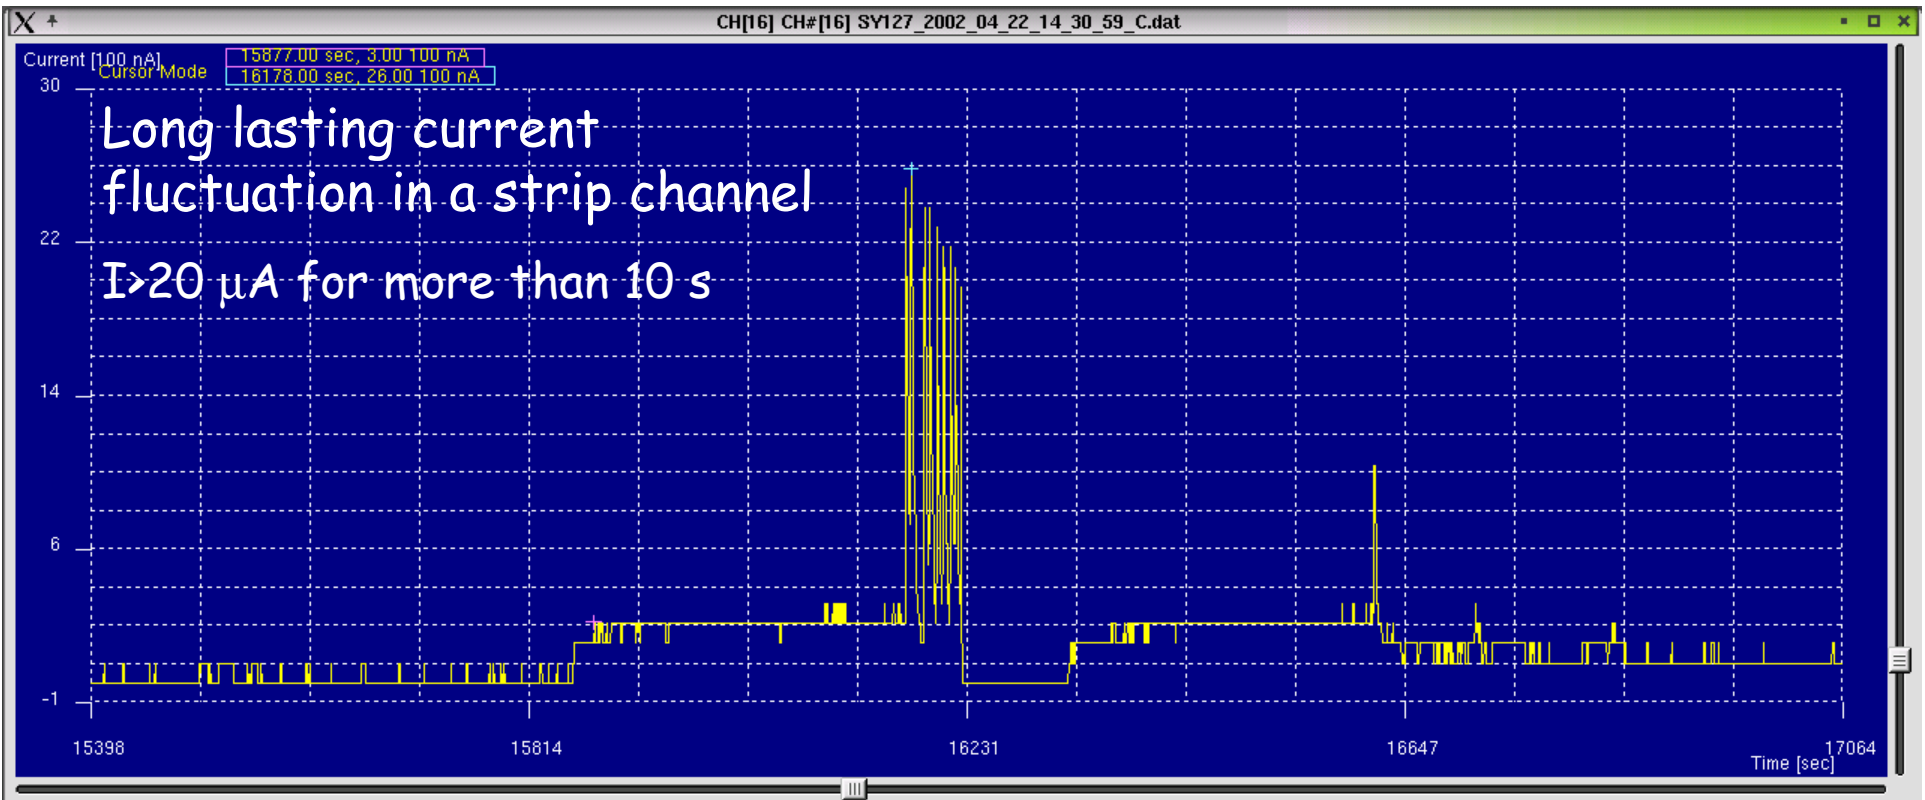
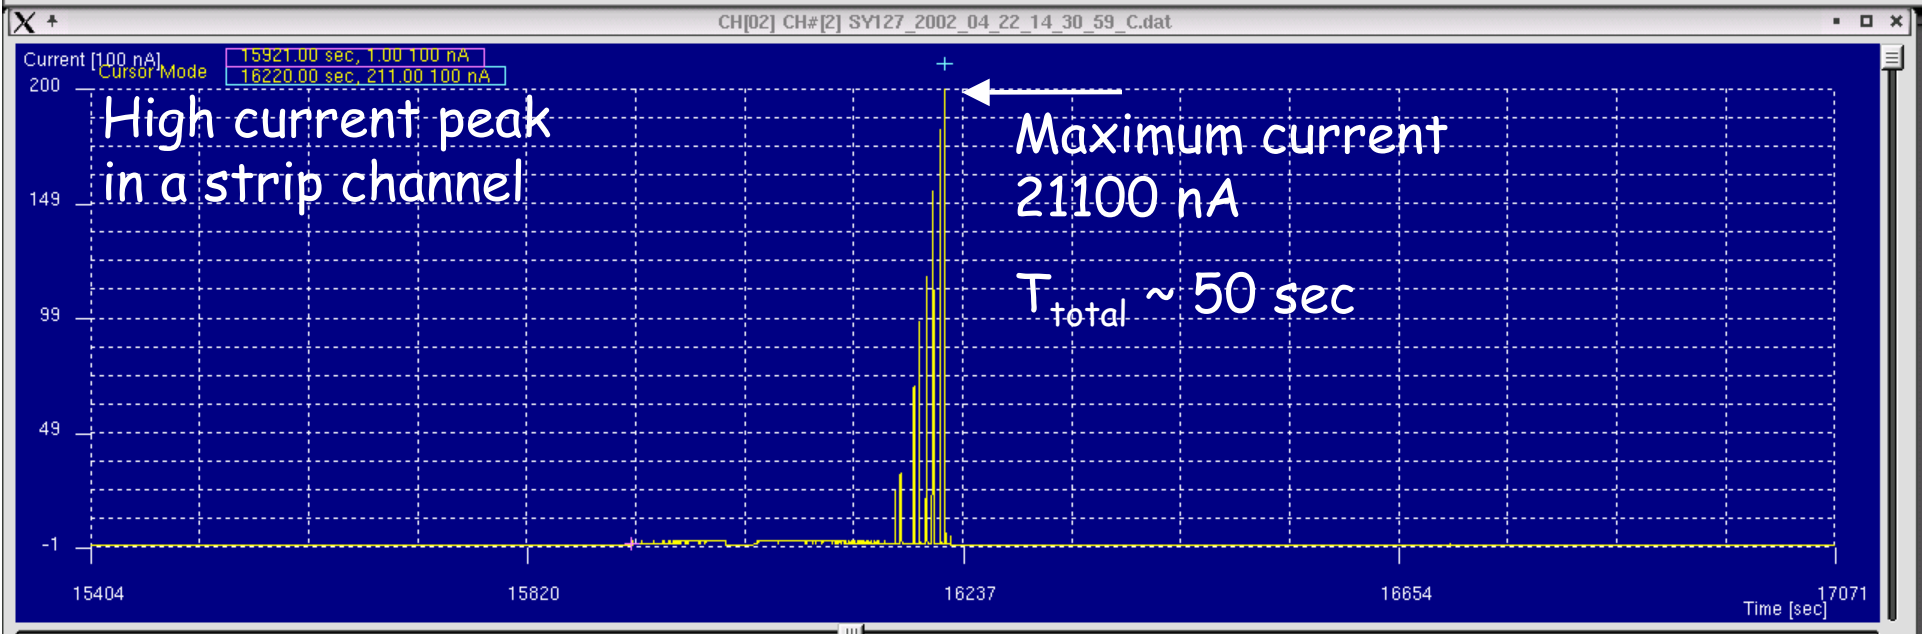
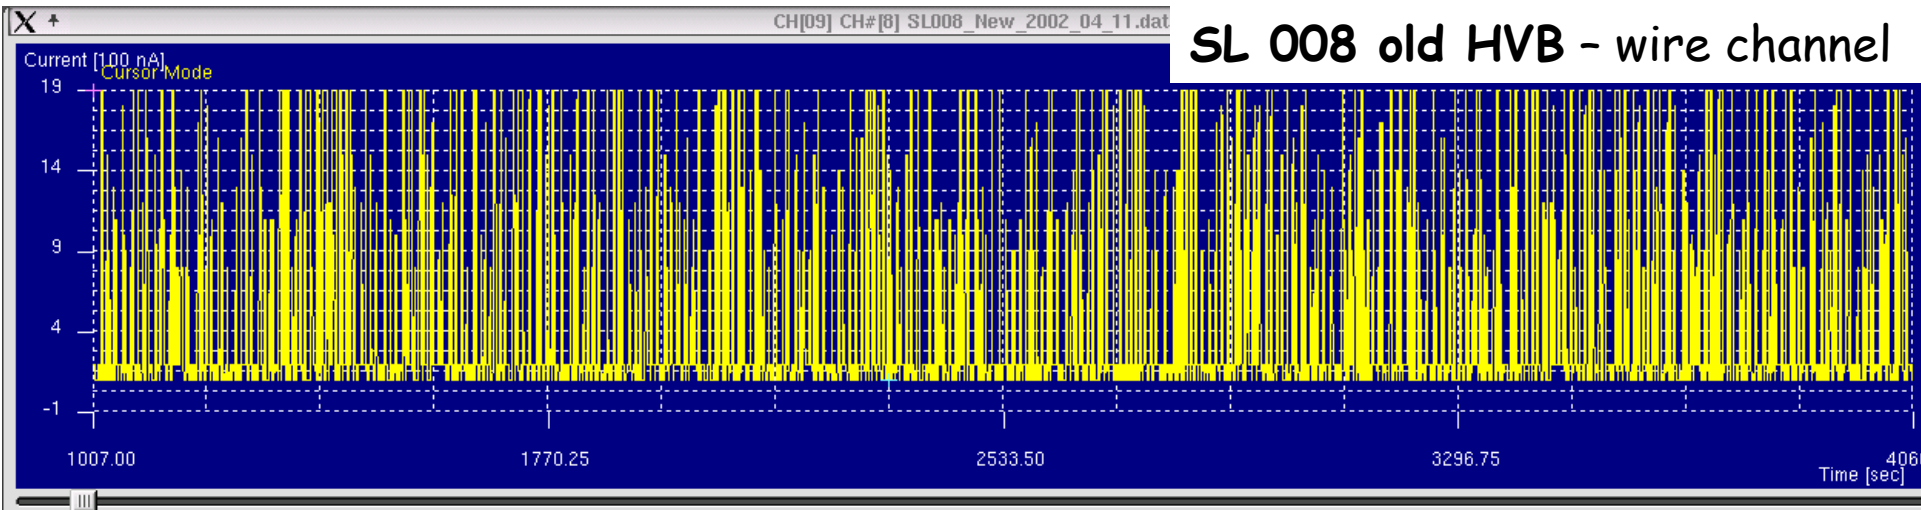
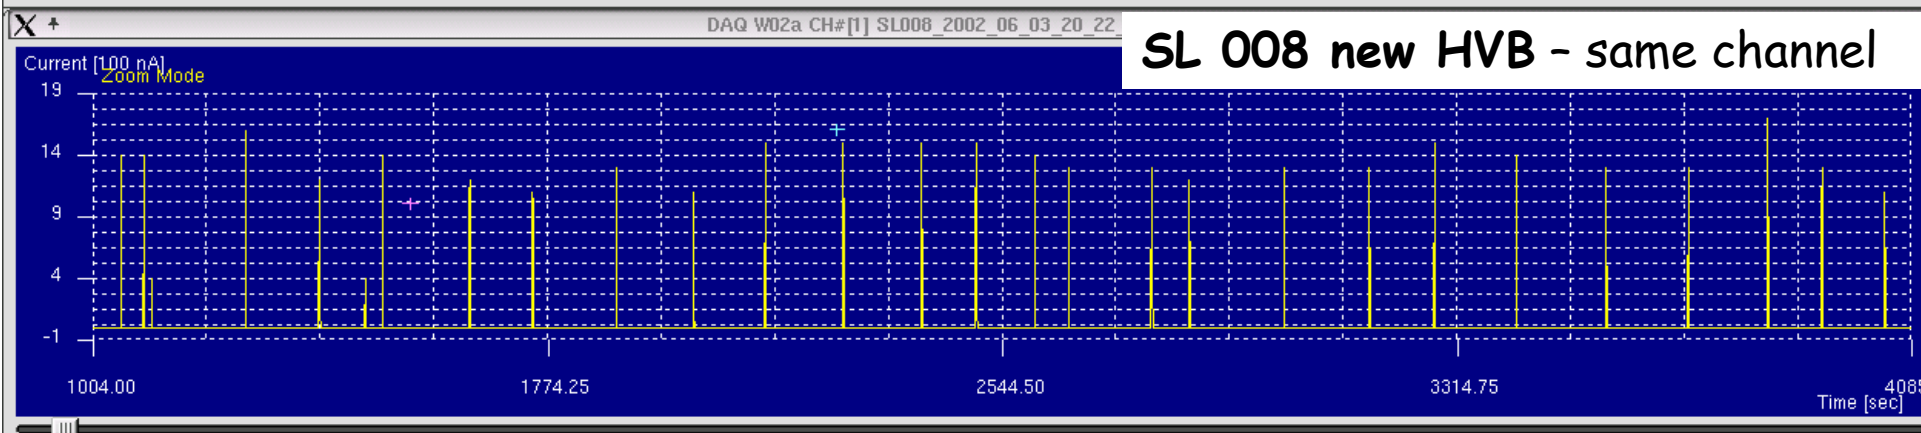
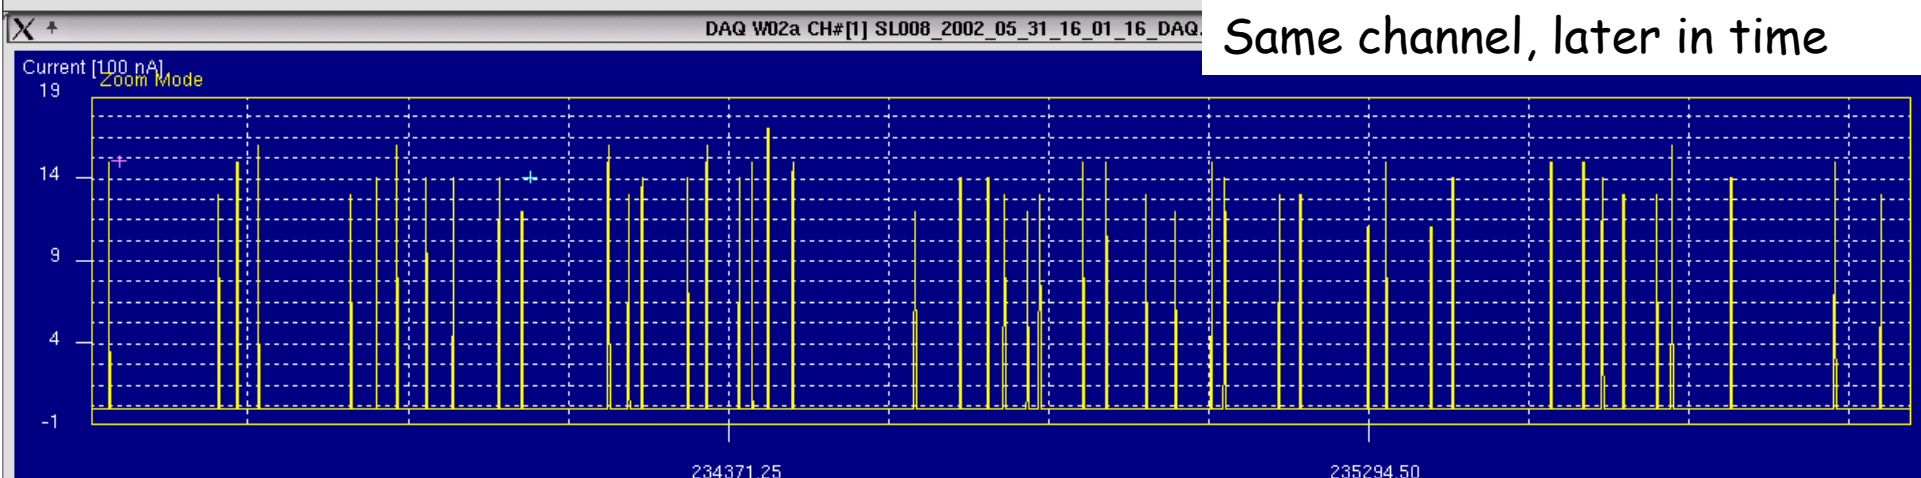
# Current Fluctuations

- I-values above 10  $\mu\text{A}$  (wire), 20  $\mu\text{A}$  (strip, cathode)
- Current were high for several seconds, not steady
- Even after many hours of running

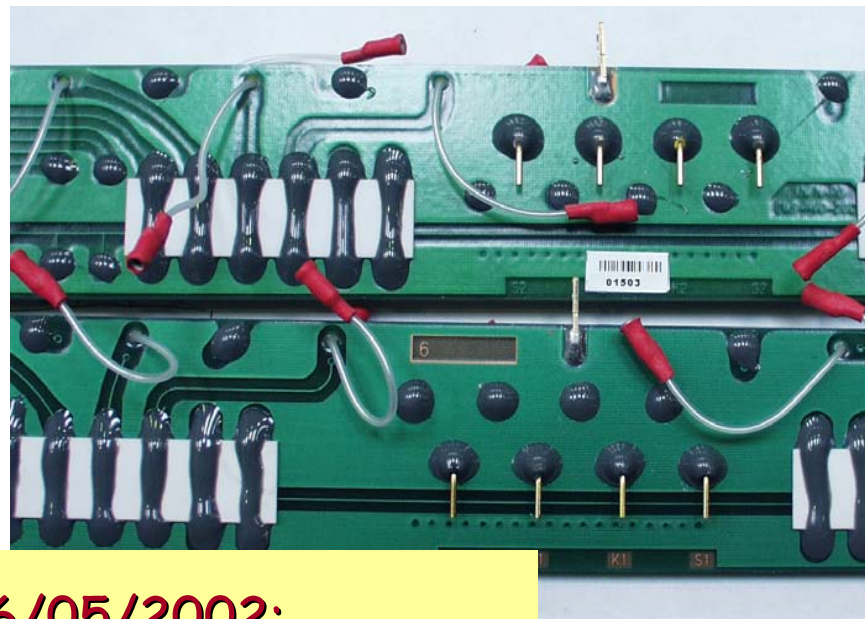
- ◆ Suspect HVB quality differing
- ◆ 15/16 (already) exchanged HVB because of high current, were optically „not good“
- ◆ During this week 2 more HVB failed. One HVB in a SL which has been running for ~2 weeks.

**Failure fraction as of 06/05/2002:**

16 failed HVB / 228 tested HVB = **7%**

**Diagnosis:** If such a faulty HVB is in the SL - relevant board seems „unstable“

- ◆ Decision by the collaboration 15/05/2002 to replace all HVB installed so far and re-cable
- ◆ Status 07/06/2002: 16/22 SL have been re-done, all HVB were removed and optically inspected
- ◆ Speed: roughly 14 SL in 2.5 weeks. Remaining 6 SL approx. in a week
