# CMS Week 10-13 June 2002

## HVBs Summary

M.De Giorgi

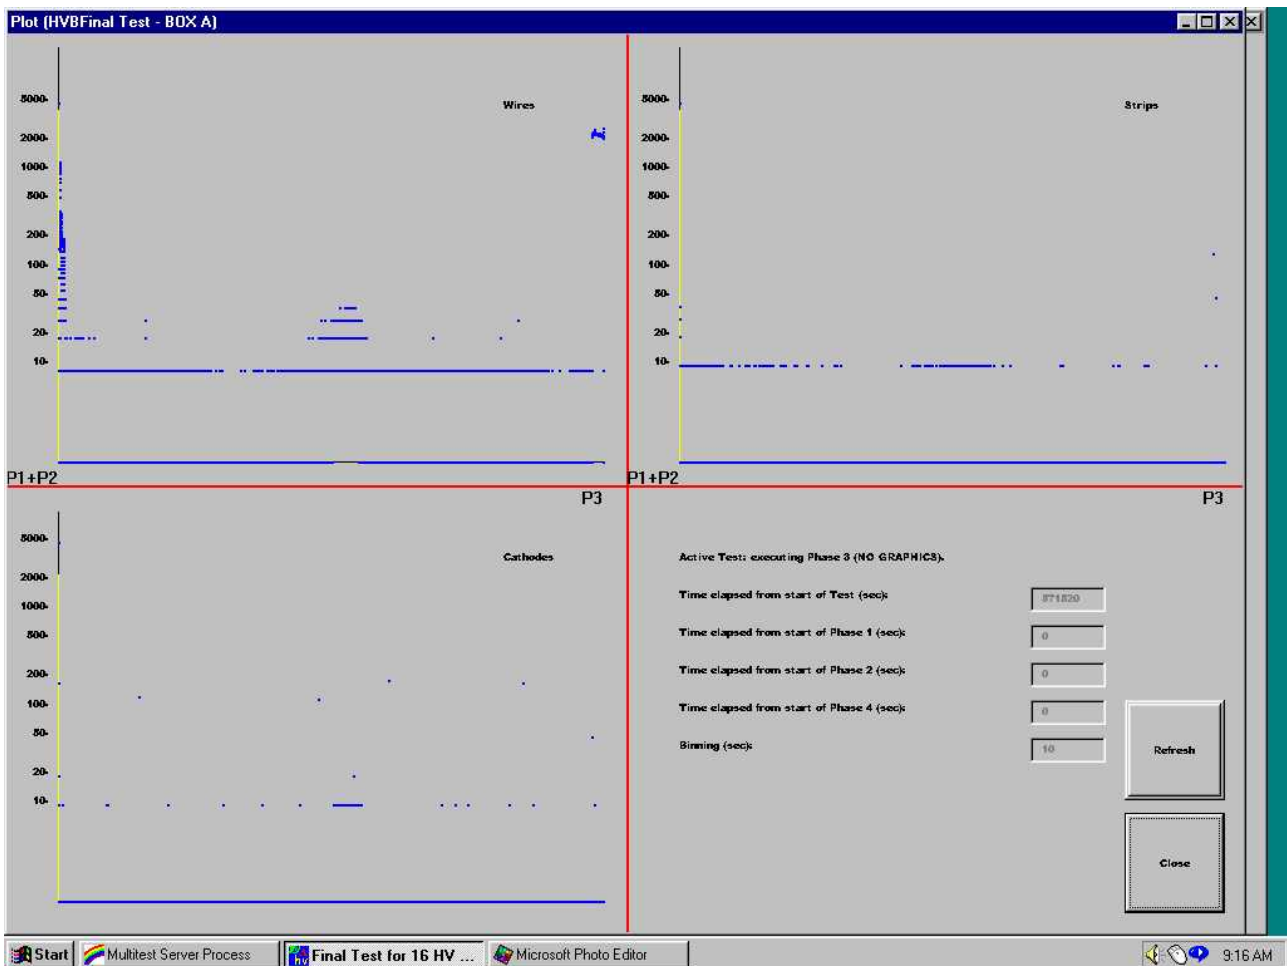
#3307  $\Rightarrow$   $\sim 2 \mu\text{A}$  after 6.5 days

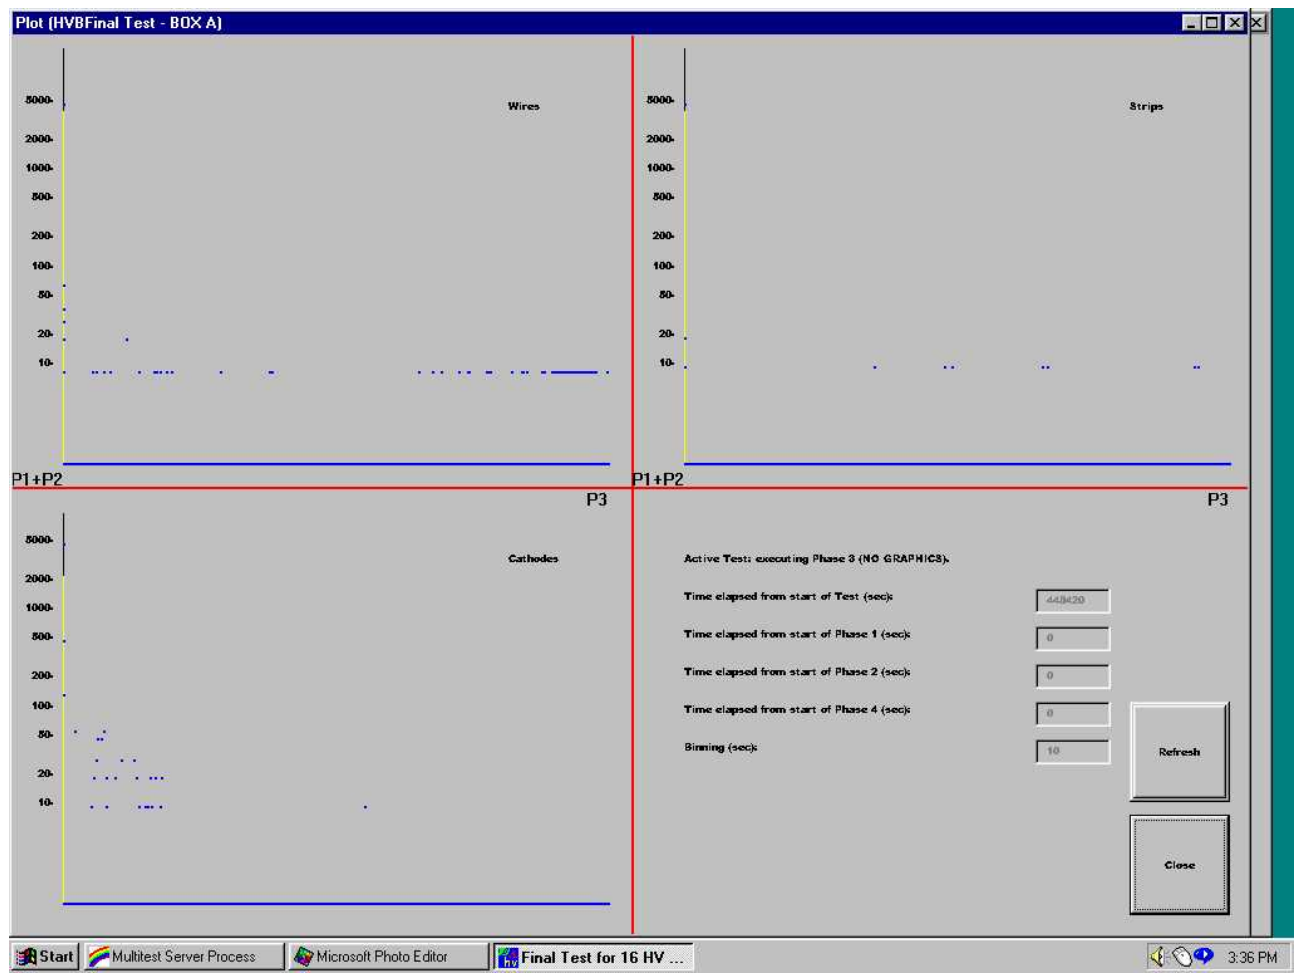
#3307 taken away

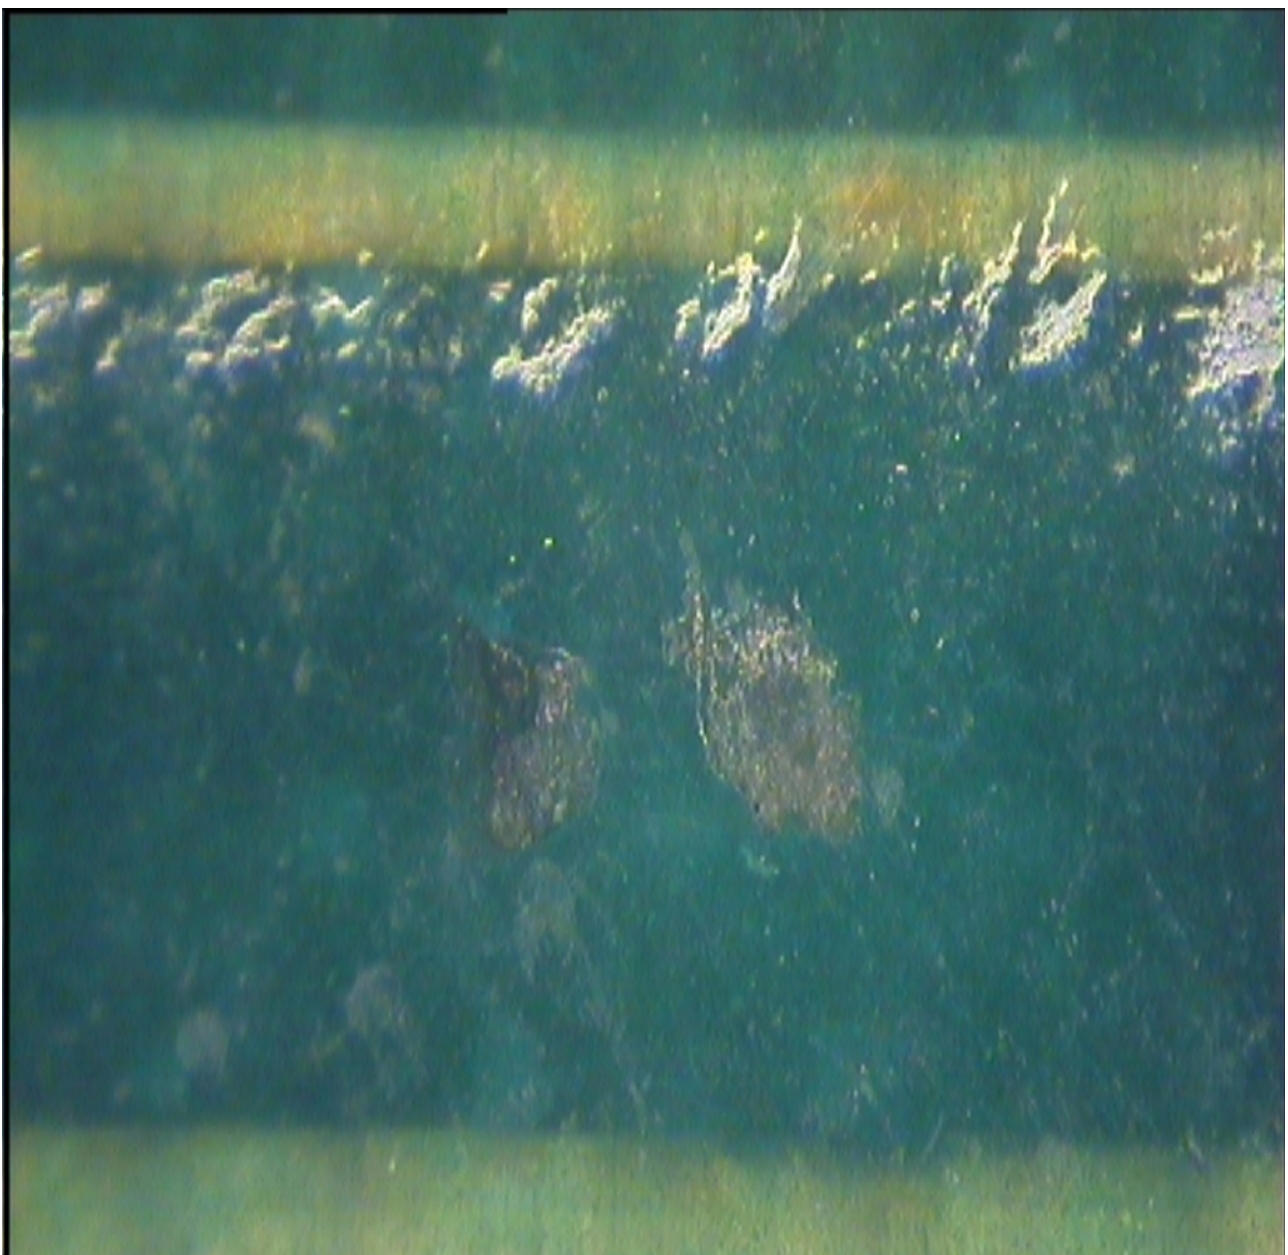
**LNL – HVB # 3307**

- 16 HVBs clearly showing the weave pattern were put in a test jig in gas for a long duration test run at ~220ppm O<sub>2</sub>.
  - ⇒ After a week one board went off to ~2μA. The board was taken away from the jig for inspection. A clear spot covering a W path and the near GND was visible, having two small dots around its center. By applying 5kV to the W paths via an HV insulation meter, a small flash was visible in correspondance to the spot.

- ⇒ At a closer inspection with a microscope the two dots appeared to be scars as if produced by some sharp or pointed body. We will try to have a microscopic cross-sectional analysis of this. The residual 15 boards were kept under test in the jig for another week with quite operation (~0 currents).

**a) View of leaking point**

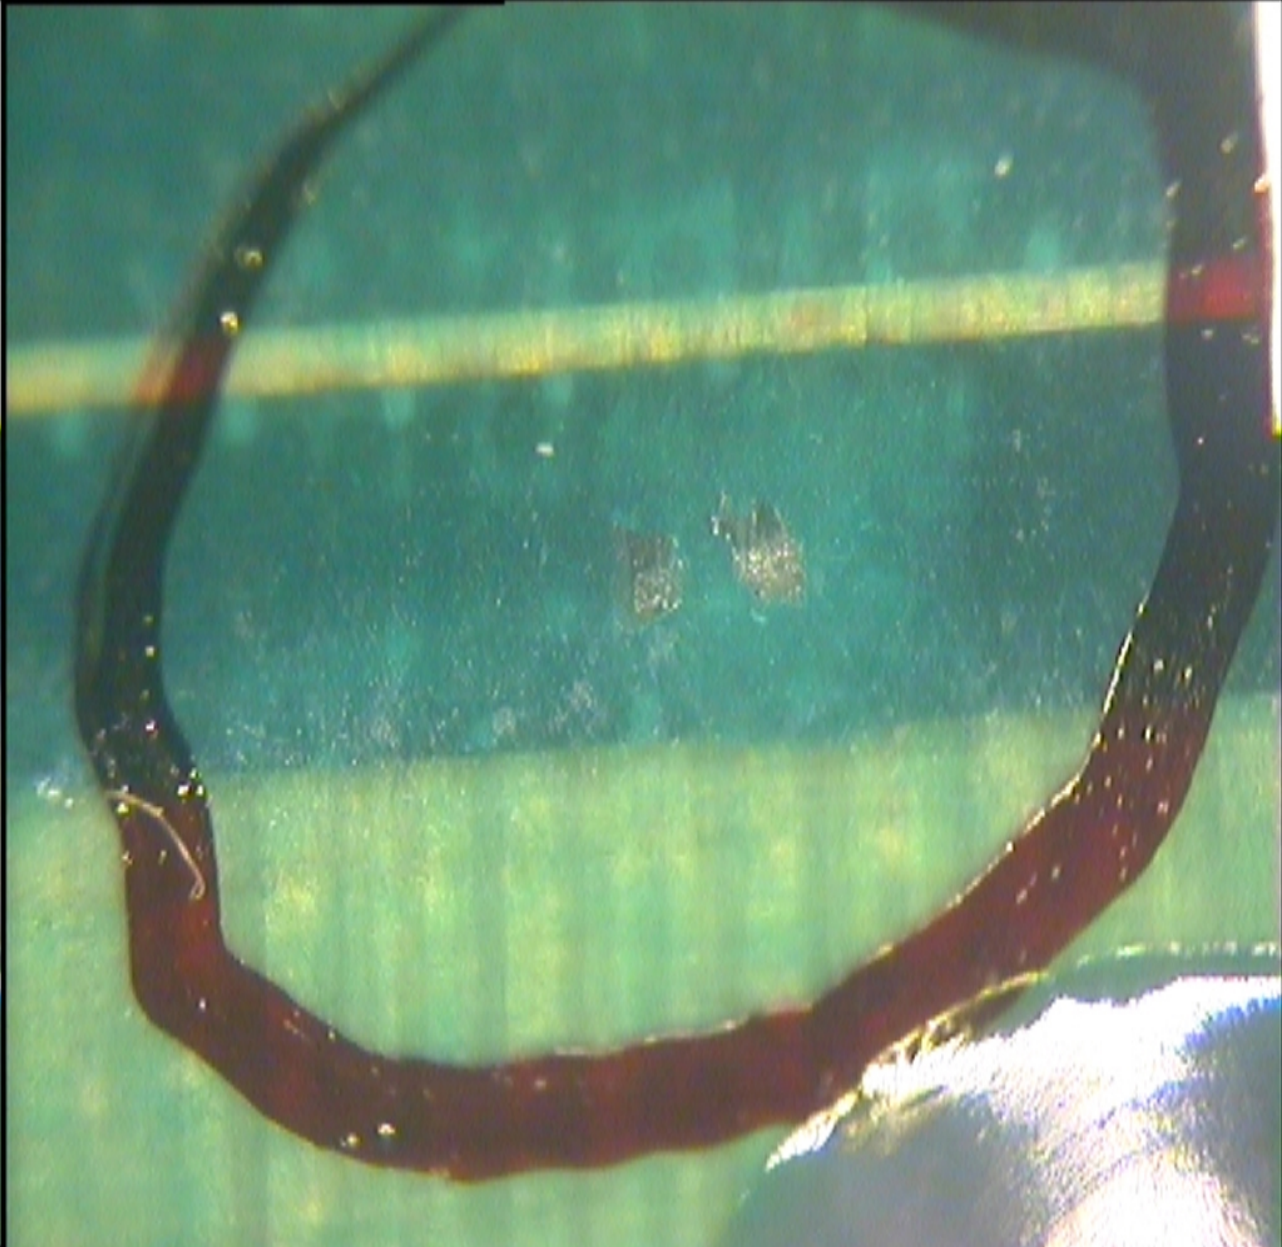
LNL – HVB # 3307

b) View of leaking point

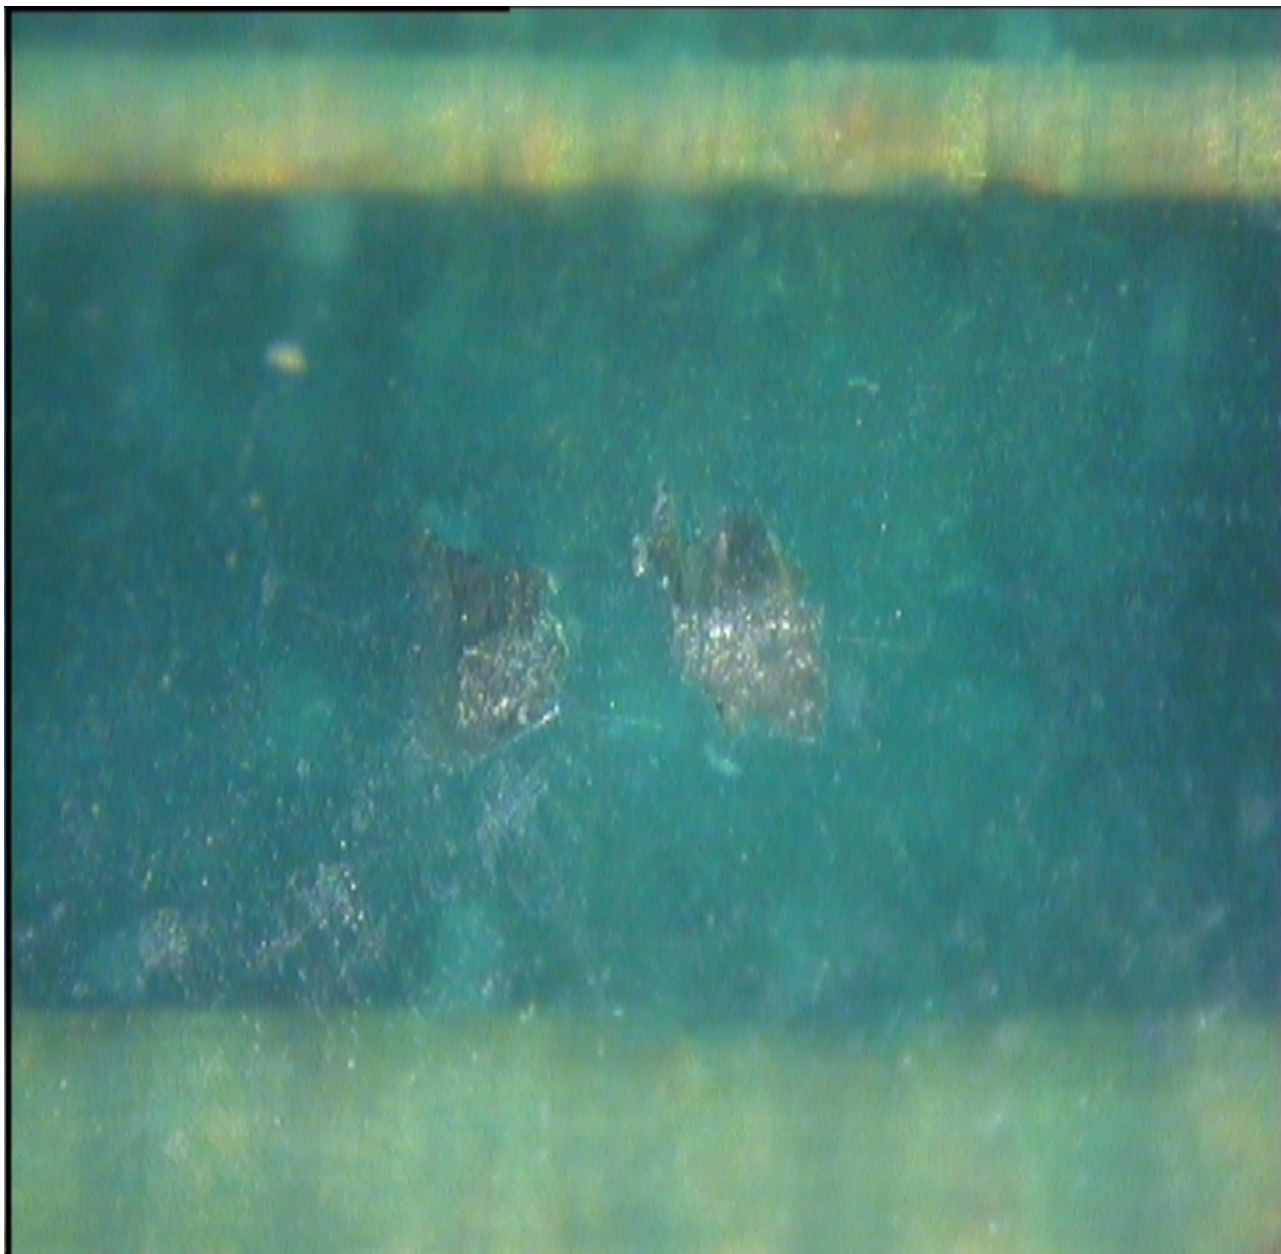
**LNL – HVB # 3307**

**c) View of leaking point**

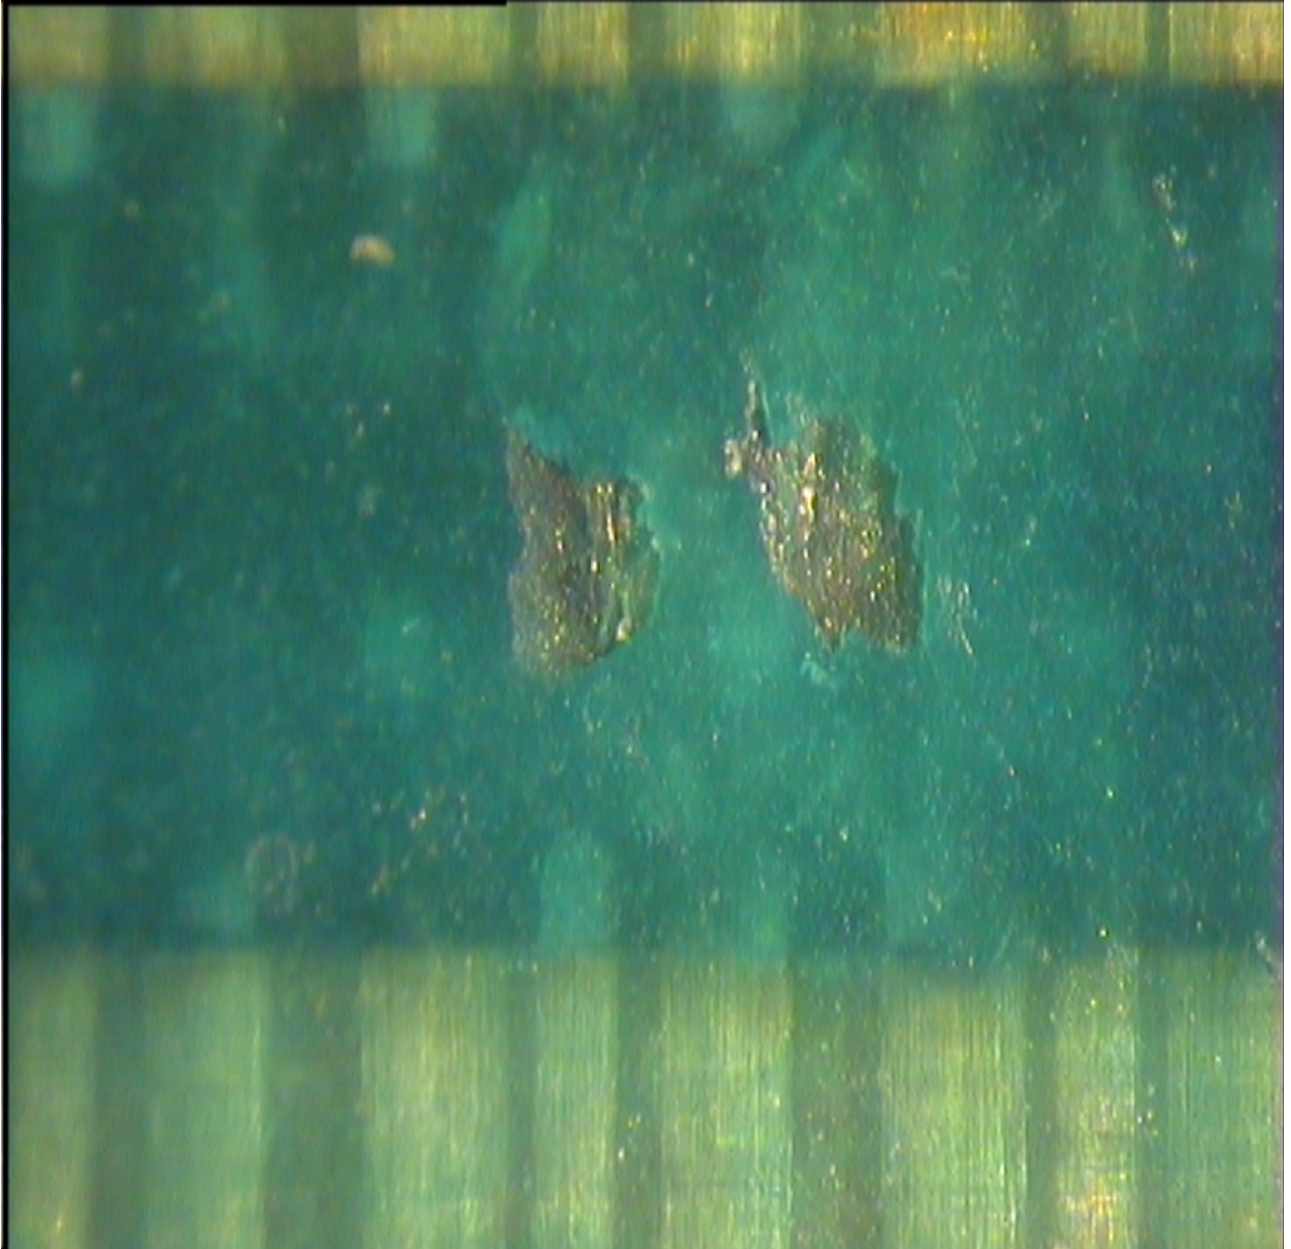
LNL – HVB # 3307

d) View of leaking point

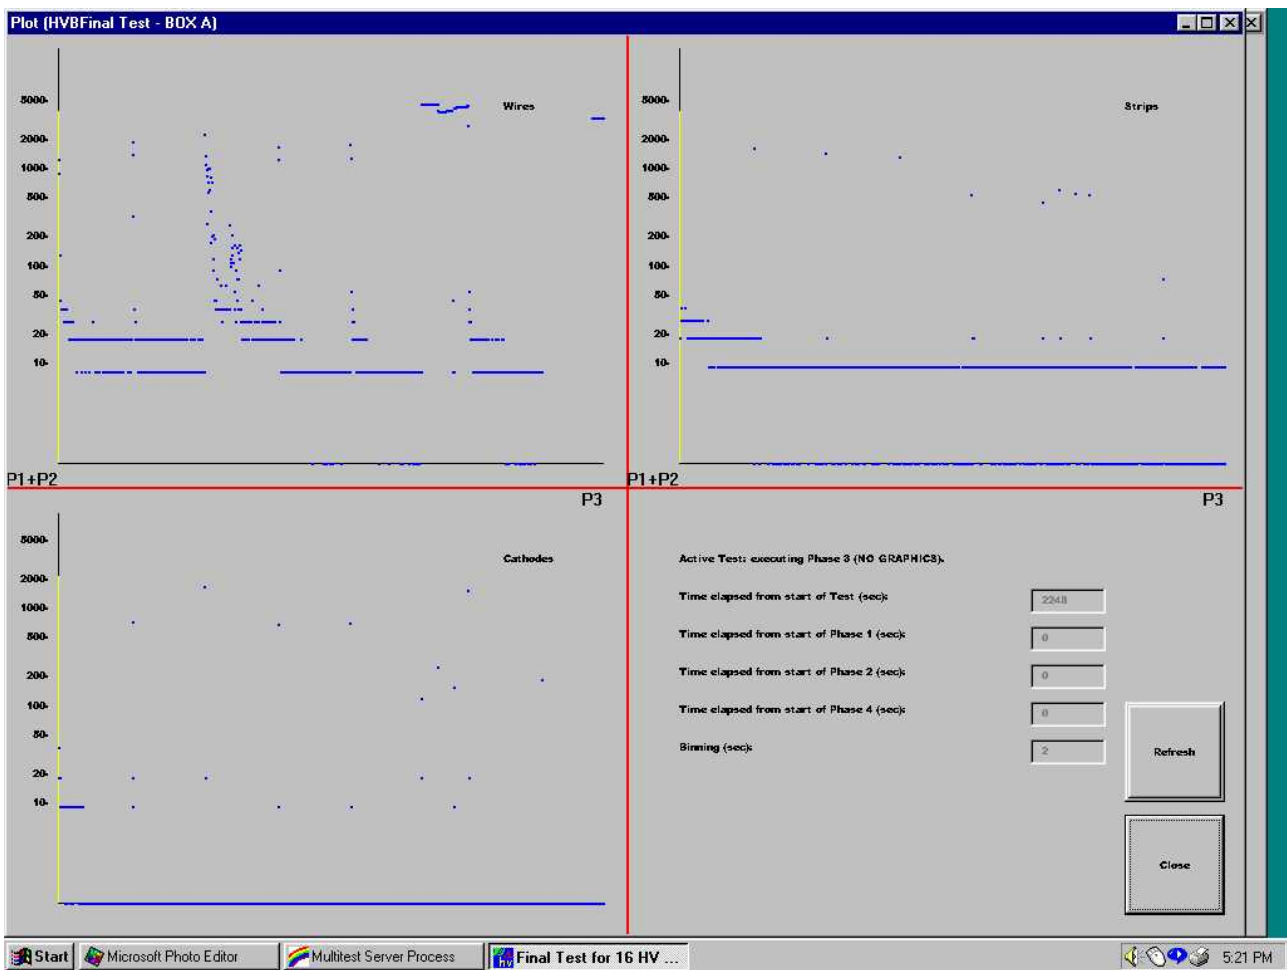
Aachen-10 preliminary test in Air

- 1) #1475 OK (10÷20nA reached in 5 min.)
- 2) #1374 OK
- 3) #1474 OK
- 4) #1360 OK
- 5) #1373 OK
- 6) # 728 BAD (4÷5 microA)
- 7) # 2317 BAD
- 8) #1441 BAD
- 9) #1359 OK
- 10) #1529 BAD

**B)** The 4 BAD were taken out of the Jig and inspected: all 4 show a dark inclusion 2÷3 mm diameter across an HV path with a small bump in correspondance.

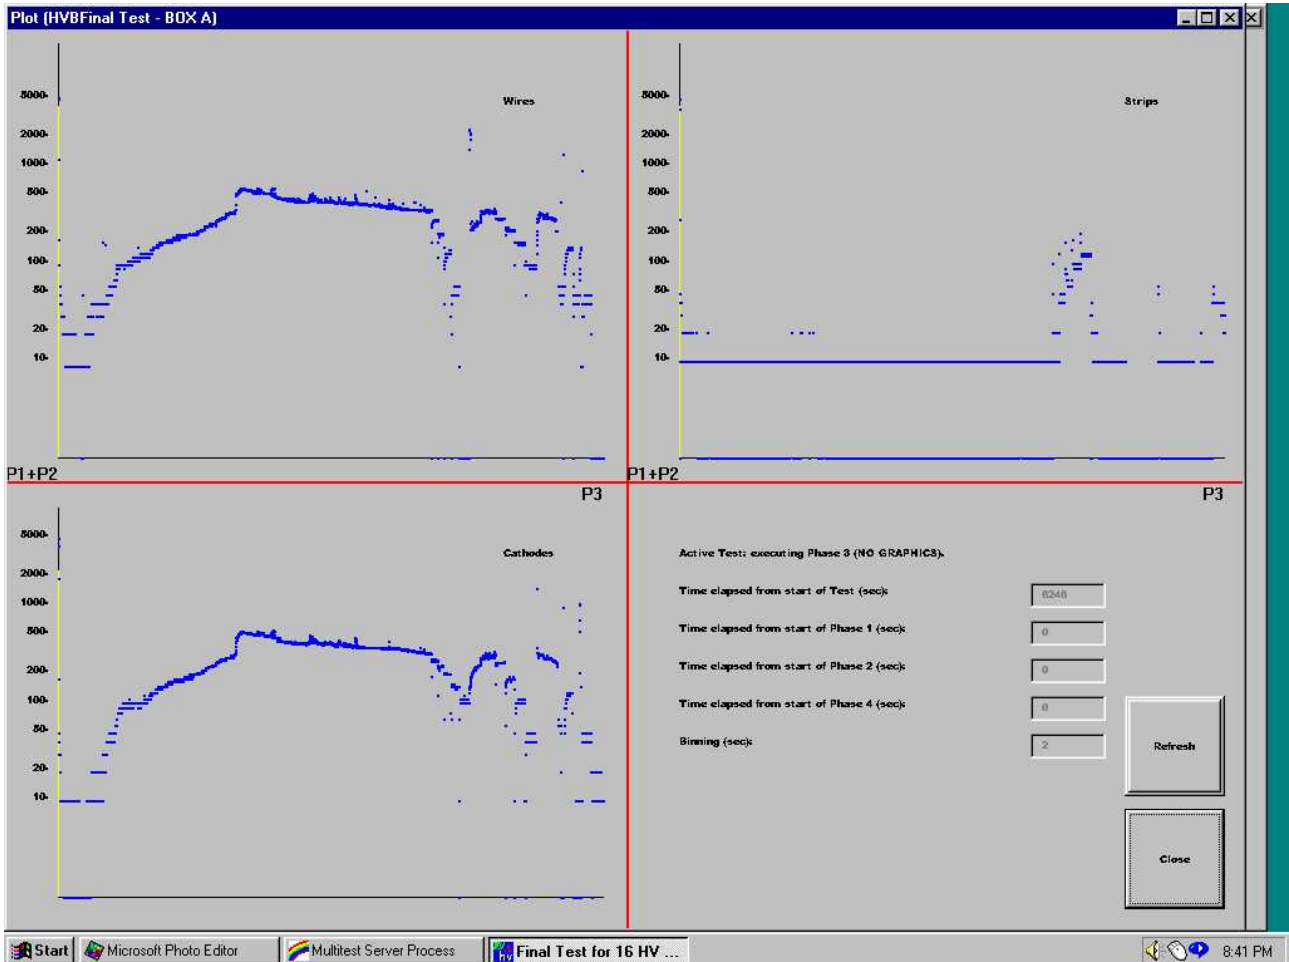
Aachen-6

**C)** The remaining 6 were put in gas and while the O<sub>2</sub> went down to ~1% #1475 and #1373 started to draw ~100nA between W and C. the current went to 0 instantly as soon as the Jig Box was opened : the problem is external, related to some mounting defect.

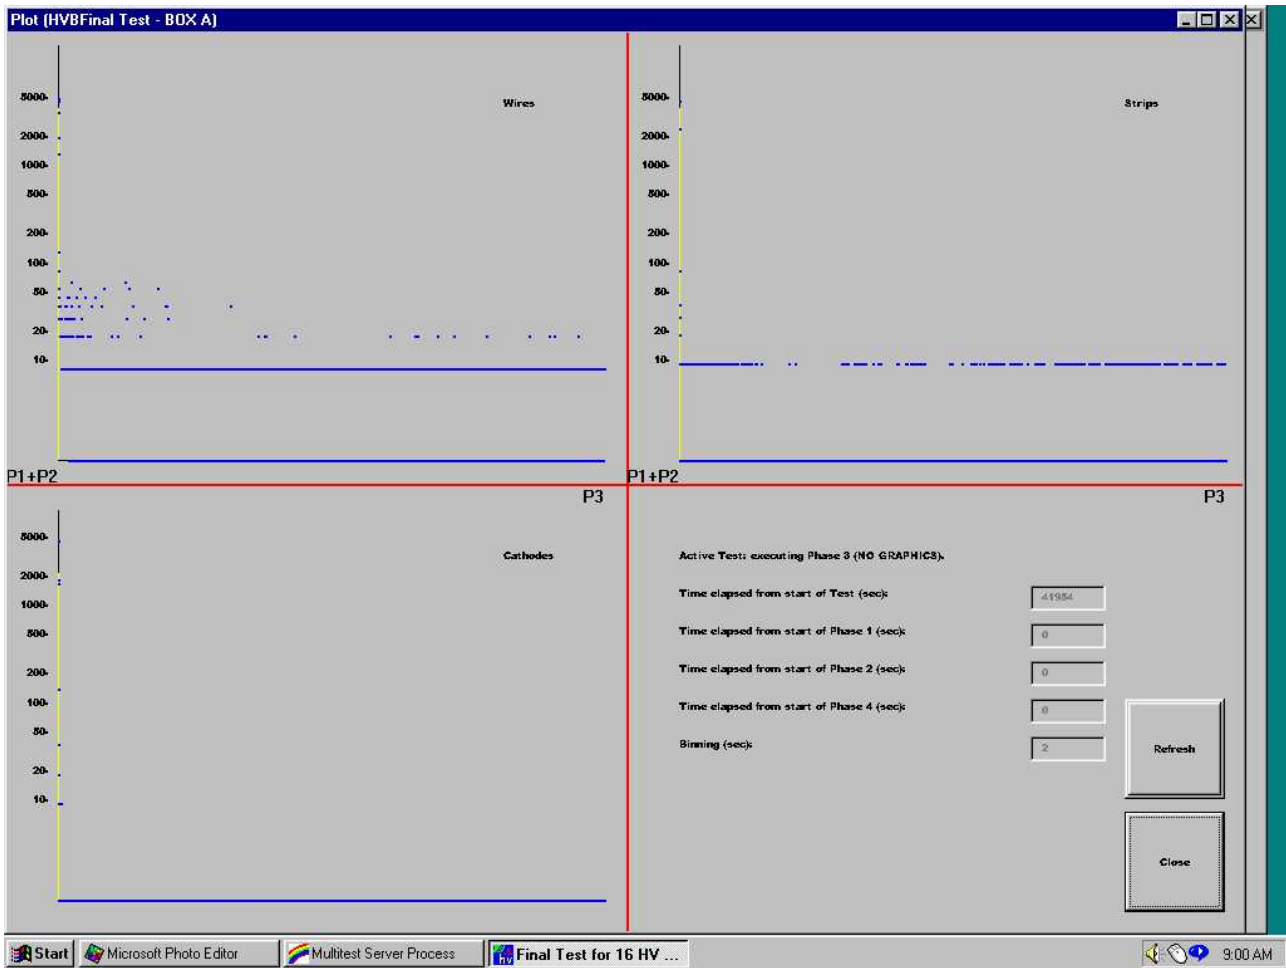
Aachen-4

**D)** Boards 2), 3), 4), 9) of the above list are kept under test as long as possible at ~40÷50 ppm of O<sub>2</sub>. They keep to show ~0 currents. #1474 is slightly "noisy" showing occasional jumps to 40 nA .

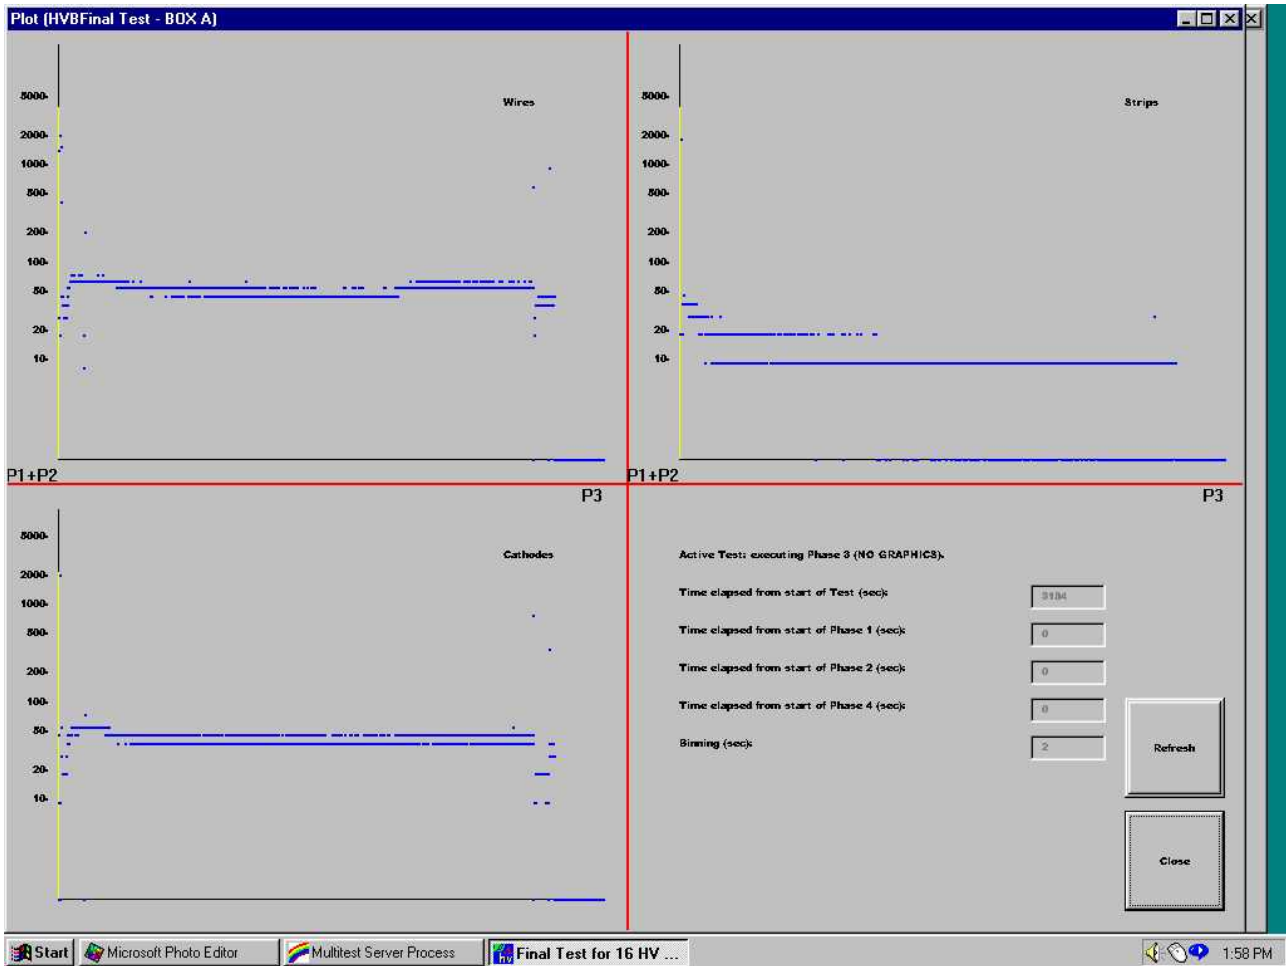
Aachen-13735-1

Jig Box opened I<sub>w</sub> = 0
