CMS
BARREL MUON
DT CHAMBERS

Status of
Production
at Aachen

Hans Reithler
020611

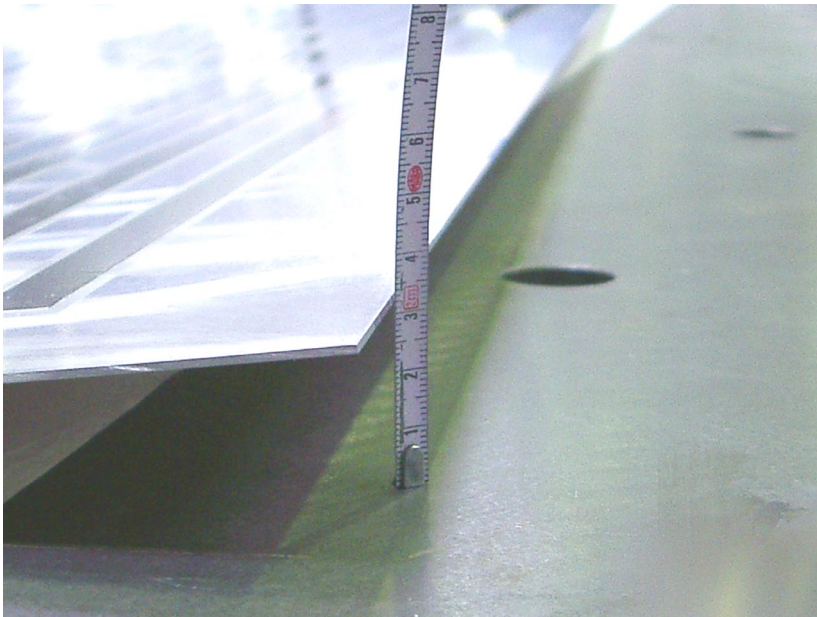
Newest batch of plates also contains plates with large bending (here ~33 mm).

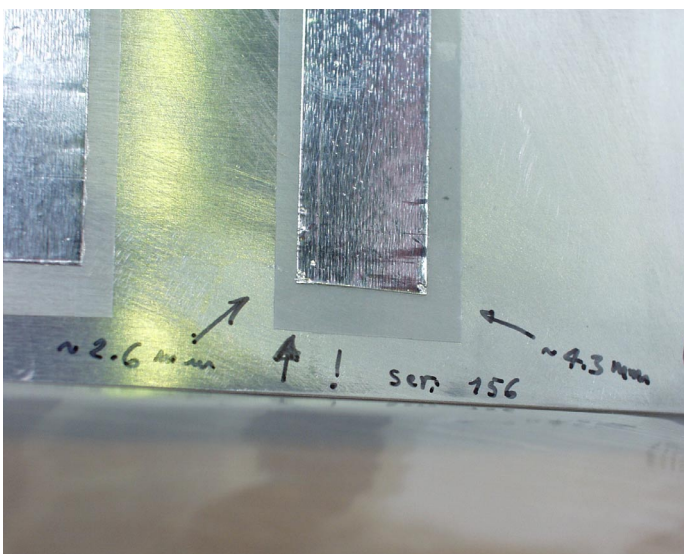
Concern: HV risk due to small insulator border outside specs (here 2.6 mm). Known problem at strip ends. In latest batch, on 63 faces found 315 strips with border < 3 mm. What to do, when below 3 mm limit (beyond another 4 kV / 10 min. HV test in air)? Attempt to remove ~1 mm Al at narrow border?

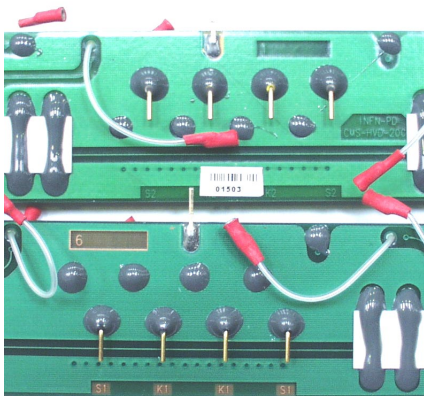
Two HVBs from two different batches (distinguish at layer numbering fields, at bottom here). Those from the batch at the bottom look all fine... but only ~500 pieces were delivered by this producer (from MDG).

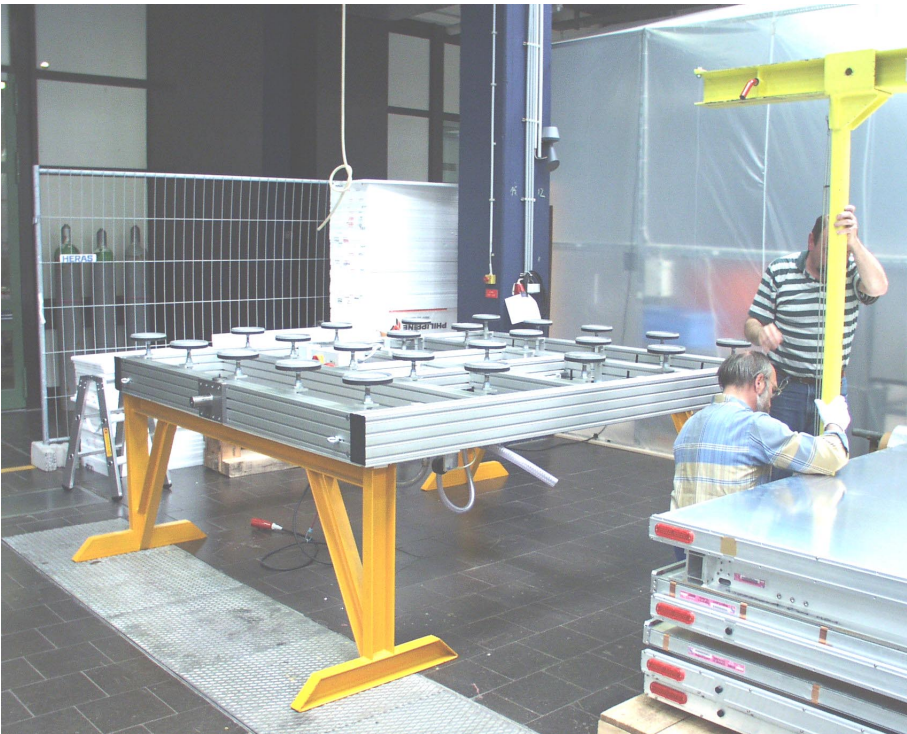
The vacuum lift is placed upside down on a support. The 24 vacuum pads are visible at the top.

The system is hold, hanging from the crane and with the vacuum lift activated but serving merely as load under the DT, ~2 cm above the support for 1 hour.

This additional load amounts to 270 kg, i.e. about **200% of the load from an RPC**.

The tension forces between load and honeycomb pass through 2 SLs.

3 precision gauges (one is visible here), mounted on a ruler underneath the DT, monitor deformations of the bottom face of the DT.

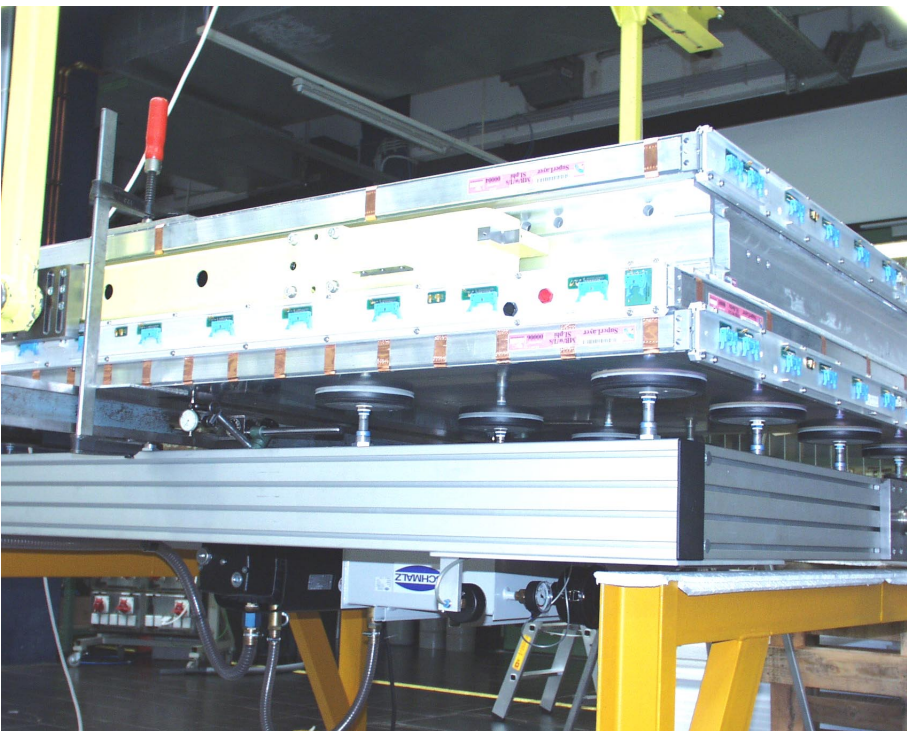
Load test performed on an MB1 chamber, to test the gluing of SLs and of SL to honeycomb panel. Result: within the test duration, no sound was heard and no deformation observed.

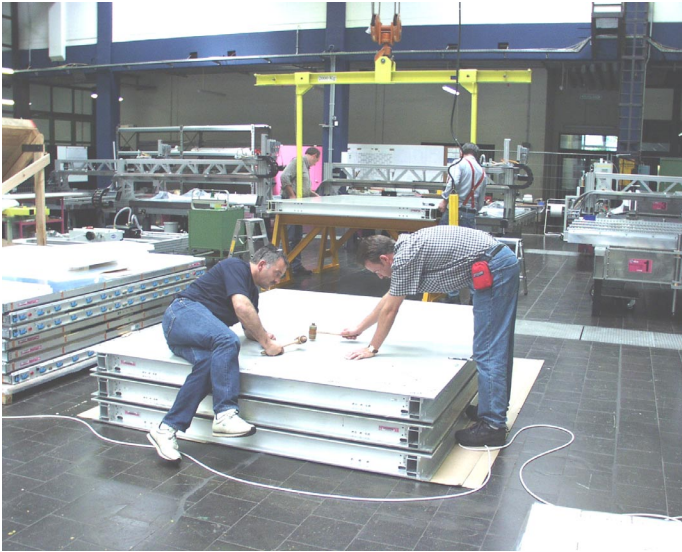
Routine test of honeycomb panel, here being performed by workers from Hexcel at Aachen to recheck the panels delivered. Hit gently with a hammer; if a region of the skin is not well glued, a difference in the sound is clearly noticed.

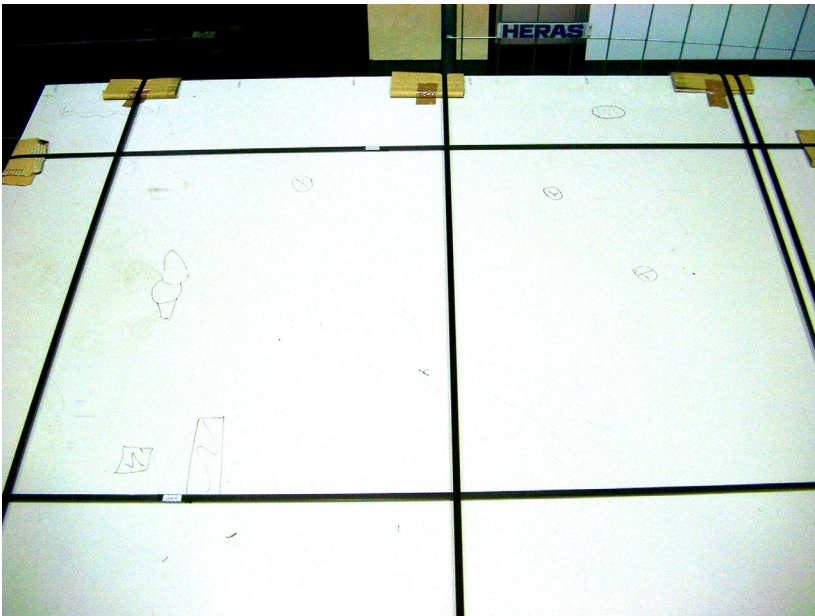
Surface of a panel being returned for repair, with the questioned areas marked by hand. This shows that even very small regions of bad gluing can be spotted.

The origin of the problem is understood and the panels are repaired.

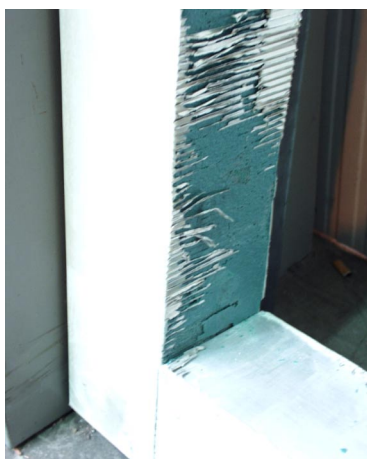
Detail of the frame from the worst panel found (an MB3), after dismantling. The rests of honeycomb along the vertical part confirm that it was well glued to the lateral C-profile, as it should.

Summary: a problem was found and solved. Panel delivery still done within deadline, thus not affecting DT assembly.
