# ISR Work Progress Report

CMS Week June 2nd 2003

A. Benvenuti  
INFN Bologna

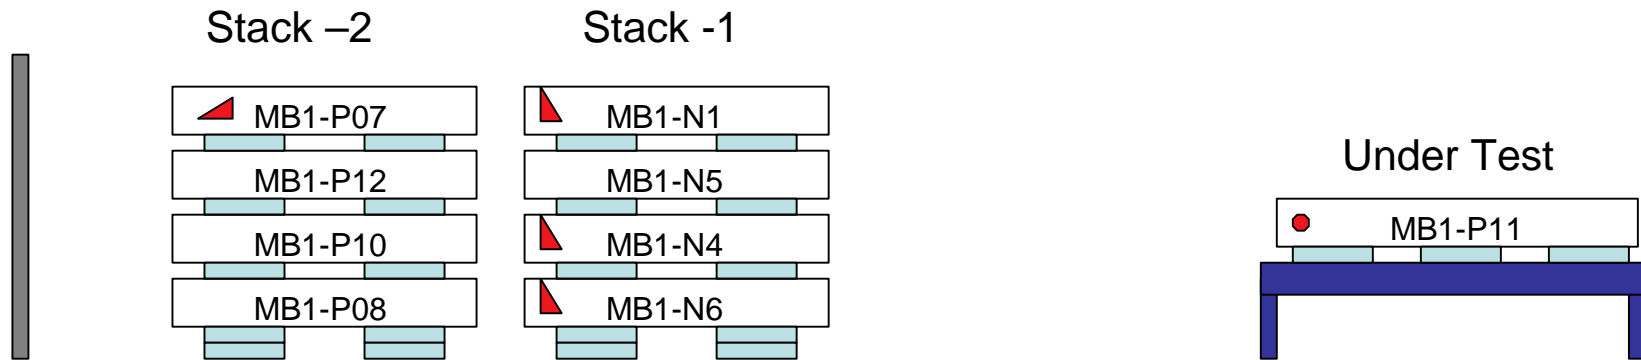
## Chamber Stacks Layout In I3-I4 Tunnel (part 1)

- All chambers under Gas
- Space for moving chambers between table and Stack -1

- ▴ Chambers with DCS problem
  - ▴ Front-end board problem
- SL must be opened to fix problem

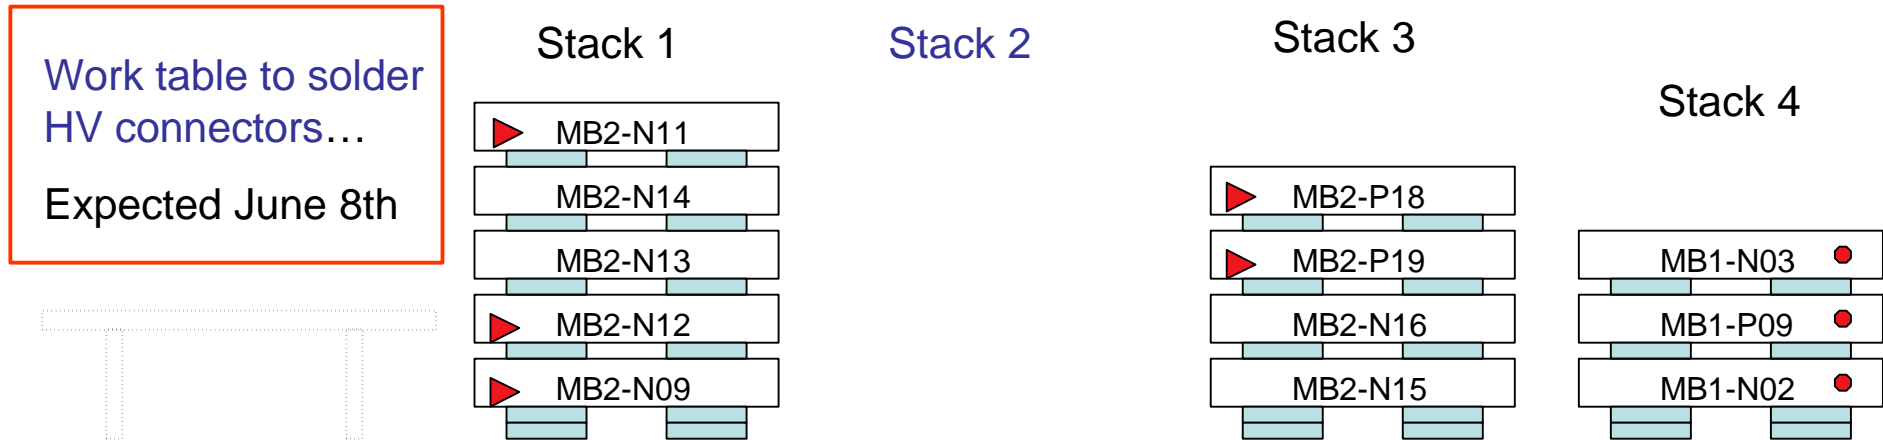
## Chamber Stacks Layout In I3-I4 Tunnel (part 2)

### ▶ HV problems:

- MB2N11: Phi1 B connector clicking badly
- **MB2N12**: Phi1 A short, Phi1 B OVC at 3000V
- MB2N09: Phi2 B OVC
- **MB2P18**: Phi2 A wire Layer 1 e, wire Layer 0 d
- MB2P19: Theta B connector clicking badly, ground strap on DCS card
- **MB2N15**: Phi1 A short, Phi1 B OVC at 3000V, Theta strip Layer 2 g
- **MB1N03**: discharges inside Phi2 B connector **FIXED**
- **MB1N02**: Phi1 A layer 0 board e (at acceptance test) **FIXED**

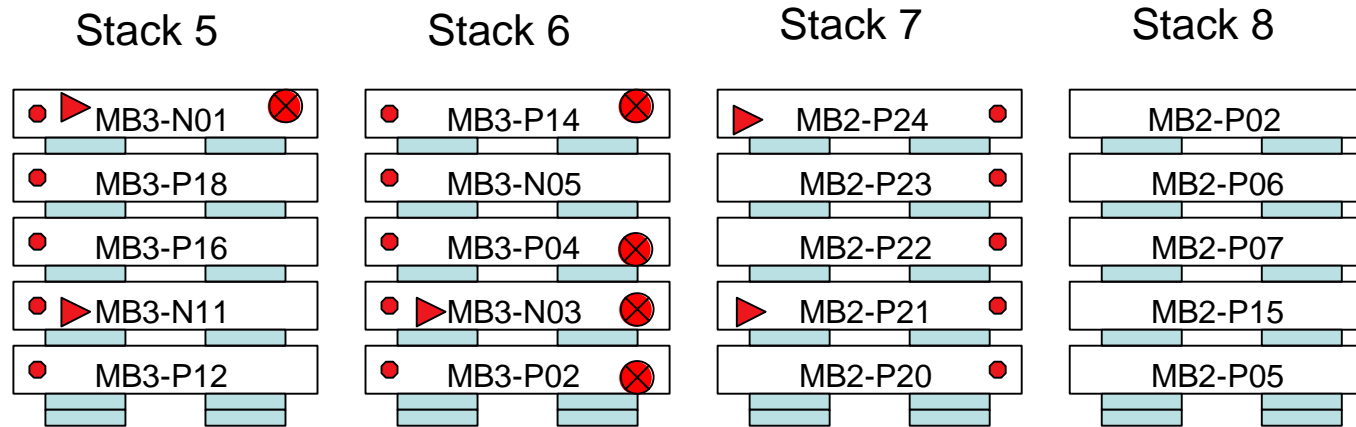
## Chamber Stacks Layout In I3-I4 Tunnel (part 3)

- Chambers under HV
- ⊗ Gas Problems
  - One wrong connector glued to gas cover (bad thread) P02
  - 7 gas caps glued to gas cover
    - MB3 N1 (Phi2, 2), P14(Tht,1), P4(Tht,1), N3(1 on each SL)

- ▶ HV Problems:
  - **MB3N01**: Phi1A cathode L2 c1 c-d
  - MB3N11: Theta B clicking badly
  - **MB3N03**: Phi1 A L0 board e, Phi2 B wire short Layer 3 board a
  - MB2P24: Phi2A Clicking badly
  - MB2P21 Phi2A OVC

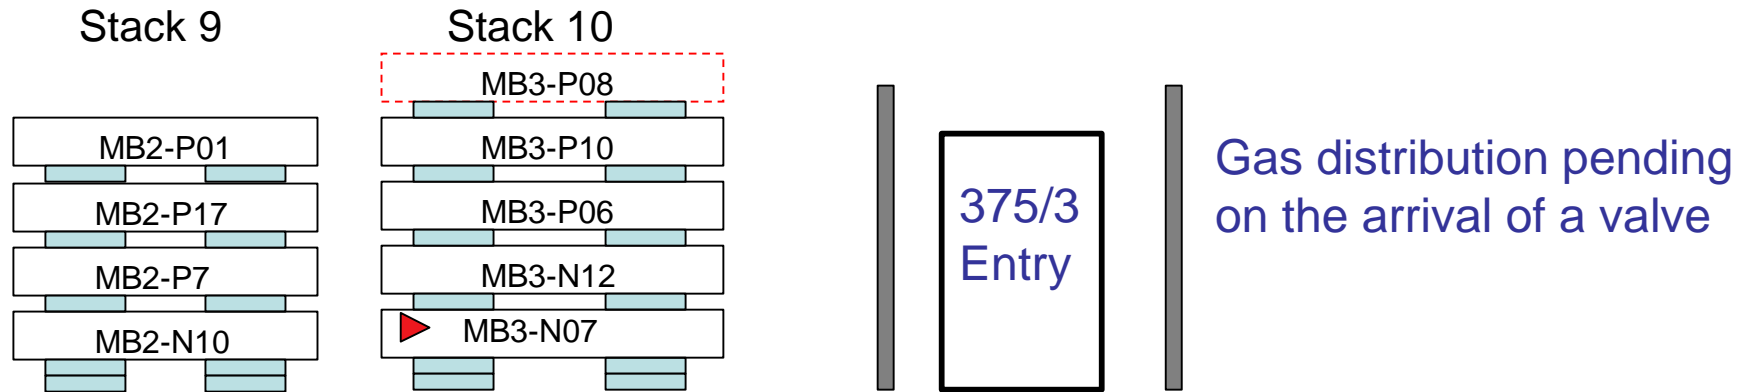
## Chamber Stacks Layout In I3-I4 Tunnel (part 4)

### ▶ HV Problems:

- MB3N07: Phi1 B OVC and badly clicking
