ISR Work Progress Report

CMS Week December 9th 2003

A. Benvenuti
INFN Bologna

ISR Status

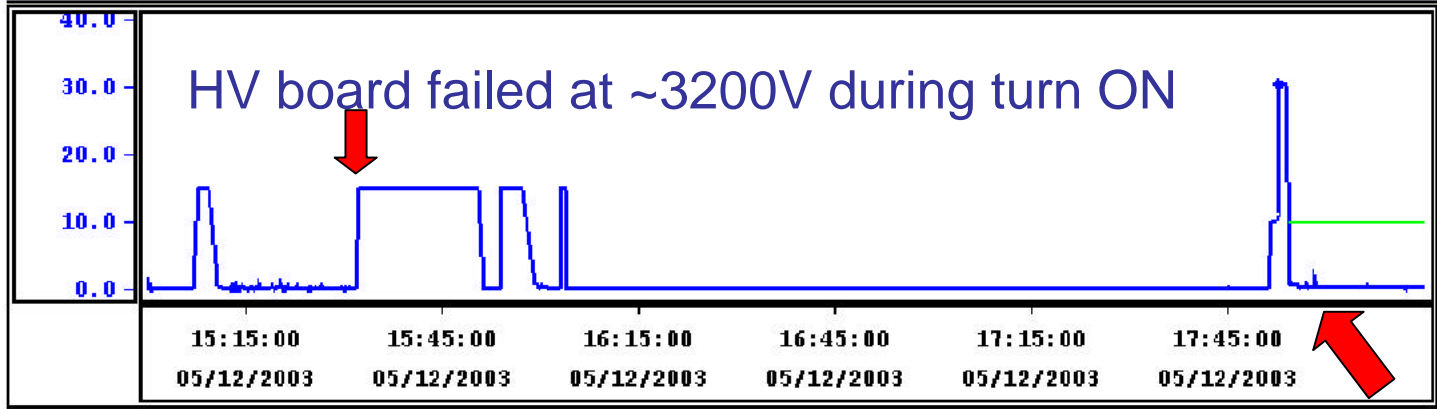
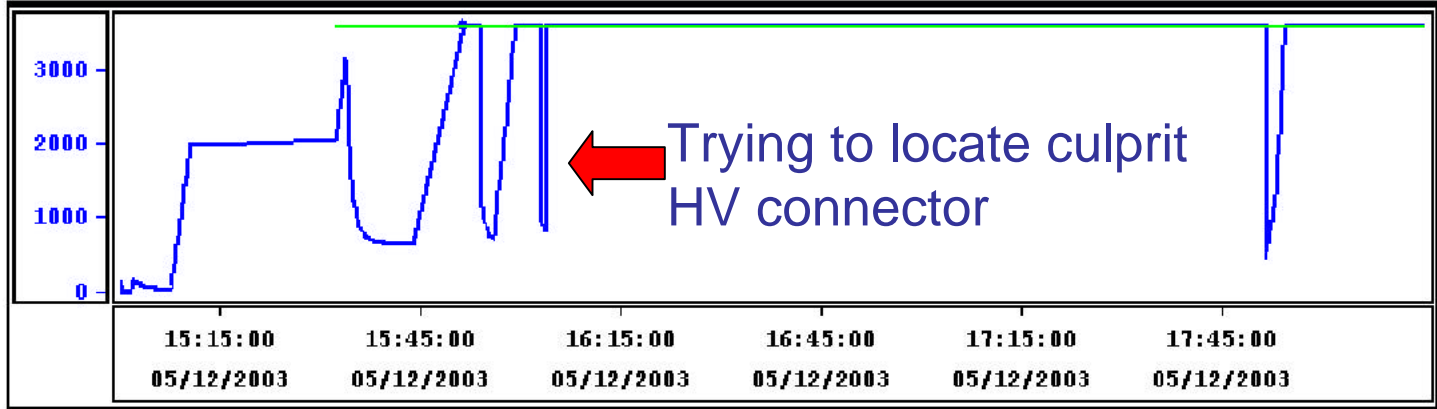
wires MB3C04

- The chambers are tested with scalers and front-end DCS after the dressing procedure is completed. The chambers are put under HV and all SLs are tested.
- 3 MB3 chambers failed at this stage: **MB3P14** and **MB3P12**, for YB+2 installation, on 28/11/03 (repaired and tested again with cosmics) and **MB3P04**, for YB+1, on 5/12/03. All failures occurred during power up.
- These chambers were taken off the HV test at the end of June after:

MB3P04 **2513h**, MB3P12 **2444h**, MB3P14 **2490h**
- **MB2P17** (YB+2 installation) gave clicking sounds (discharges outside the cell) when put under HV for the DCS-scaler test. The problem is mainly on the Phi2SL B connector but has not been localized.

Glitch after inserting HV (Ignore)

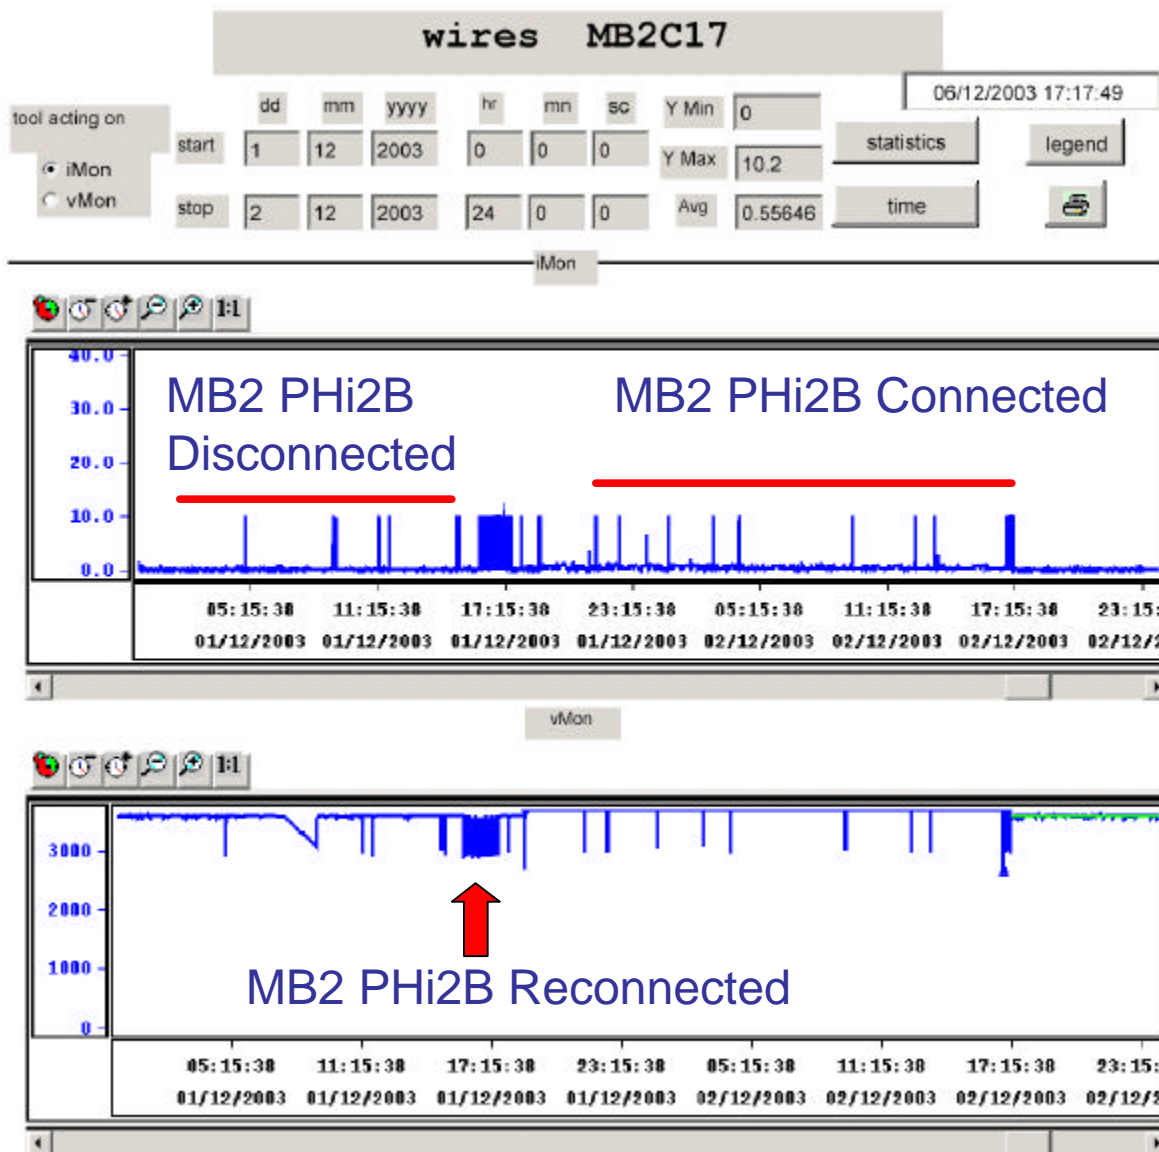
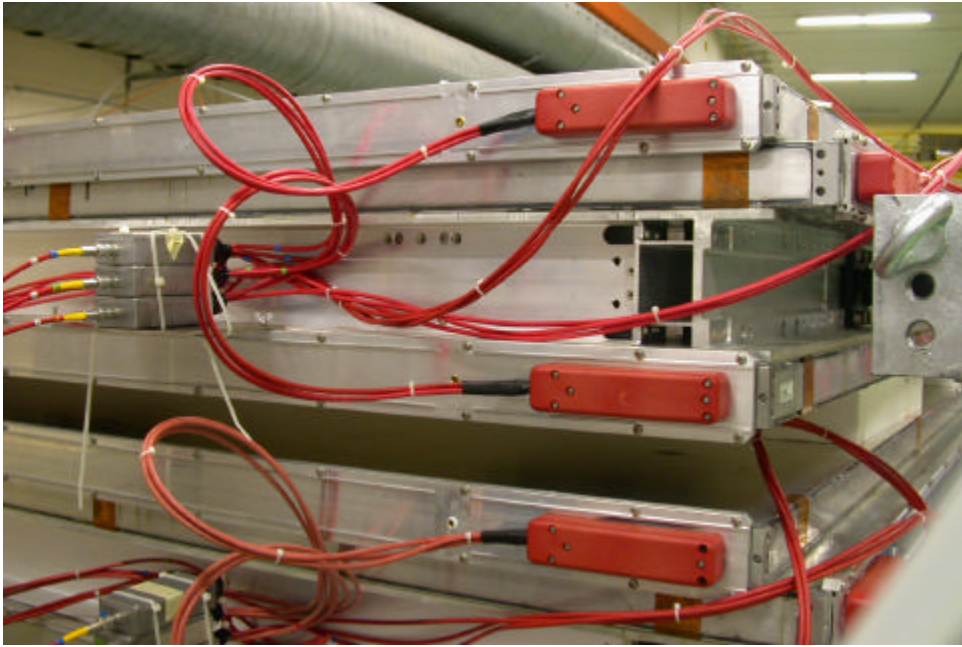
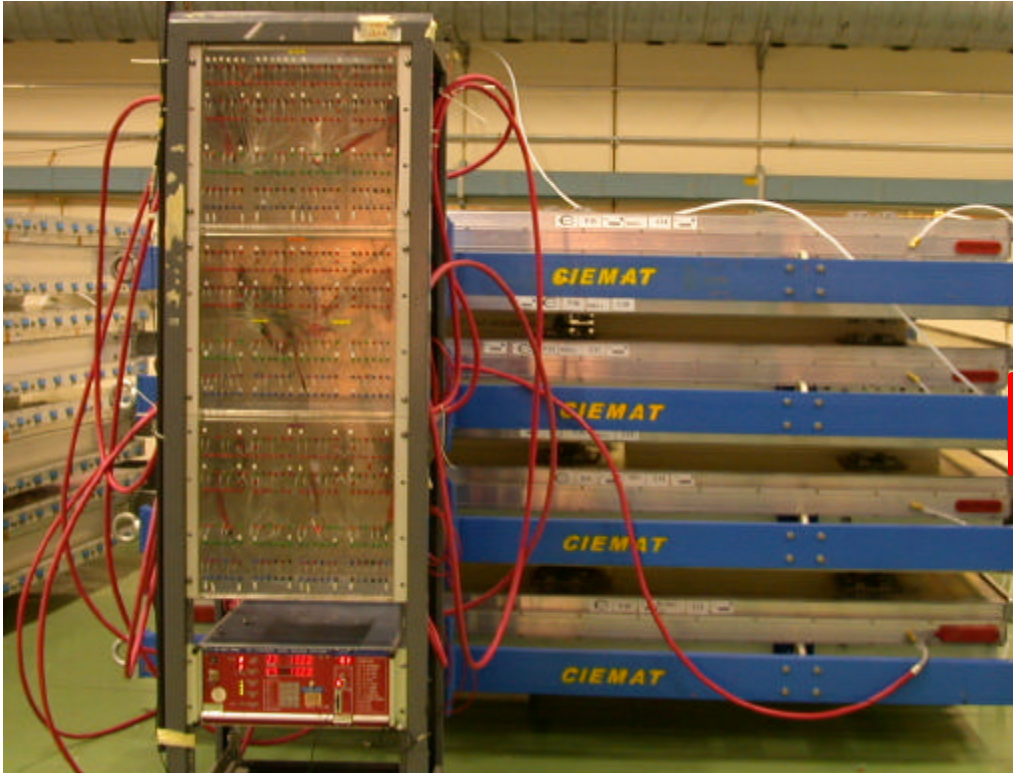
MB2P17 and MB2P24 are on the same HV channel.

MB2P17 was discharging (clicking) the problem was localized on MB2P17 Phi2 B connector that was removed until 01/12 at 16:30 when it was put back to take data with scalers.

Since this did not help to find the problem, Phi2B was put under HV on the CLONE system (allows to isolate HV boards) but the clicking disappeared.

Back to the standard HV system still low clicking rate????

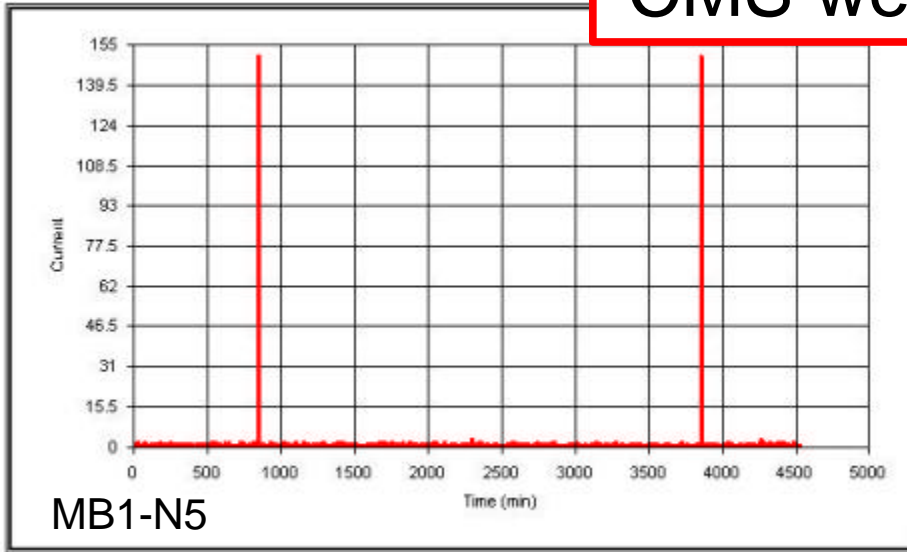
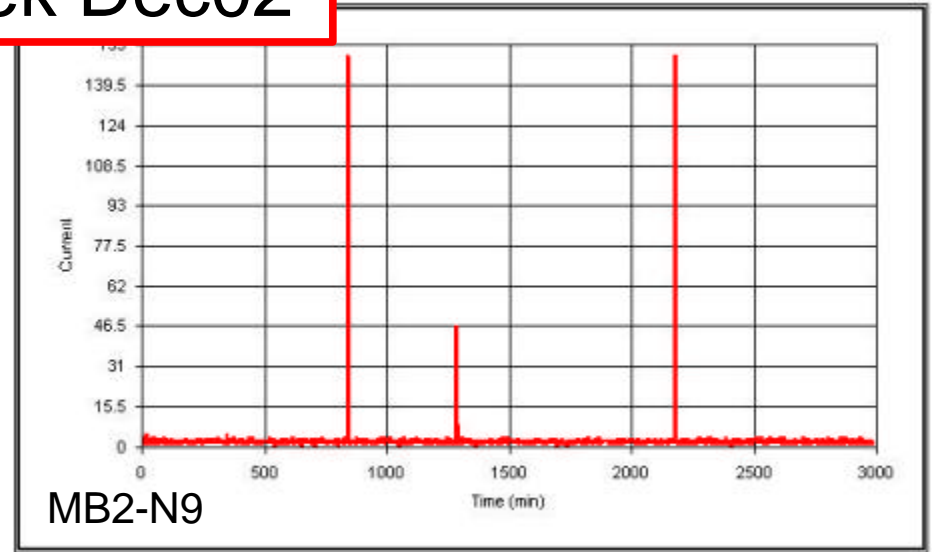
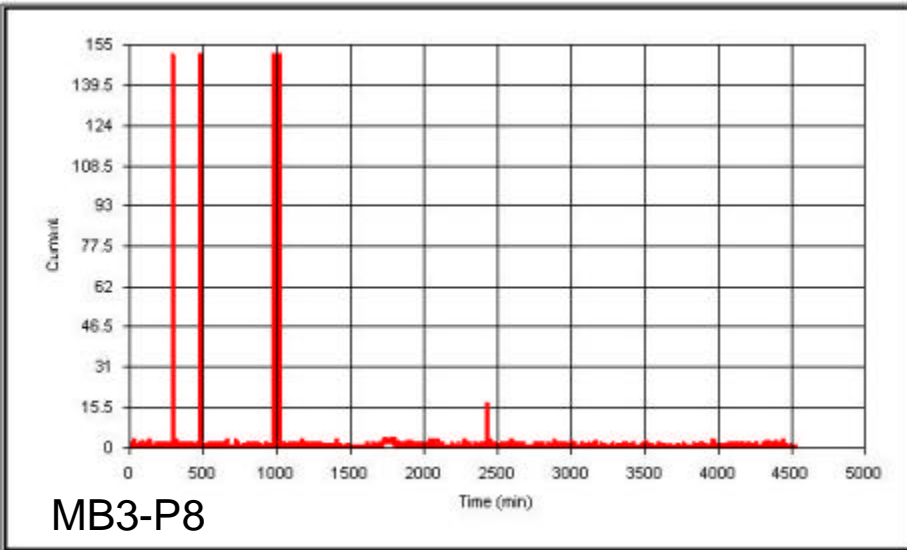
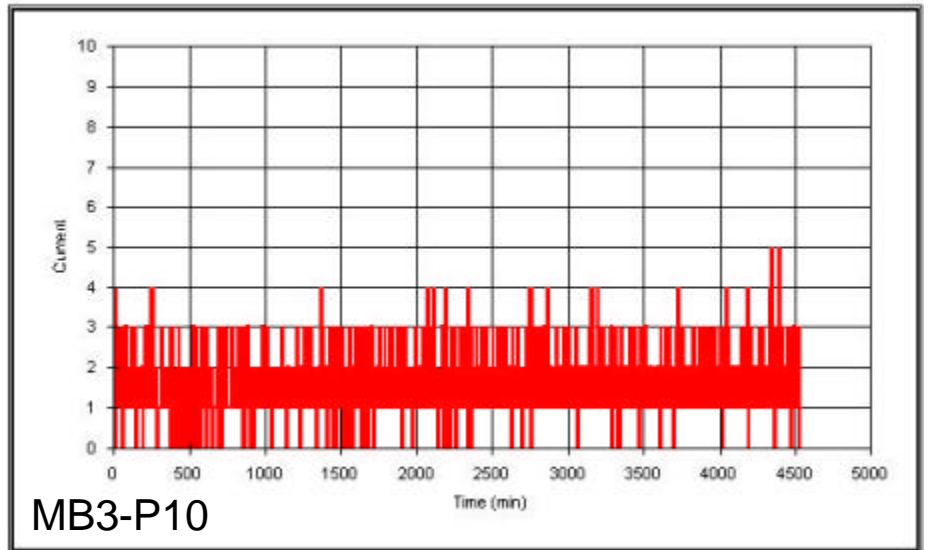
HV Long Term Test Current Monitor

Observe discharges outside the cells in Long Term Test (clicking sound)

➔ Patch Panels unisex or DT specific?

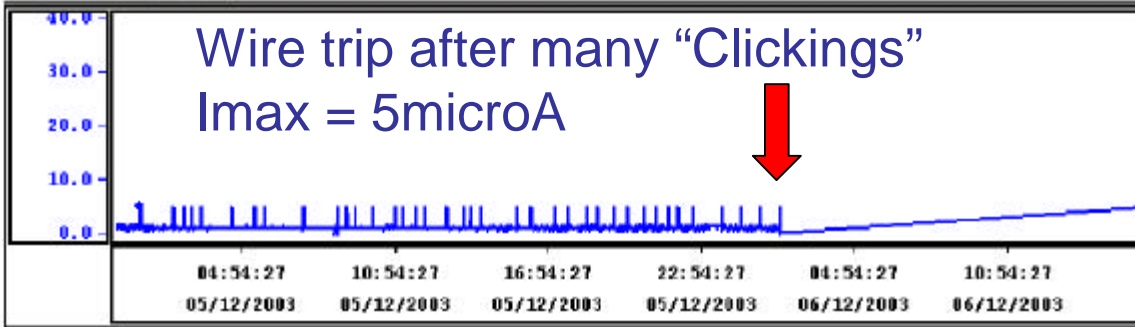
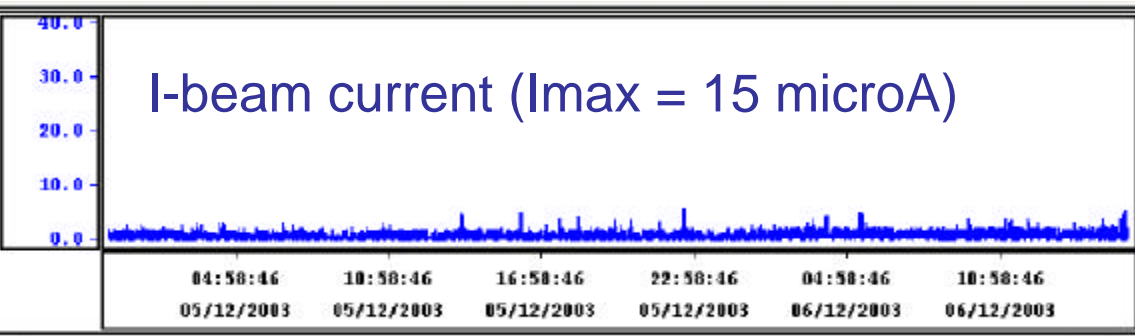
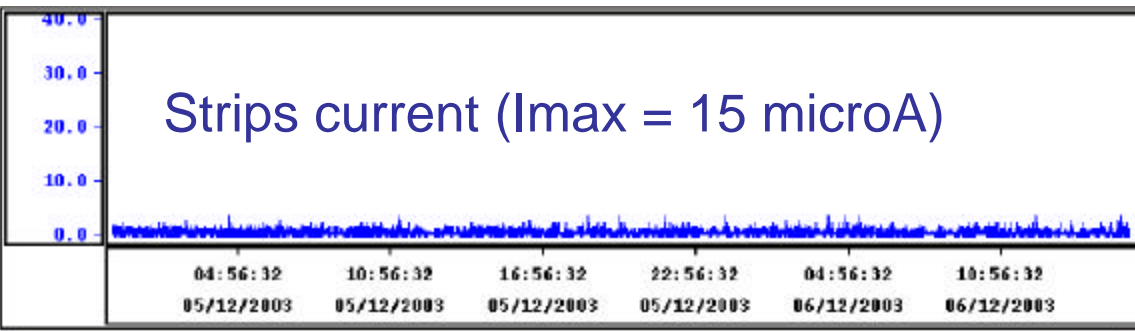
wires MB2C18

Discharges outside the cell volume:

overcurrent on wires,
Voltage drops below 3000V,

no current spikes seen on I-beams or strips

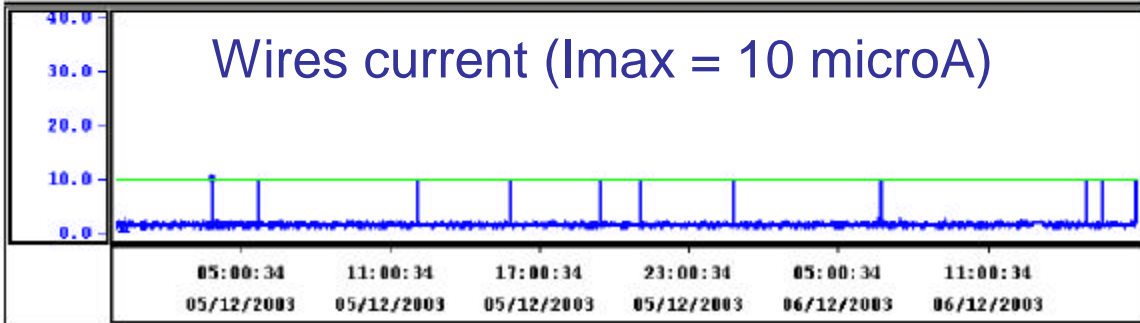
Wires current (I_{max} = 10 microA)

The discharges occur at different rates in different chambers.

- The “clicking sound” problem is not new, I reported it at the December CMS week last year.
- The discharge occurs outside the cell volume because there are no corresponding spikes in the I-beam and strips currents.
- I assumed that the discharges were due to pins under HV that are not connected to the HV boards inside the gas volume. This happens and it actually damaged a wire on a MB1 chamber but obviously it is not the only cause.
- The discharges are present in many if not all chambers with varying degrees of frequency and intensity (maybe different causes are still out there).
- MB2P17 is anomalous because the discharges are varying in frequency without apparent reasons.
- Obviously this problem must have been spotted during the tests at the assembly sites.
