# ISR Work Progress Report

CMS Week March 16th 2004

A. Benvenuti  
INFN Bologna

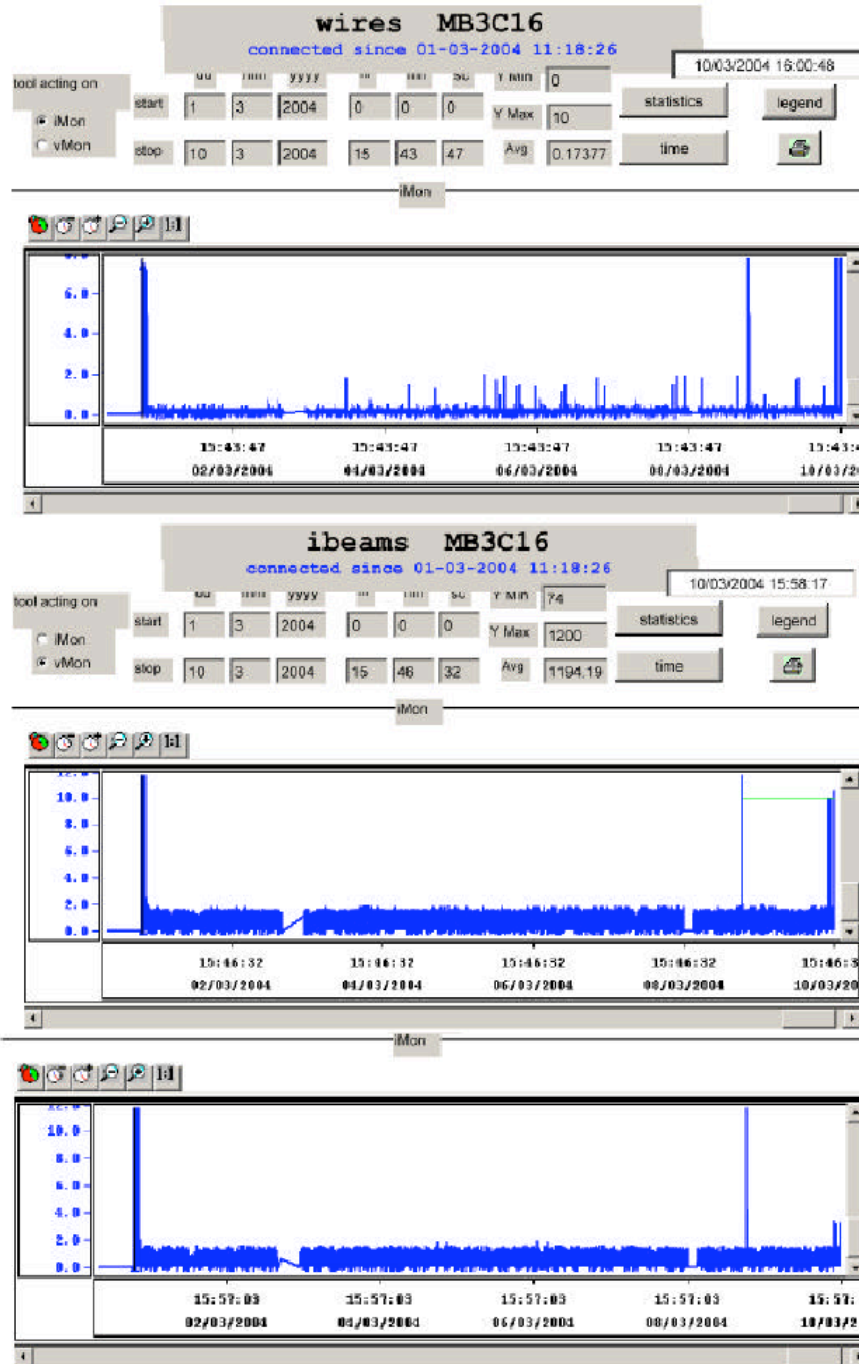
Type 2) is due to a “tappino” that does not have a side cover.

Type 2) is a real problem since discharges can result on repeated HV trips and requires the chamber to be turned off in order to disappear.

HVB replaced end of February.

1 missing cover on PHI1 and another in Theta SL

Probably some missing on Front-end side

- The current spikes problem is still with us, better QC is needed at the sites to ensure that all “tappino “covers are inserted and the aluminum surface is covered with mylar tape.
- We must decide if we should open the front-end side for the chambers with wire to cathode discharges.
- Replacing HVBs is not a simple operations, some wires were lost in the process, repair work is often needed afterwards.
- Chamber dressing is progressing but some items have to be postponed until the HVBs are replaced
- The space situation in the ISR tunnel is becoming critical

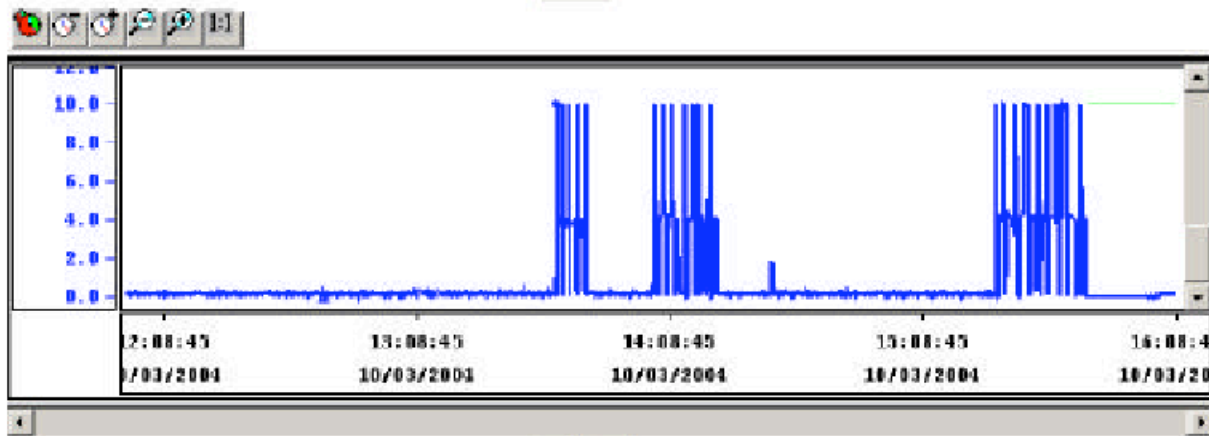
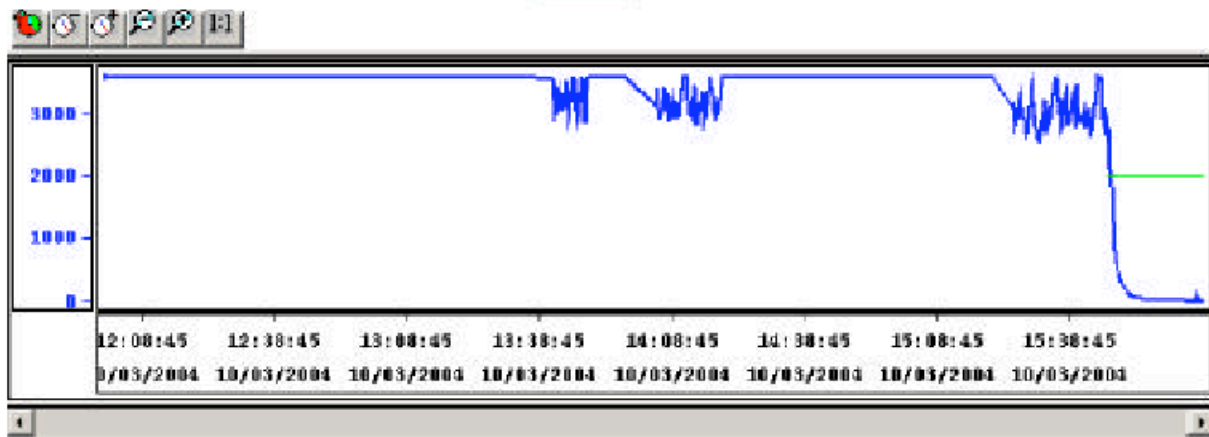
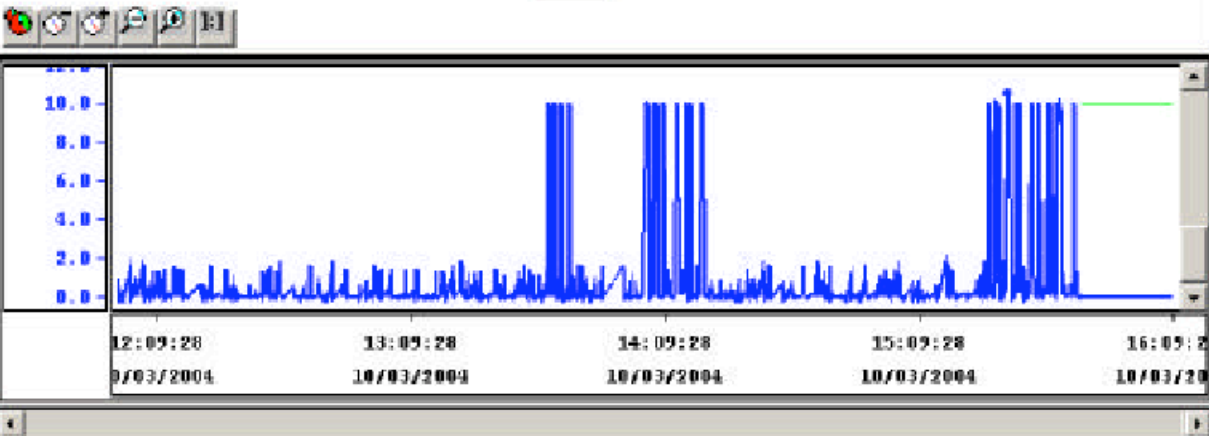
MB3C16 on  
March 10th

Discharges appeared  
for no obvious reason.

Oscillation due to  
Monitor program  
attempt to recover  
OVC

Chamber moved to  
Sys 1527

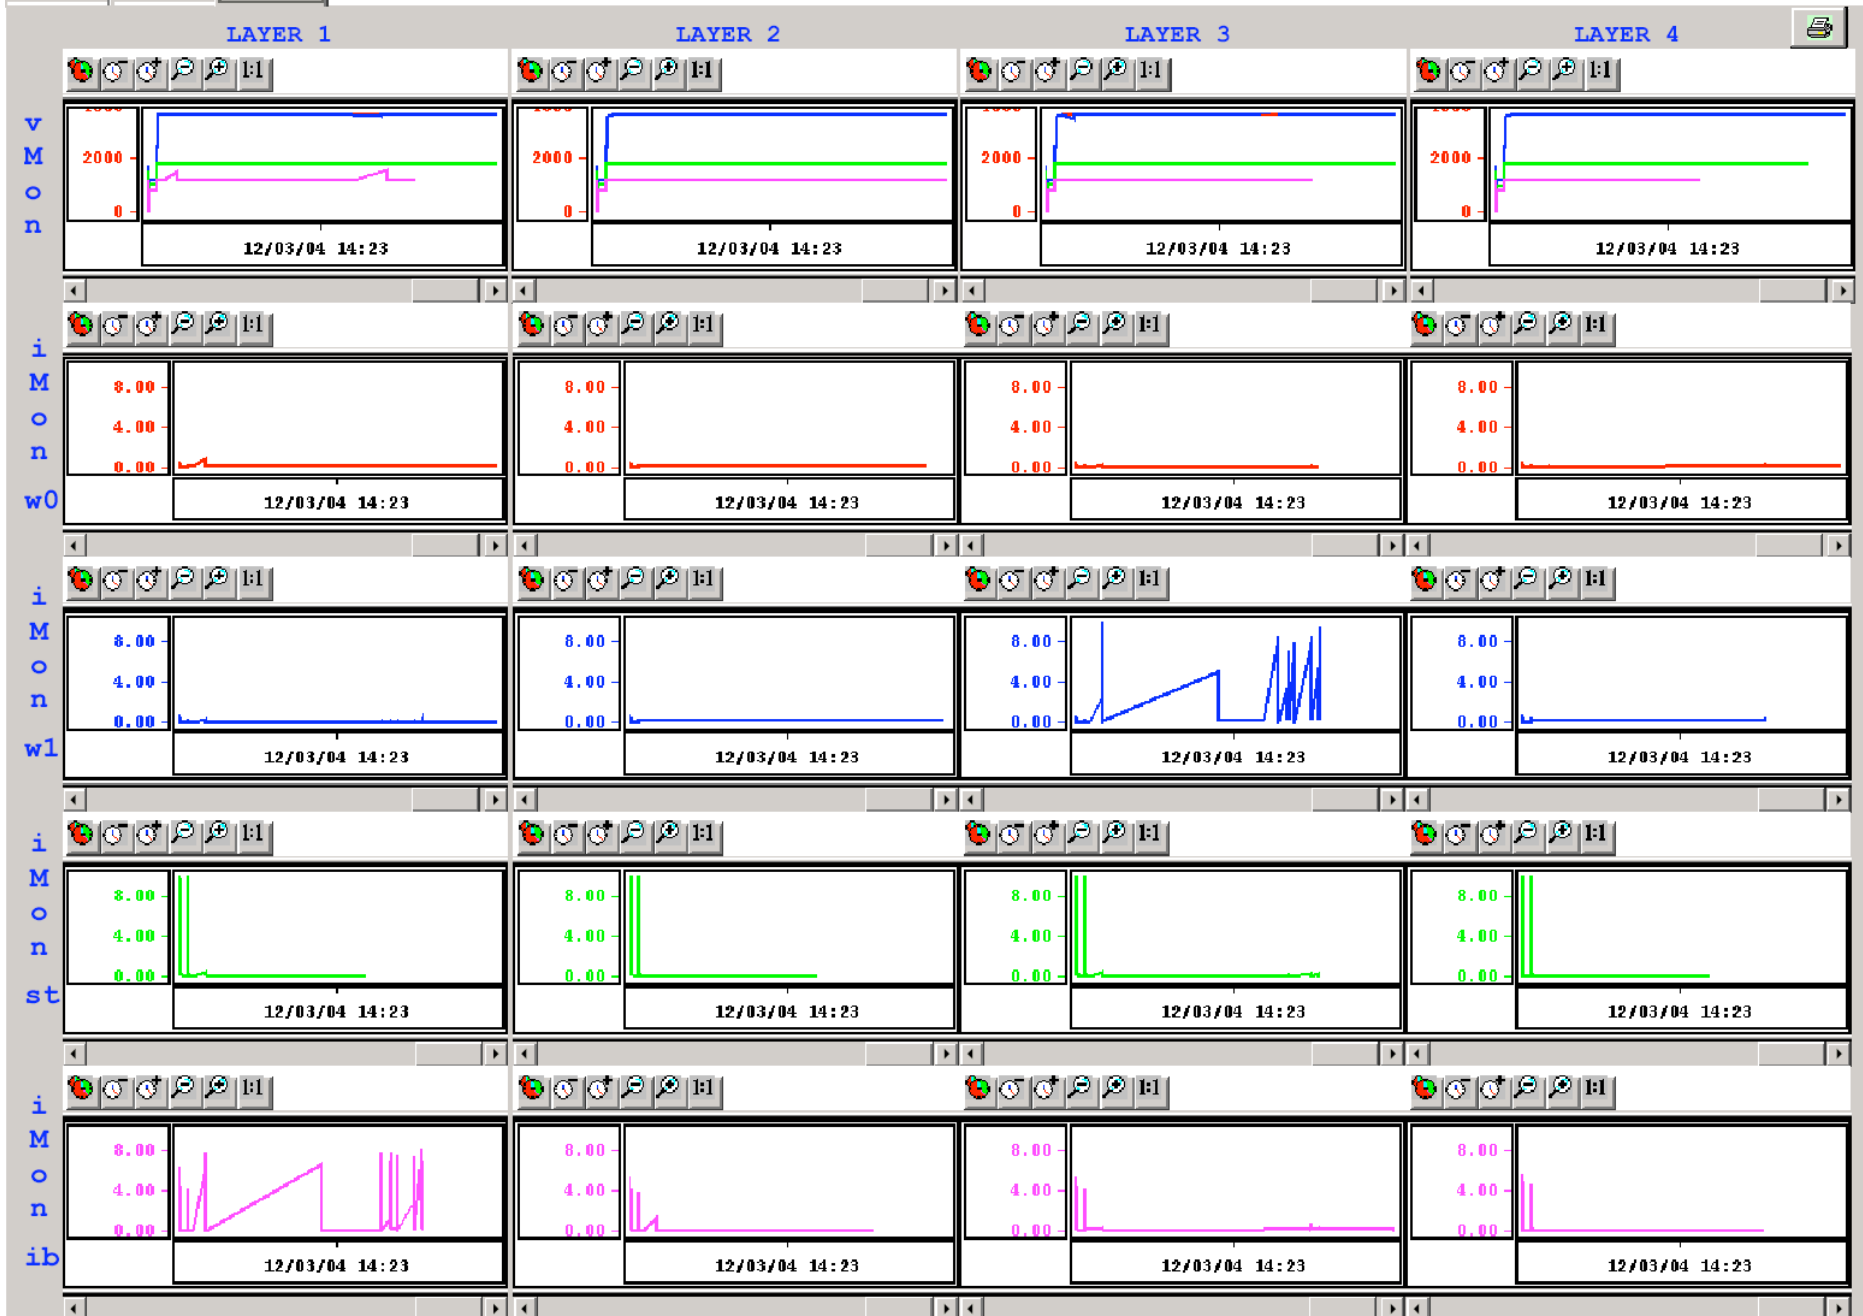
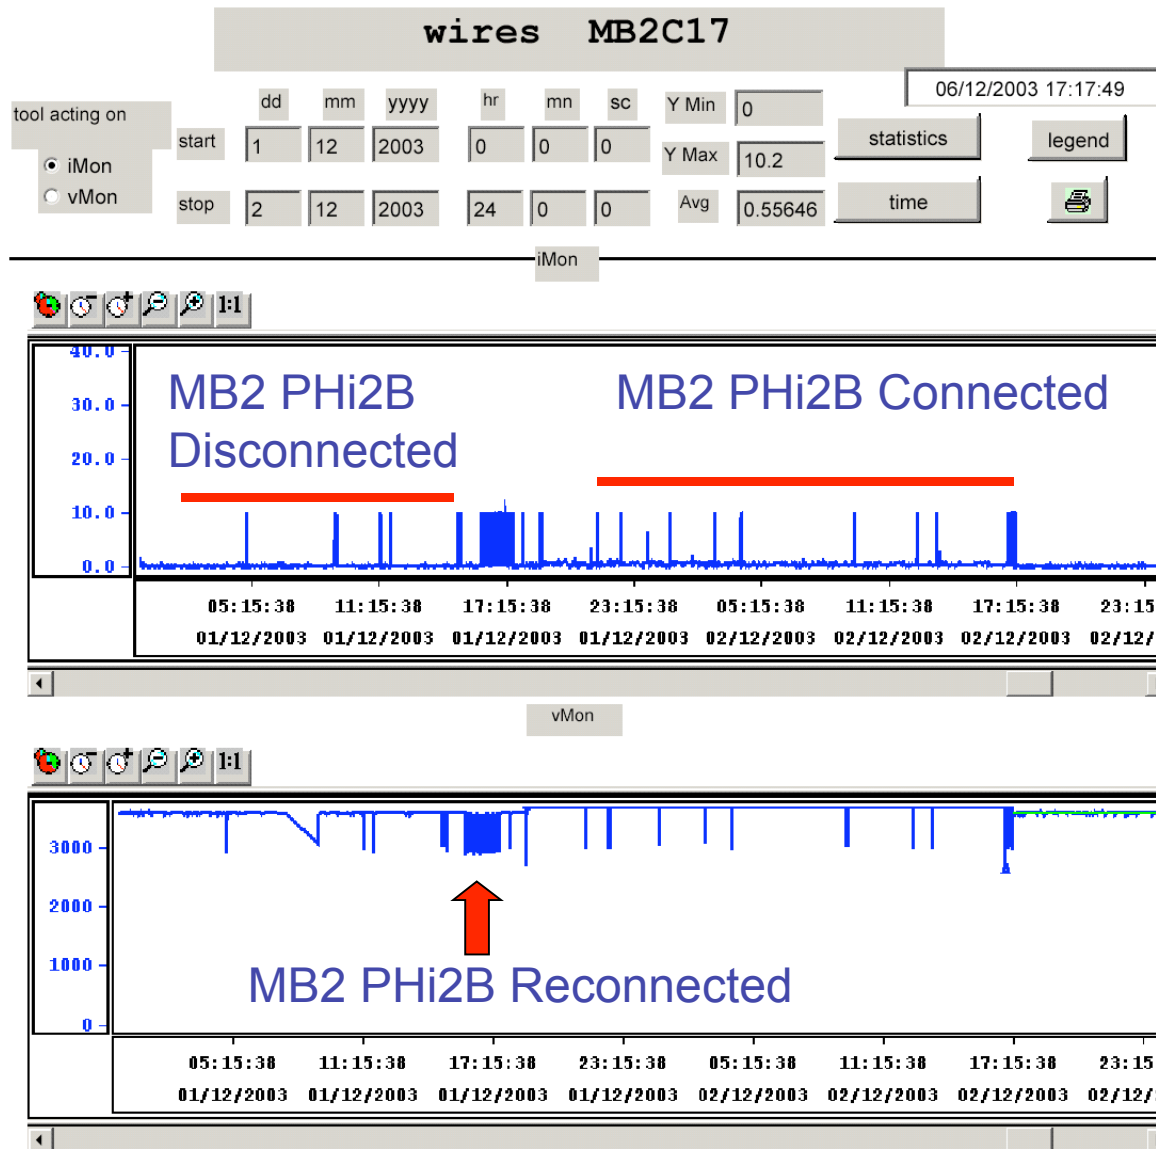
MB2P17 and MB2P24 are on the same HV channel.

MB2P17 was discharging (clicking) the problem was localized on MB2P17 Phi2 B connector that was removed until 01/12 at 16:30 when it was put back to take data with scalers.

Since this did not help to find the problem, Phi2B was put under HV on the CLONE system (allows to isolate HV boards) but the clicking disappeared.

Back to the standard HV system still low clicking rate????

Mary Cruz fixed the problem during the Dec03 CMS week (protection on HVB8)

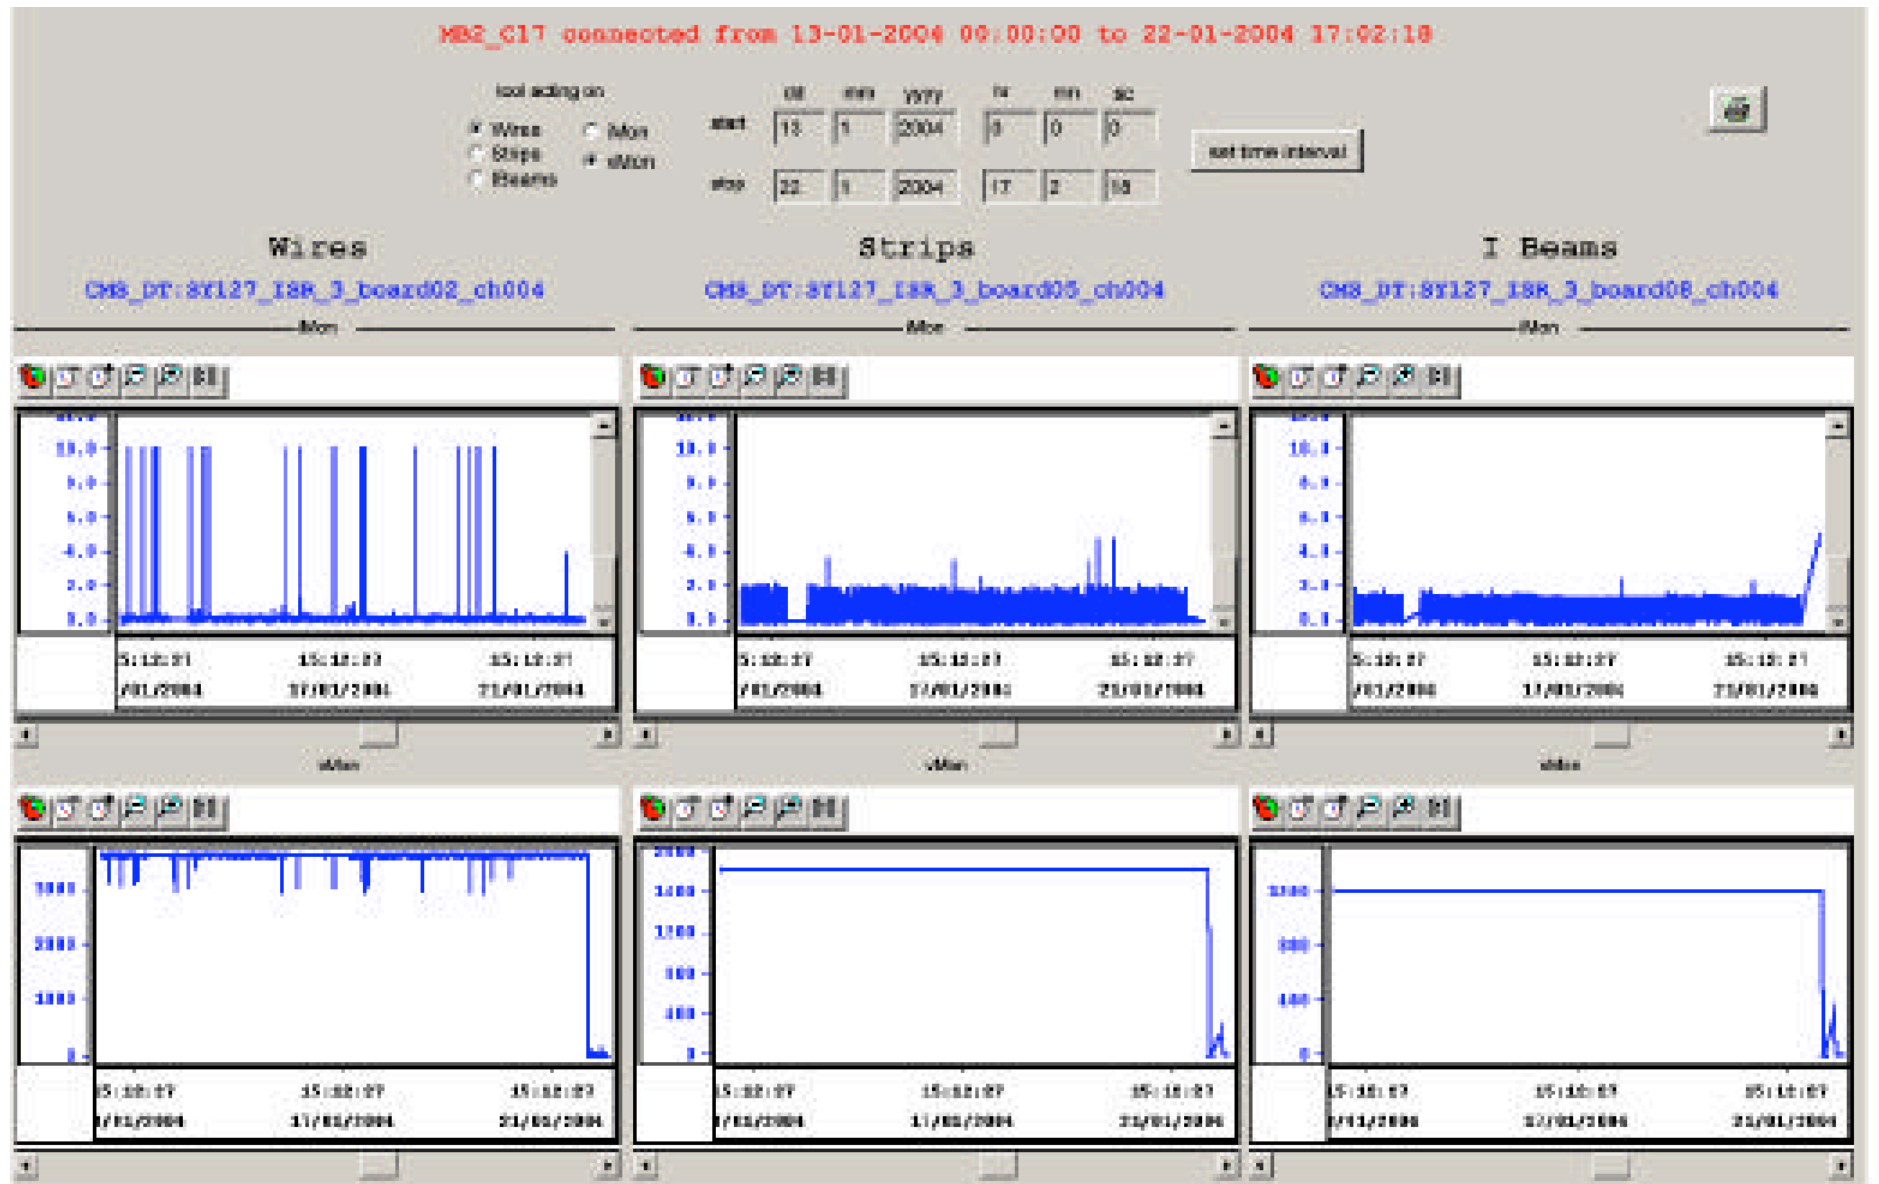
# MB2C17 Before Changing HVB

Discharges reduced to 1-2 /day

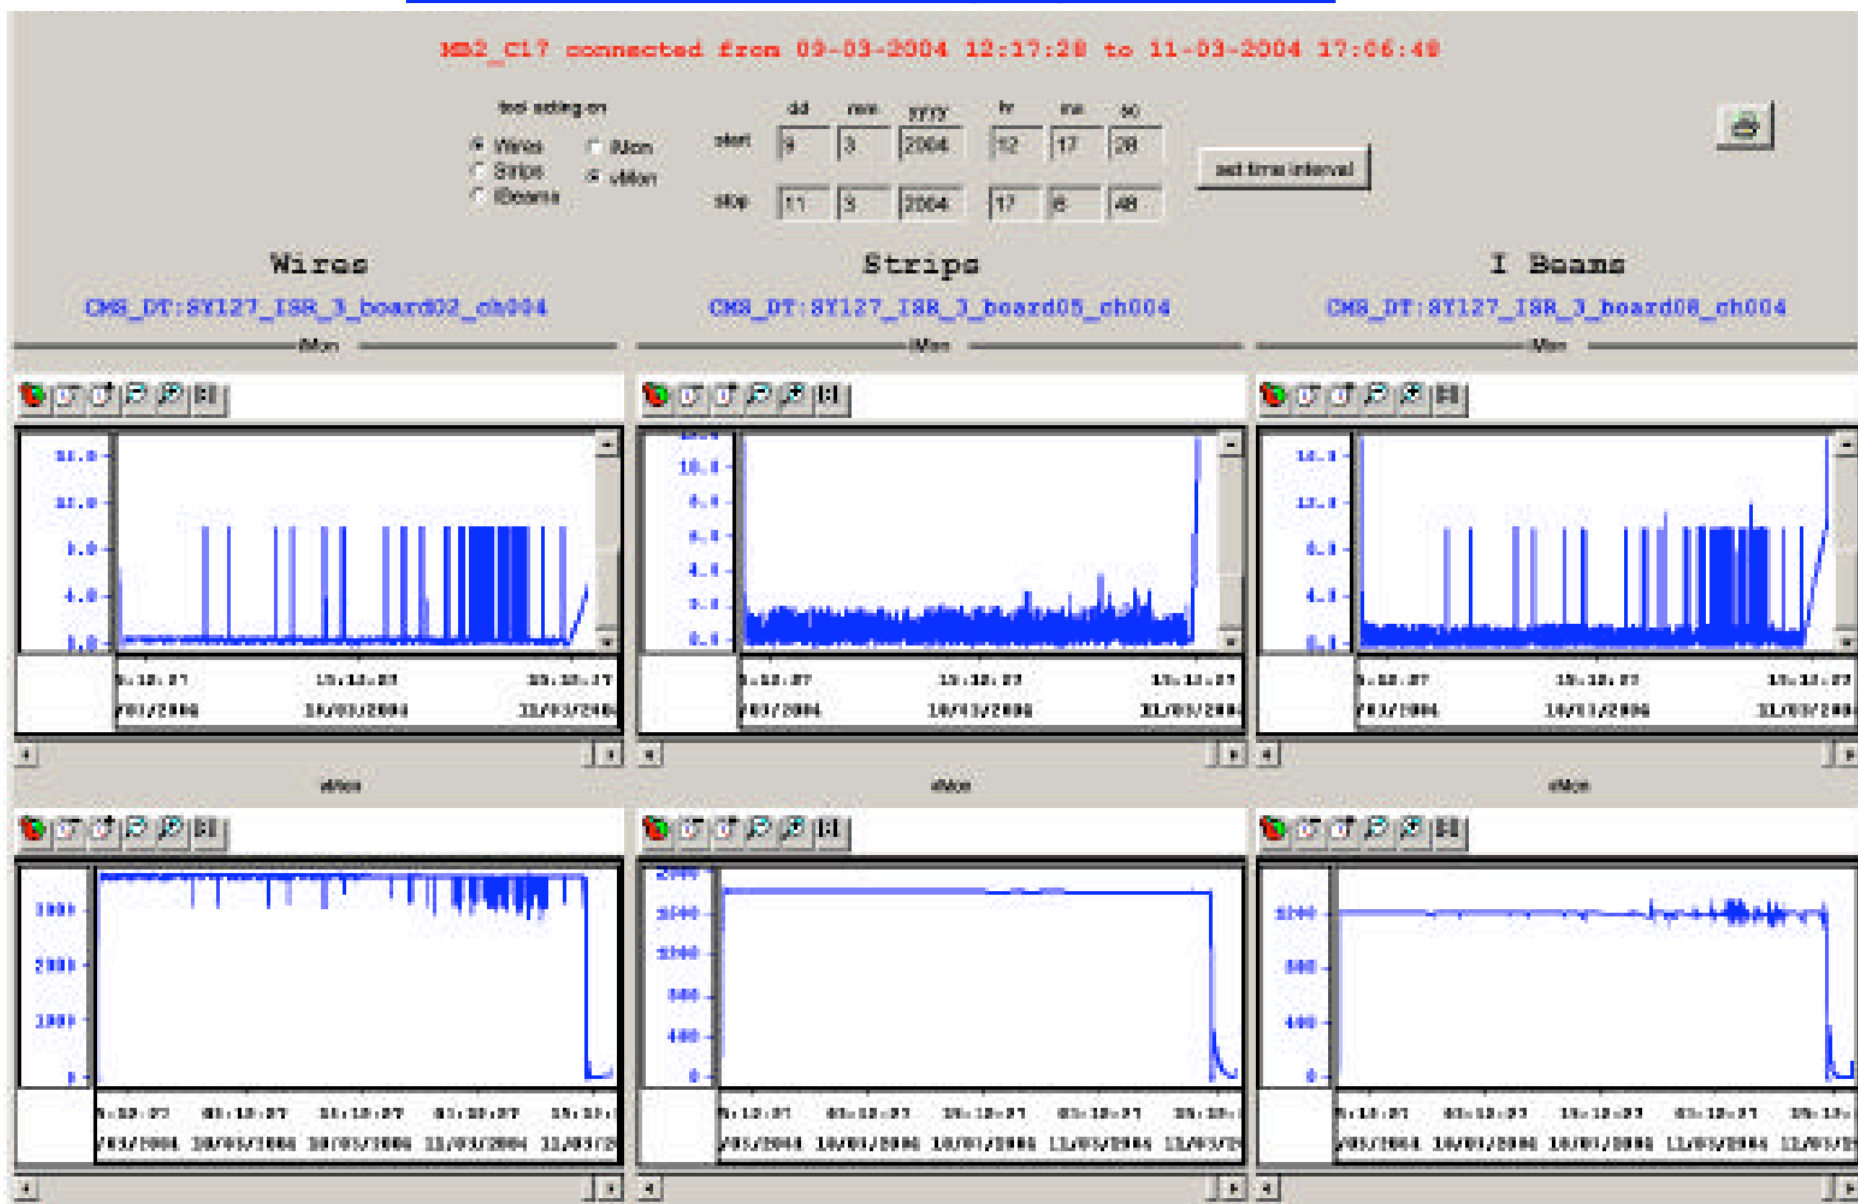
## MB2C17 after changing the HVB

Wire to cathode discharges appeared, problem not yet localized
