ISR Work Progress Report

BMU Week,
Aachen April 28th 2004

A. Benvenuti
INFN Bologna

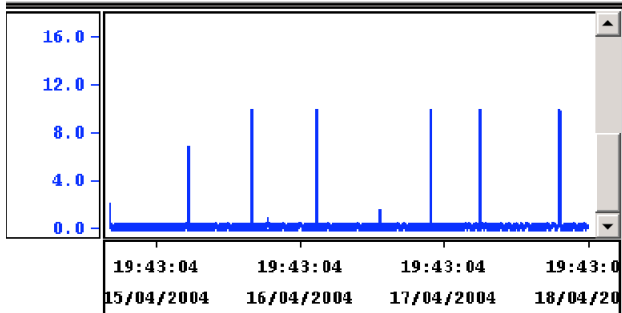
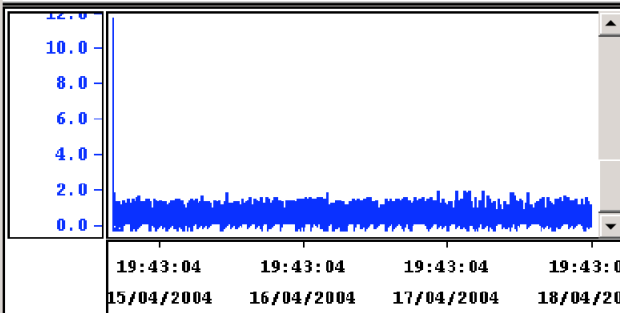
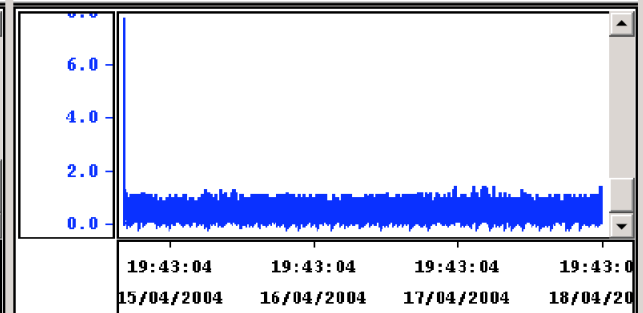
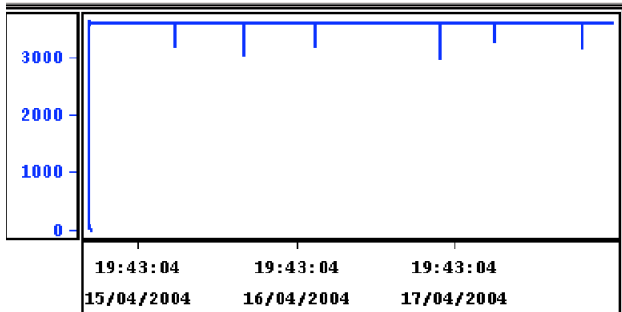
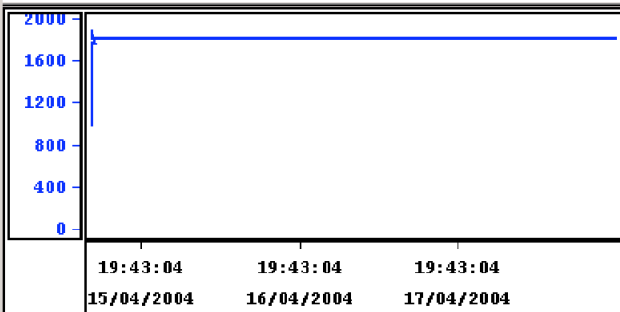
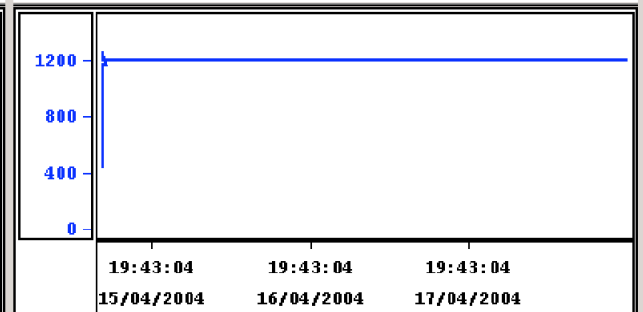
MB3_C04 connected from 15-04-2004 11:59:23 to 18-04-2004 19:42:30

- A total of 16 MB3 SLs are without tappino covers
- MB3C04 is one of these and is among the chambers slated for installation
- MB3C04 was removed from HV since two bad HVBs were taken out from the Theta SL and not replaced.
- The chamber has been under HV (Phi SLs only) for 3 days with only few discharges wire to ground.
- Apparently the absence of tappino covers does not imply discharges wire to cathode

- Inserting tappino covers when the HVBs are replaced is not trivial, it adds ~2 hours/SL.
- In MB3C04 the tappino covers were put only on the HV side of the chamber.
- We have to decide what to do with the remaining chambers.
- It is important to standardize the chamber construction at all sites, including tricks and fixes:
 - Mylar tape on the outer plates
 - Cathode contacts at both ends,
 -

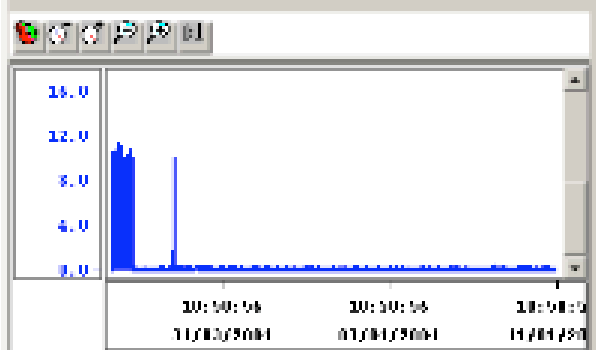
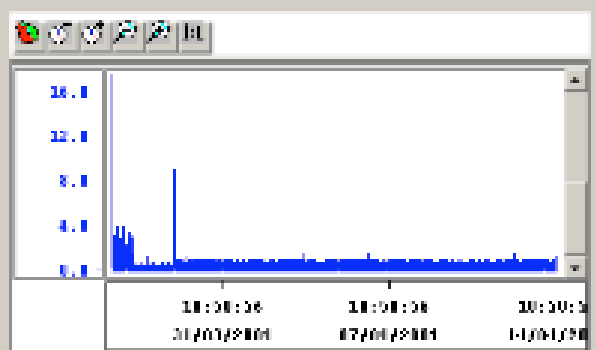
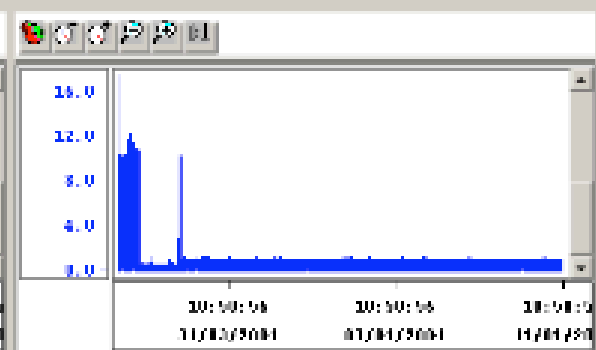
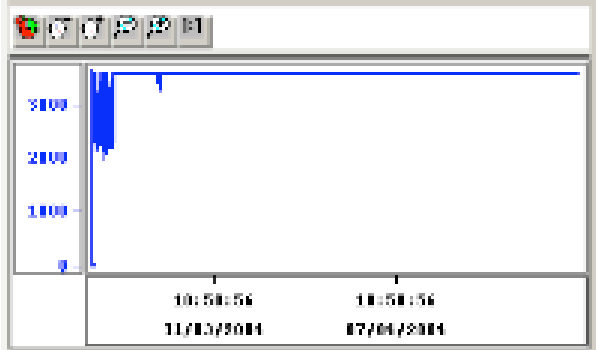
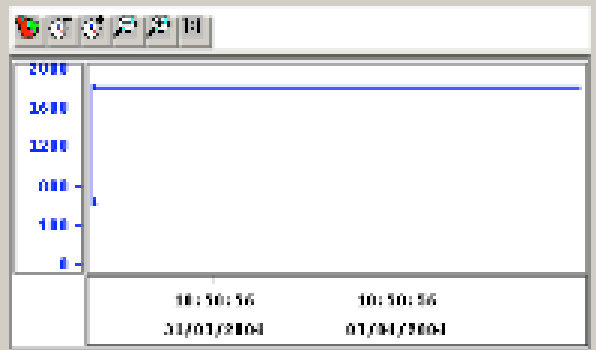
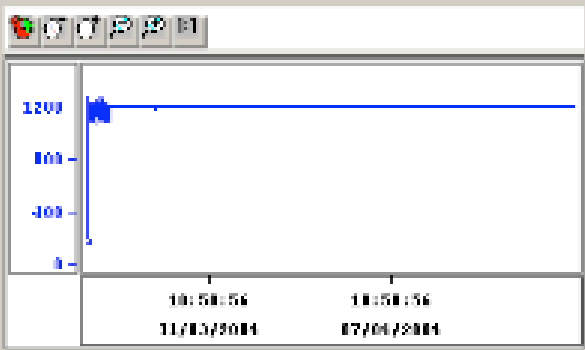
MB2_C17 connected from 26-03-2004 17:28:20 to 14-04-2004 10:50:25

- 20 channel HVB **to be replaced in 5 Theta SL**
- MB2C23 wire to ground discharges in Theta B (removed)
- MB2C26 wire to ground discharges in Phi 1B (removed)
- MB2C17 Intermittent HV problems in Theta A (clicking), Phi 1 SL. Fixed last December by Mary-Cruz
- Cosmic ray started but noise problems with the dressed Theta SLs
- MB4/10 still naked (no drawings for HV cabling yet)

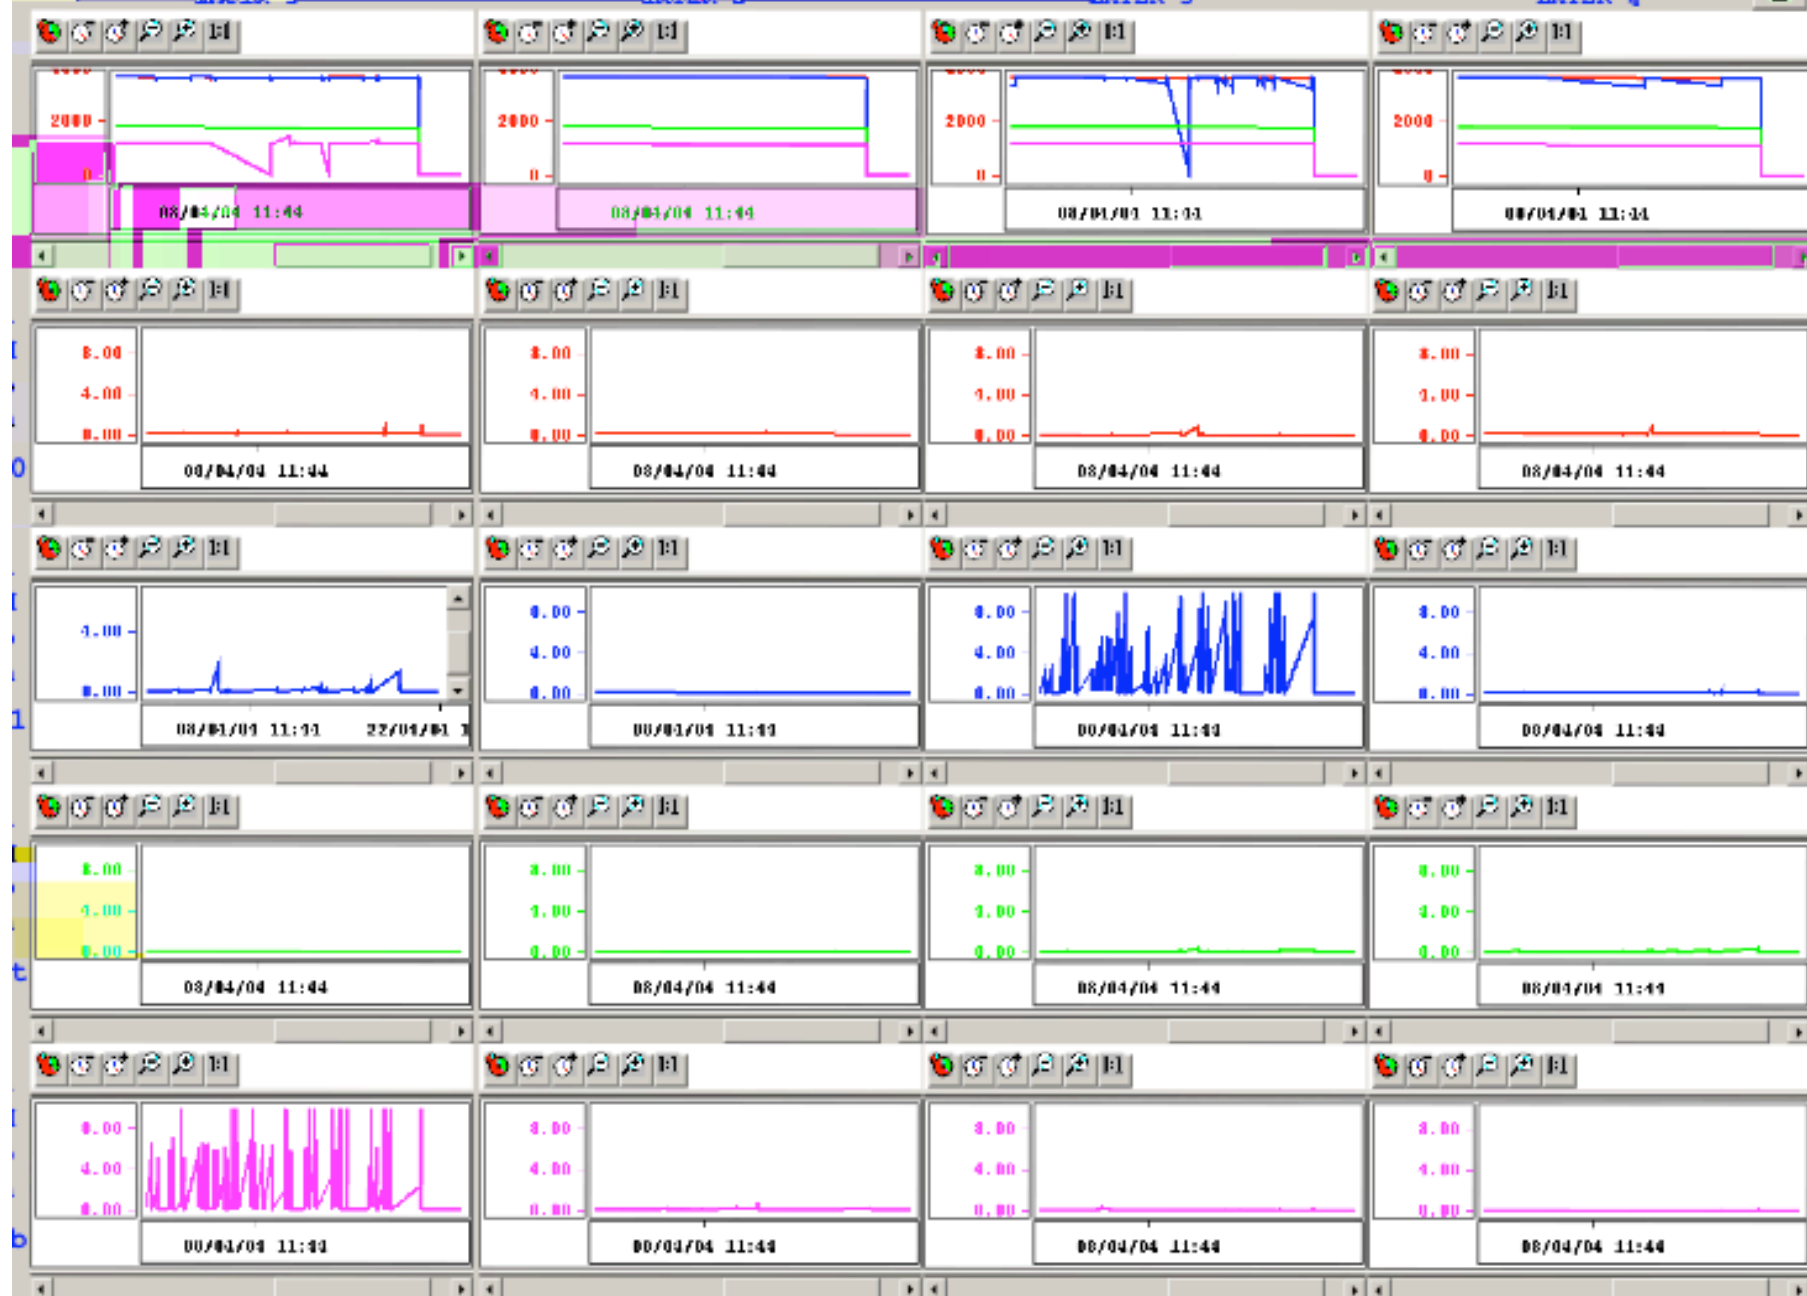
- HV test restarted after intervention on Theta SI and some Phi SLs with disconnected cathodes
- MB3C08, C10, C12 and C16 under HV for ~2 months with Sy1527.
- MB3C16 Phi2 SL puzzle, L3 W1 discharges to I-beam L1
- MB3C10 Theta SL (L3 W0 spikes wire/I-beam, L4 W1 discharges to ground)
