ISR Work Progress Report

CMSWeek,
CERN June 8th 2004

A. Benvenuti
INFN Bologna

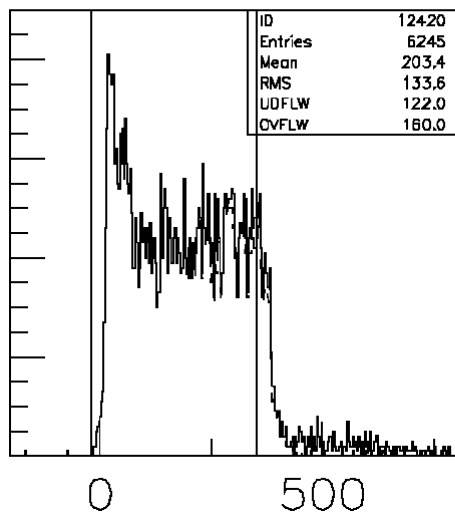
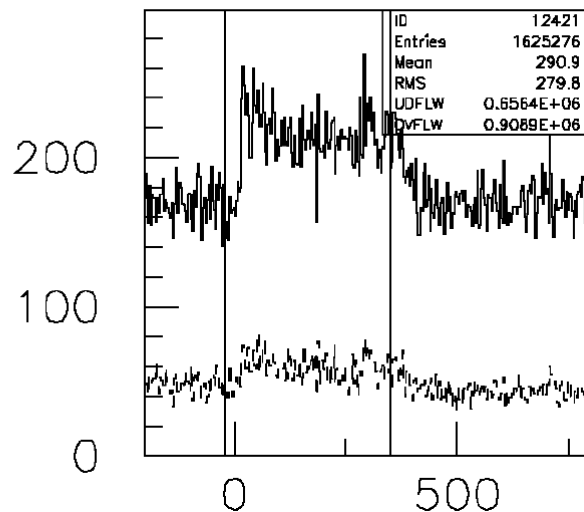
MB1C17 Theta SL layer 4 cell 21

P HVB-I Run 4078 Vth=16mV Theta SL

Noise present in several runs taken at different times

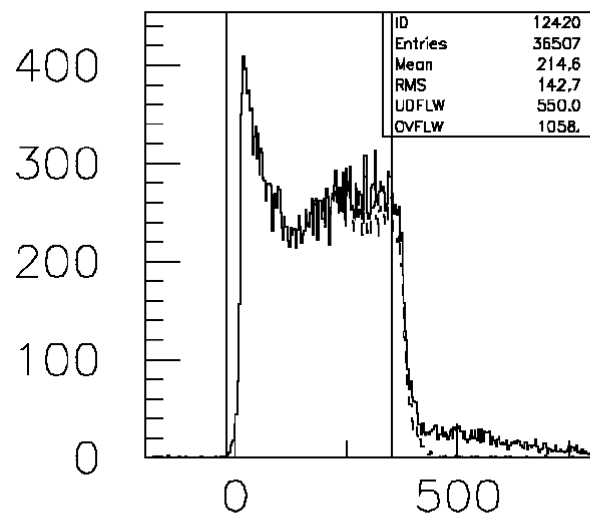
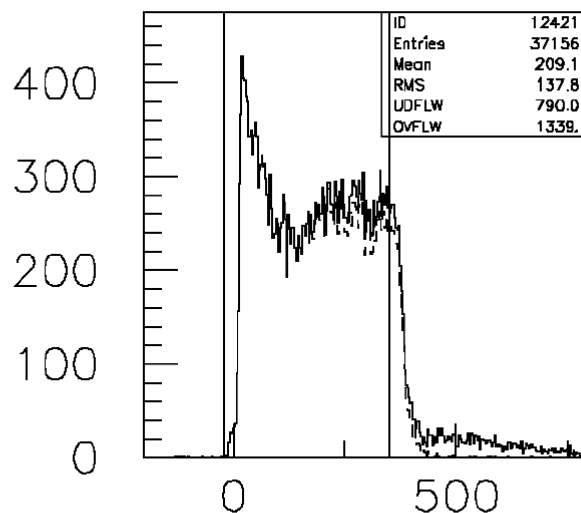
d HV PP HVB-I Run 4271

Vth=16mV Theta SL

After replacing FEB + HVC

Timebox cell 20Layer 4

Timebox cell 21Layer 4

Send boards to Matteo for post-mortem

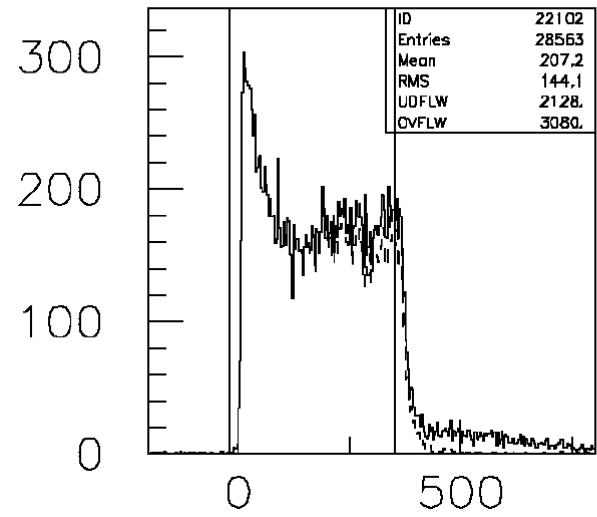
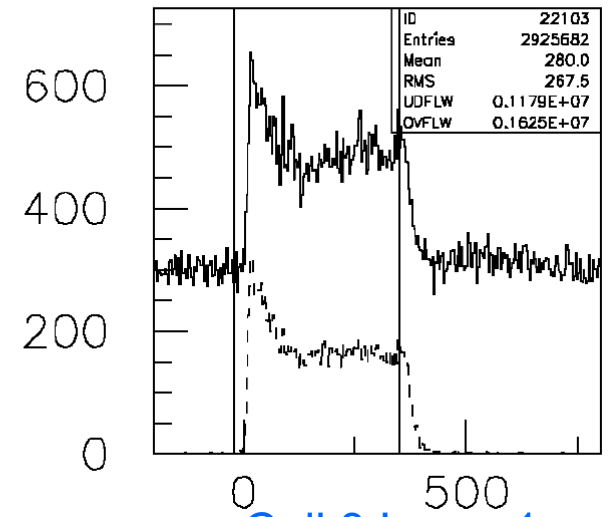
MB1C13 Phi1 SL

d HV PP HVB-I Run 4261 Vth=16mV PHI1 SL

Cell 3 Layer 1

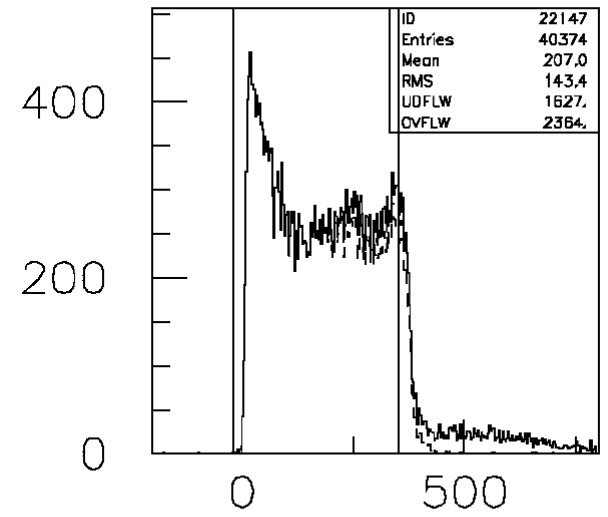
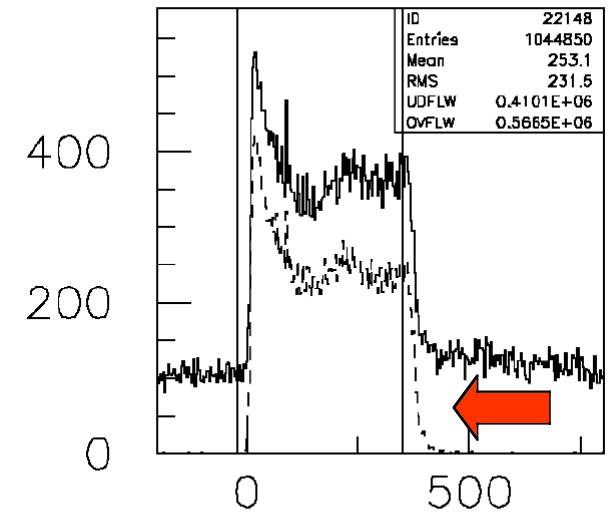
Same problem??

d HV PP HVB-I Run 4261

Vth=16mV PHI1 SL

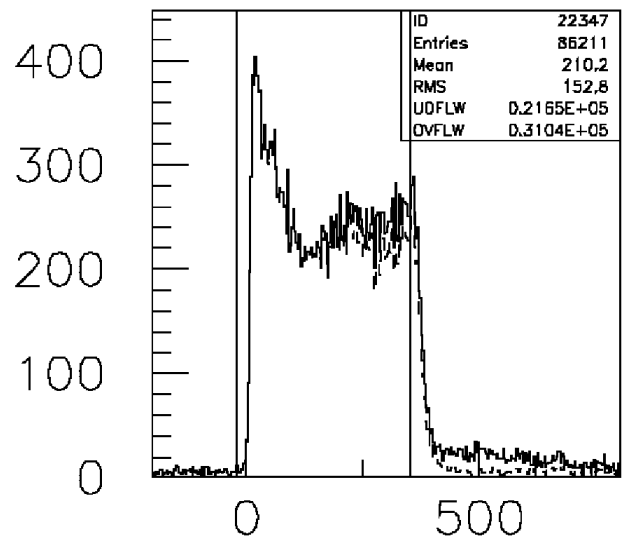
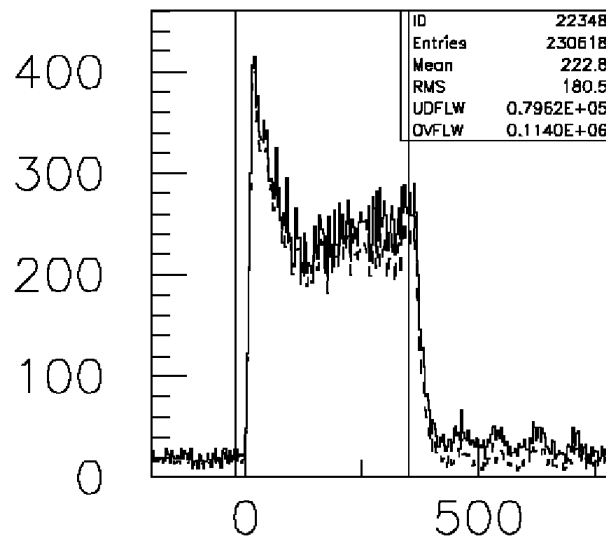
Timebox cell 47 Layer 1

Timebox cell 48 Layer 1

ed HV PP HVB-I Run 4268

Vth=16mV PHI1 SL

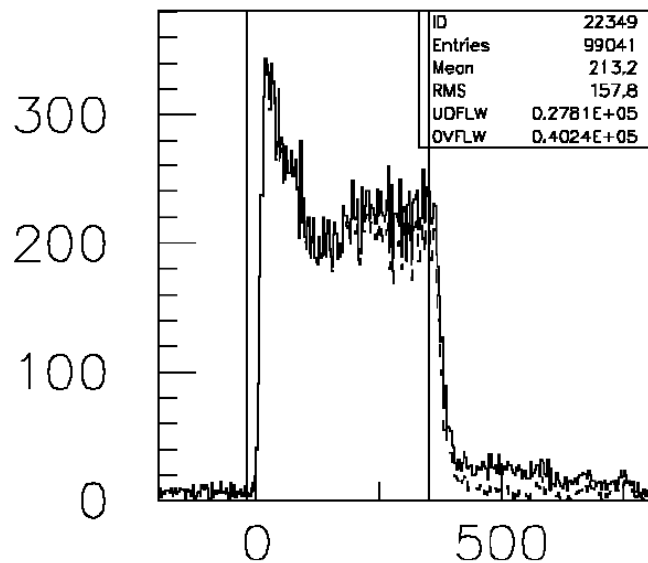
MB1C10

Timebox cell 48 Layer 3

More "garden variety" noise.
 Not obvious if due to external cabling or to problems inside the chamber

Timebox cell 49 Layer 3

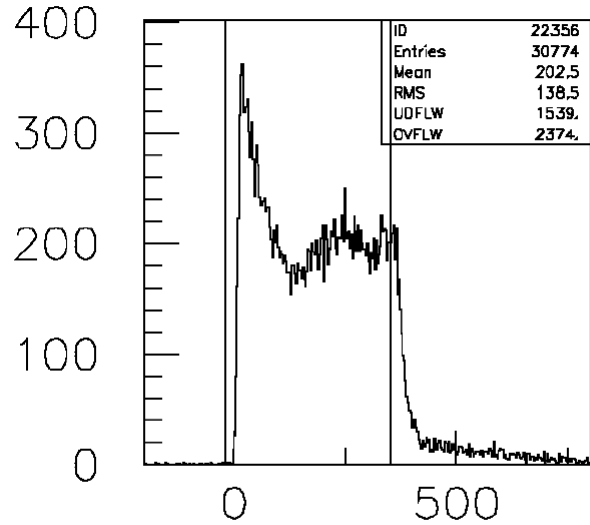
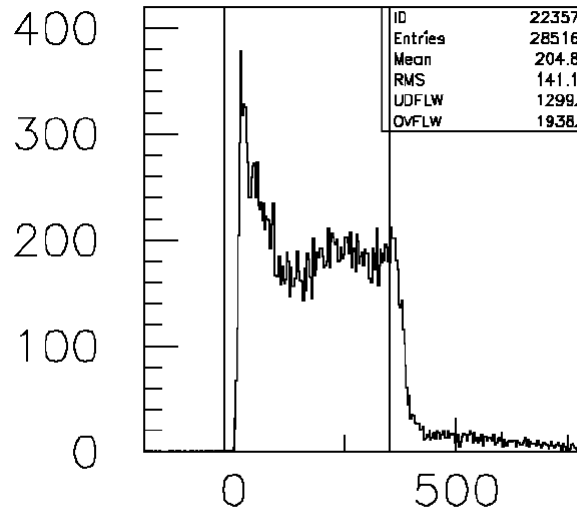
[MB2C22](#)

Run 3025 HV 3200 Vth=16mV PHI1 SL

Disconnected
I-beam

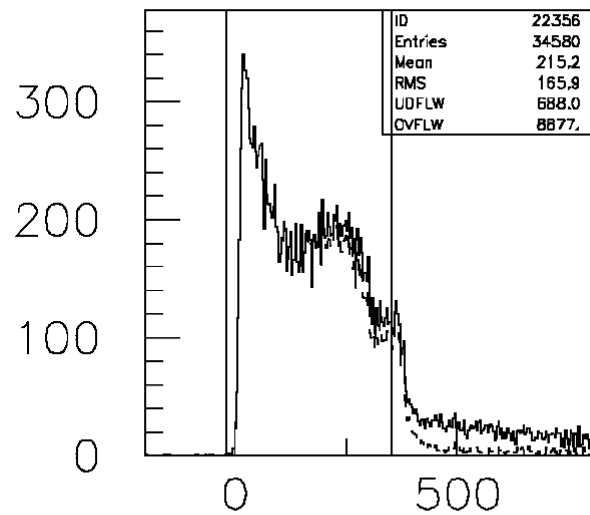
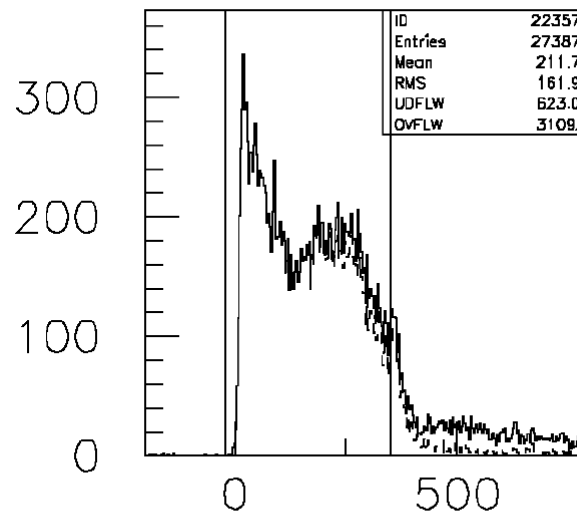
Timebox cell 56 Layer3 Timebox cell 57 Layer3
d HV PP HVB-I Run 4255 Vth=16mV PHI1 SL

Timebox cell 56 Layer 3

Timebox cell 57 Layer 3

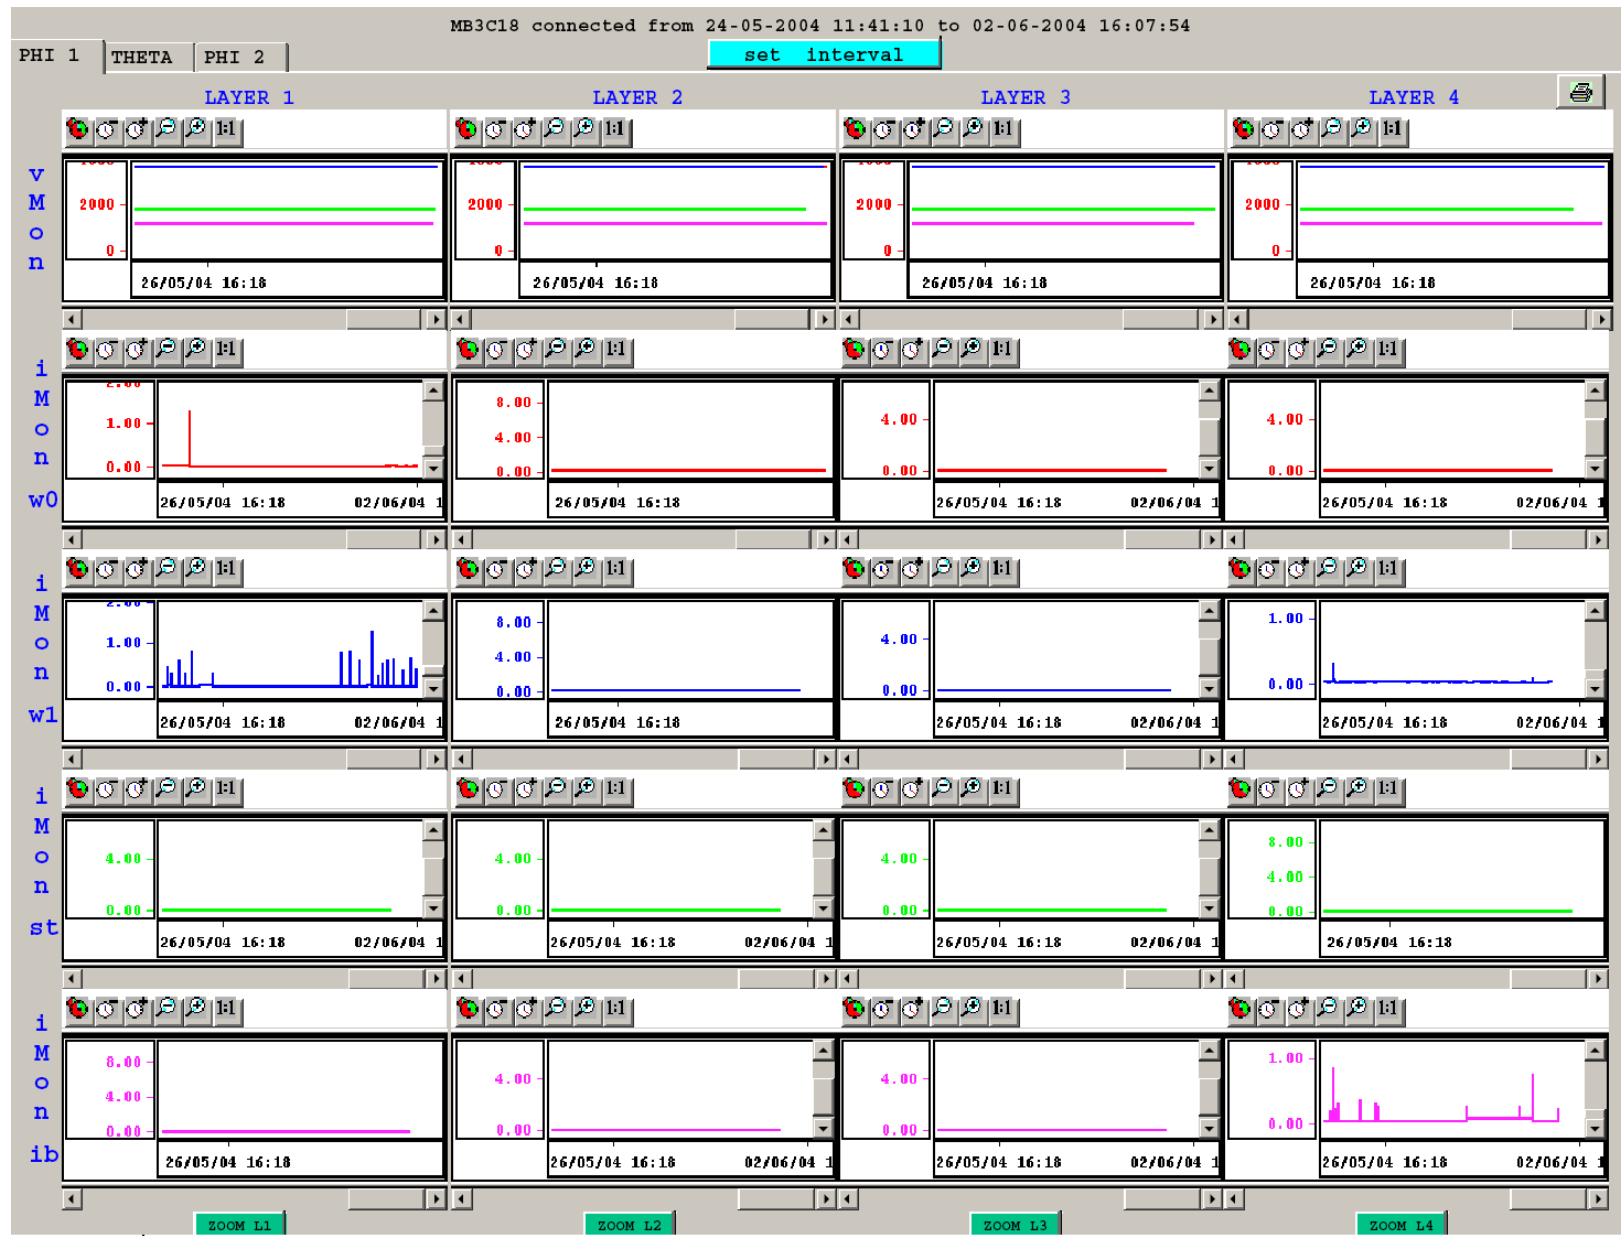
MB3C18 Phi1

L1 w1 current spikes ~ 1 microA

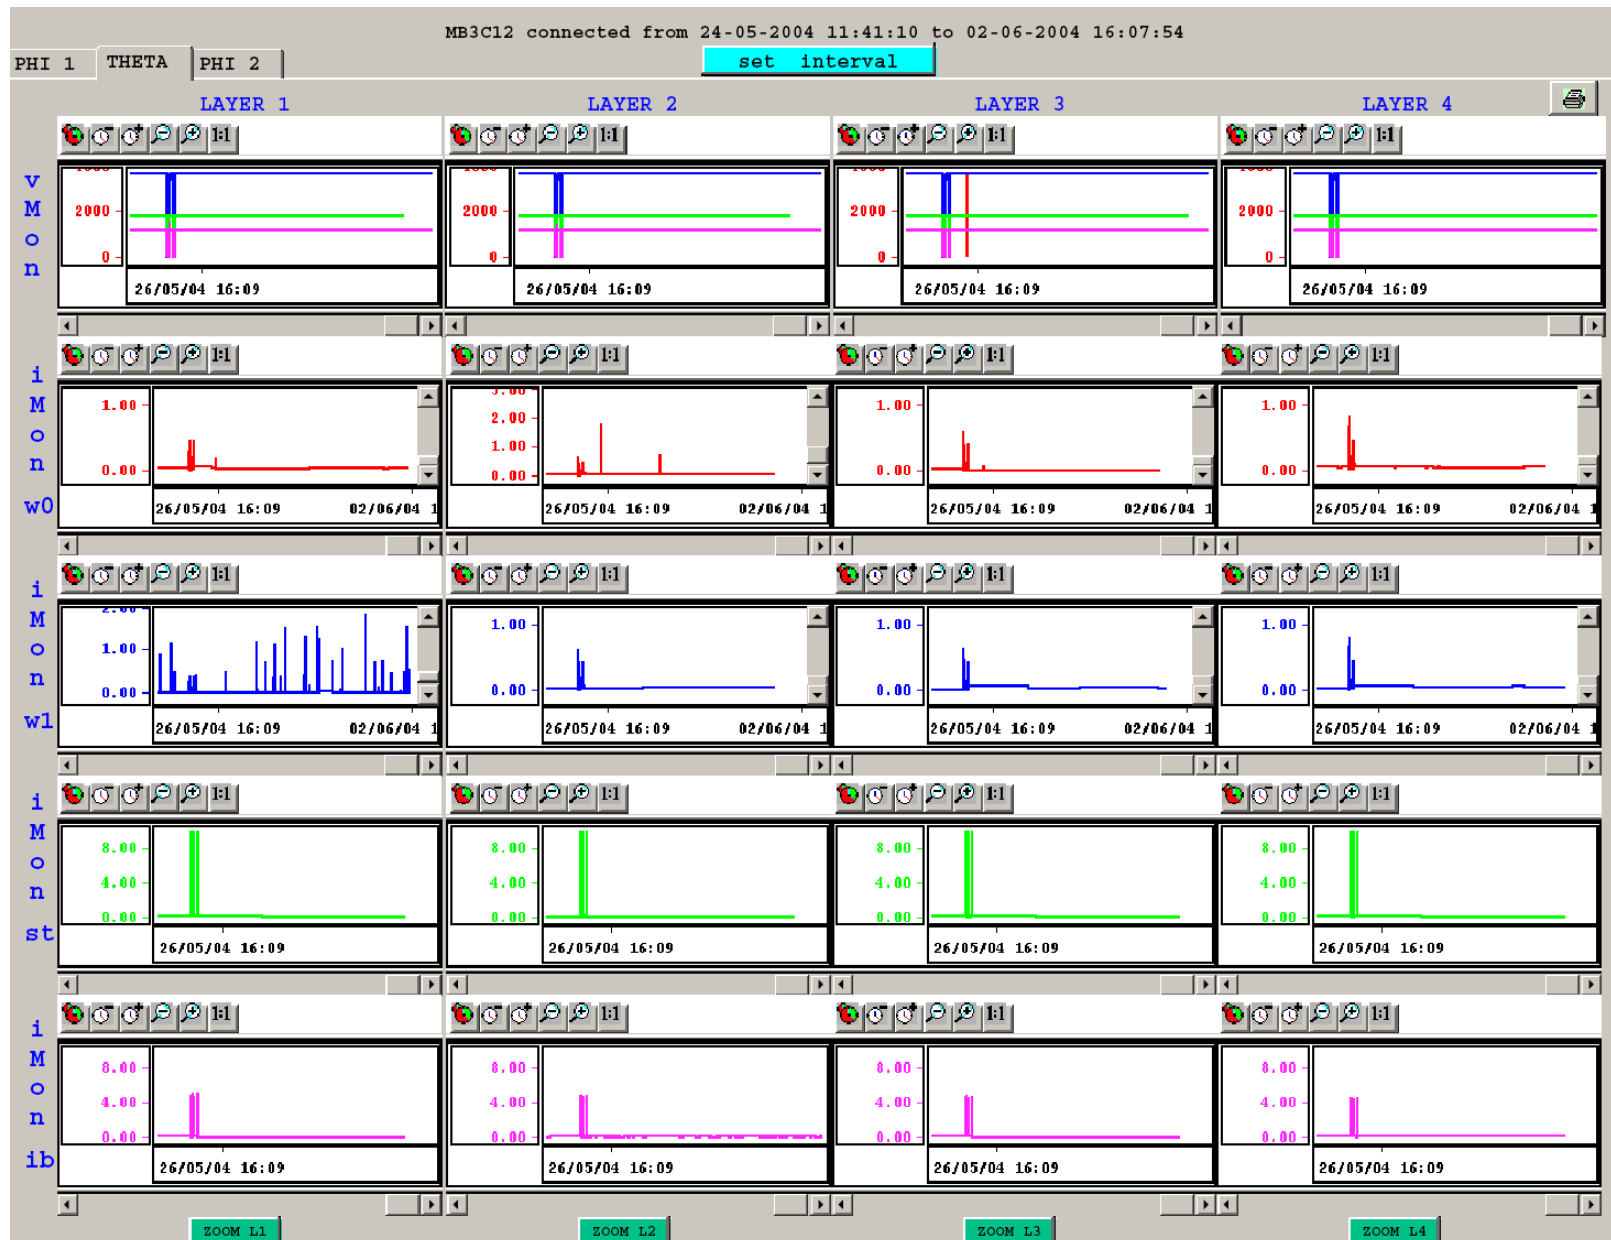
MB3C12 Theta

L1 w1 current spikes up to 2 microA

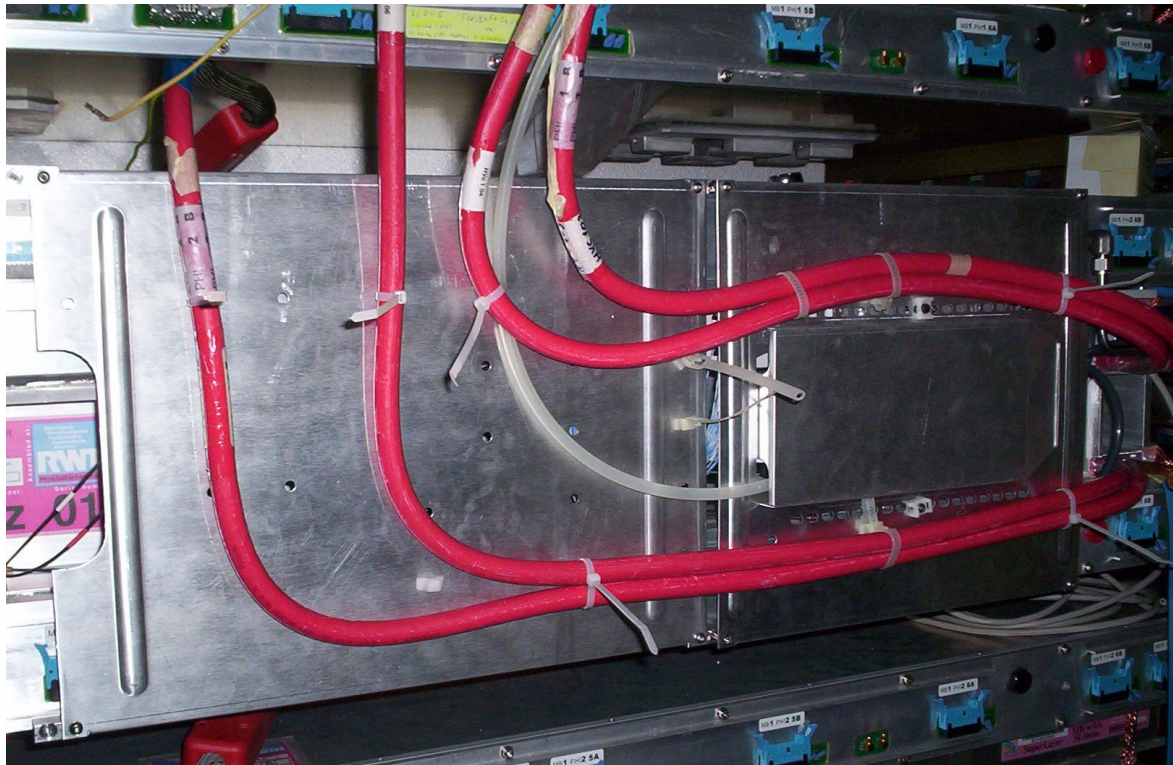
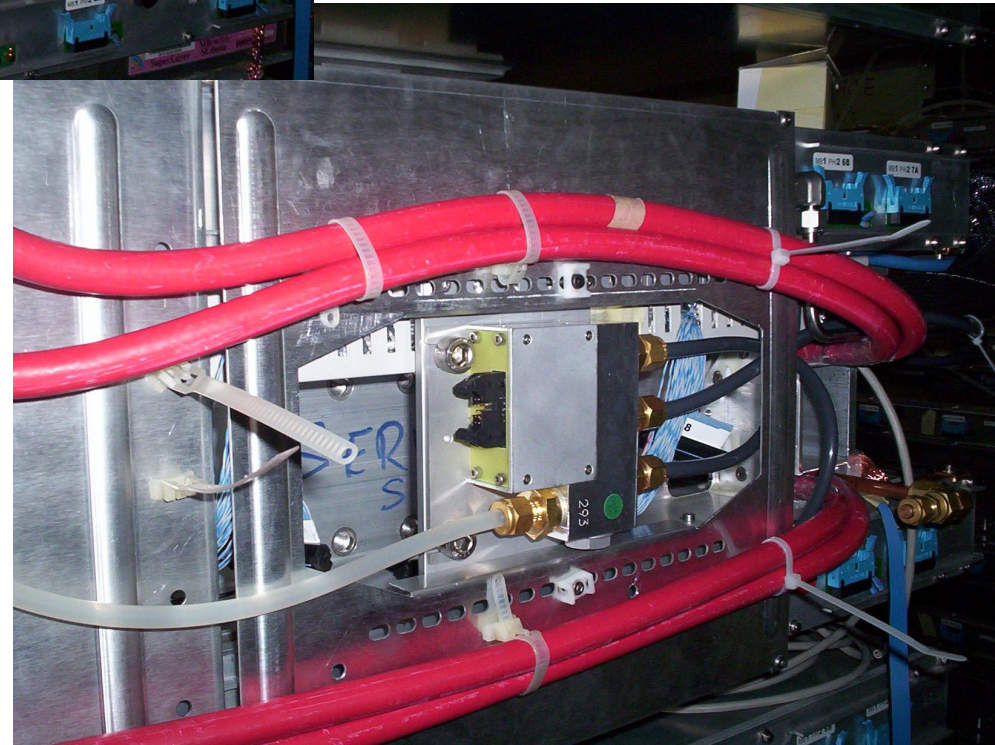
Gas Manifold Carter

Test with MiniCrate
and final cables
needed to be sure
that all fits.

Problems happen as seen
with the alignment DCS
cable (to be replaced in
~60 Chambers)
