**By beginning of May we sent to Legnaro 10 MC's:**

**For assembly on YB+2 top  
(Sep. To Nov)**

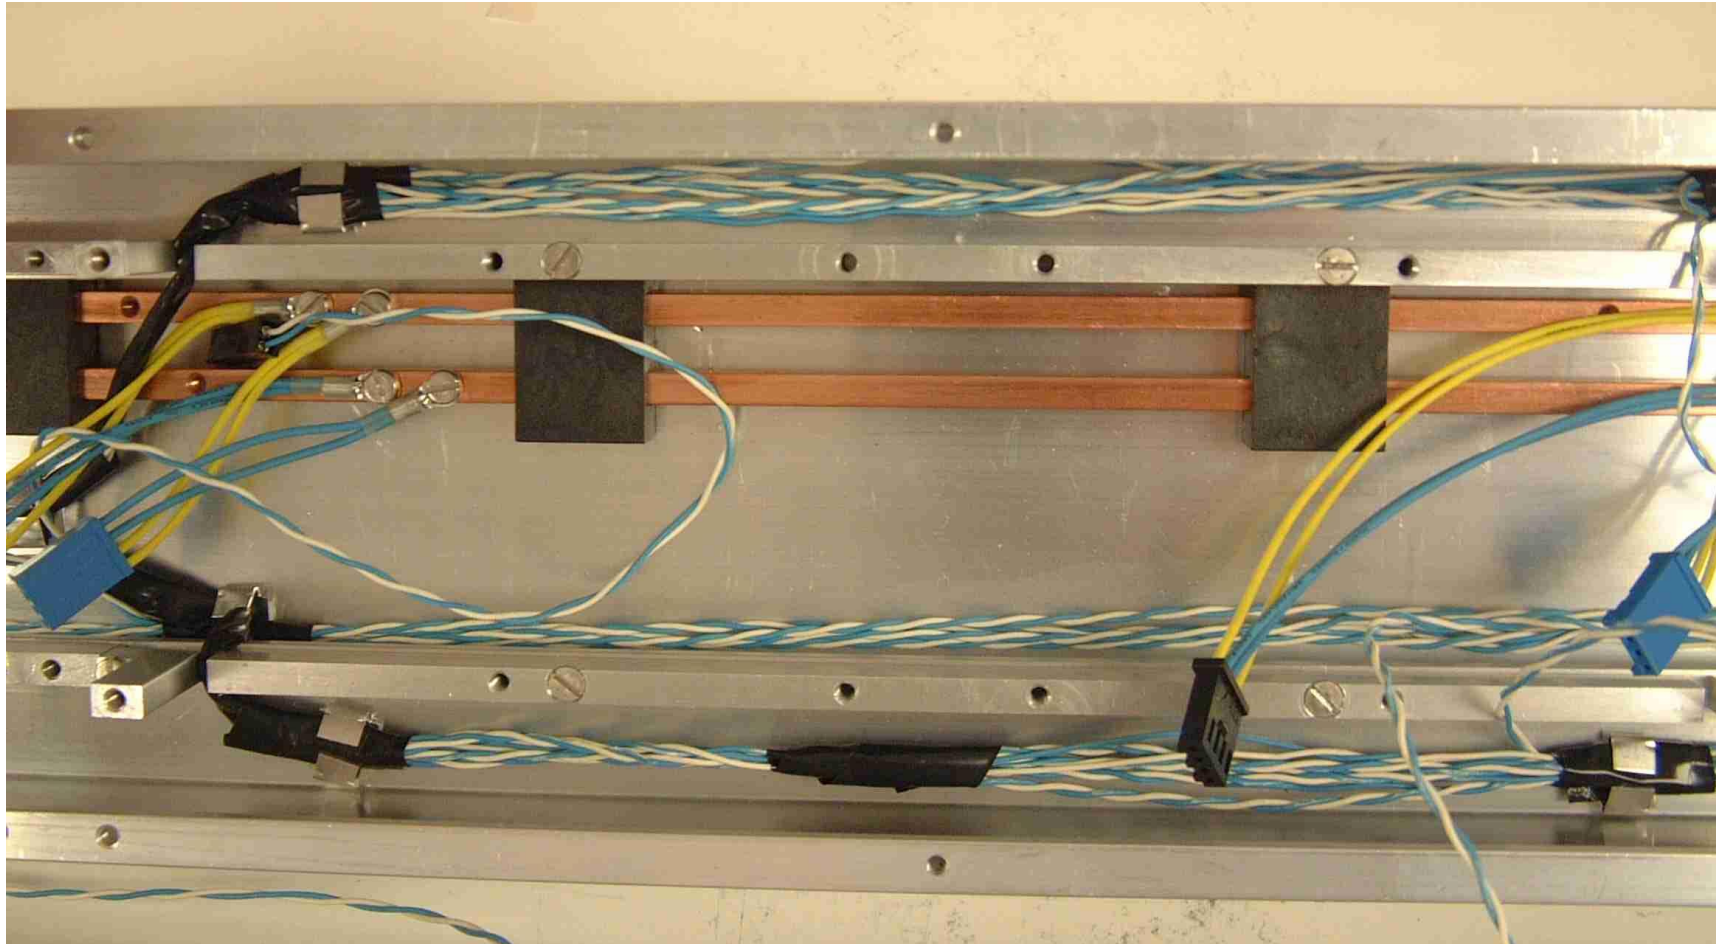
## PREVIOUS CABLE ROUTING

- **During first inspection Matteo and Lorenzo disagree on the way clock cabling was done. They argue that clock cable assembly procedure has to be reconsidered again, in order to minimize interference with front-end signals.**
- **They propose a different routing.**

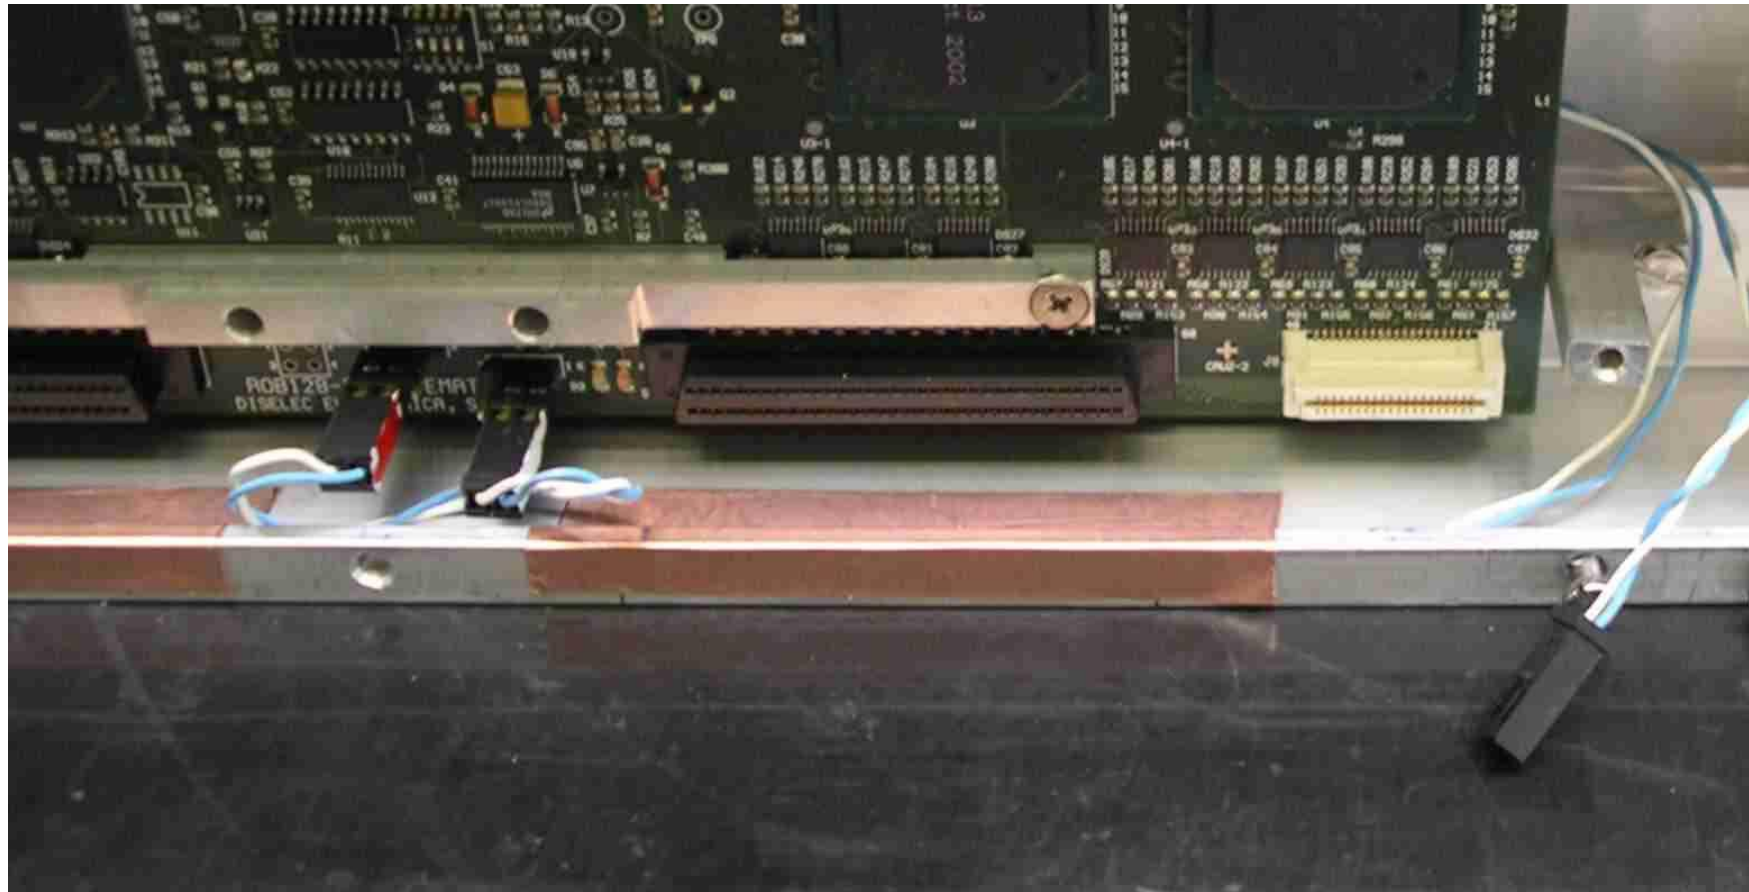
- and include shielding of some parts of clock cables:

- **The conclusion is that all MC's now in Legnaro have to be dismantled to rewire clock cables.**
- **We offered to send to Legnaro 3 people to do this job.**
- **For the moment Lorenzo and Matteo are going to test a full final MC to check noise problems and fix final wiring.**
- **In Madrid we continue with mechanical assembly waiting for a final decision on clock cables.**
