# **DT Quality Control Status in Torino 6<sup>th</sup> December 2004**

# Torino DT Production Status

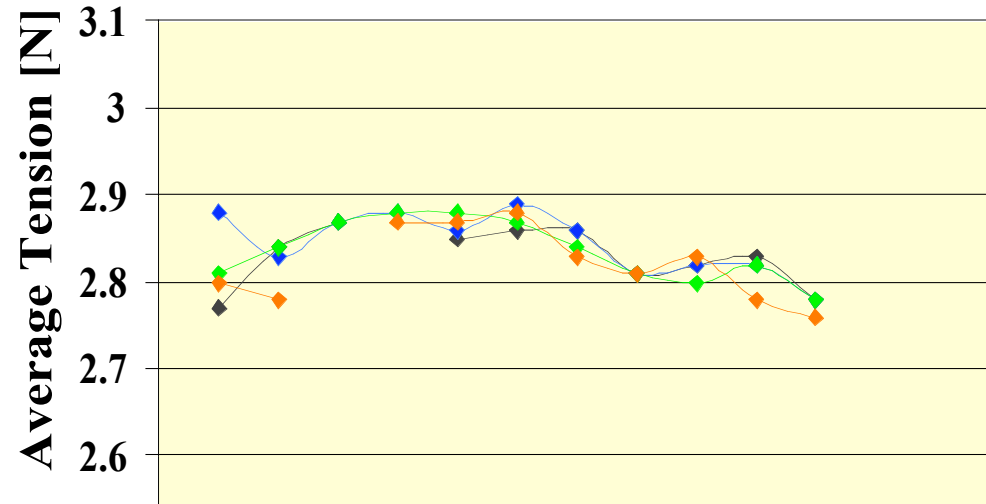
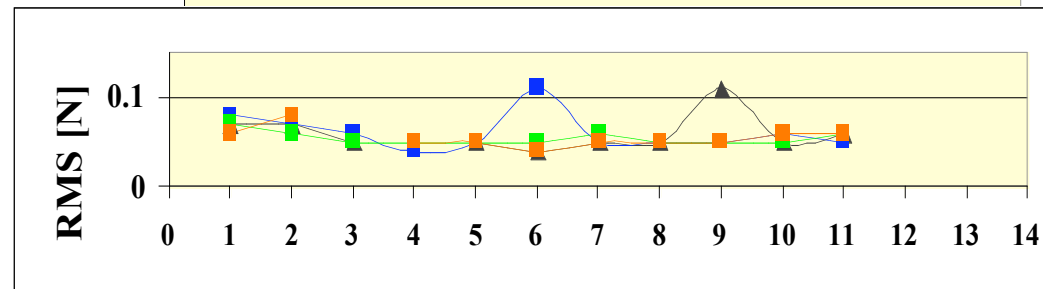
Frequency range 79.3 –83.3 Hz (phi)

Wires with frequencies outside this range get adjusted or eventually replaced

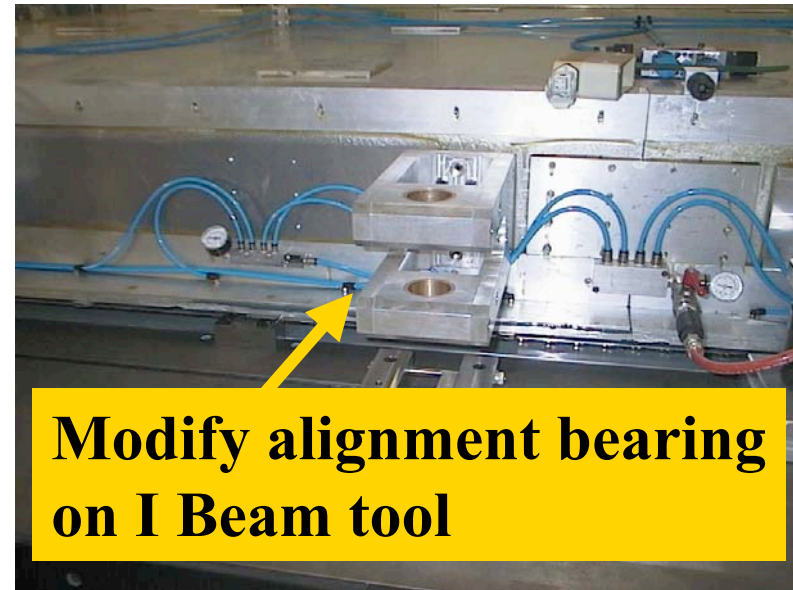
**SL001-SL002-SL003 endplugs  
reference on Ibeam tool out of position**

**SL004- SL005-SL006: I Beam tool  
alignment problem.**

**SL007- SL008-SL009-SL010: still I Beam  
tool positioning problems (absolute  
avarage mean position)**

**SL011 Avarage absolute wire position still to  
be corrected but under control with  
comparator. Much better alignment among 4  
layers**

**Tuning of positioning the alignm. bar**

**➡ Comparator**

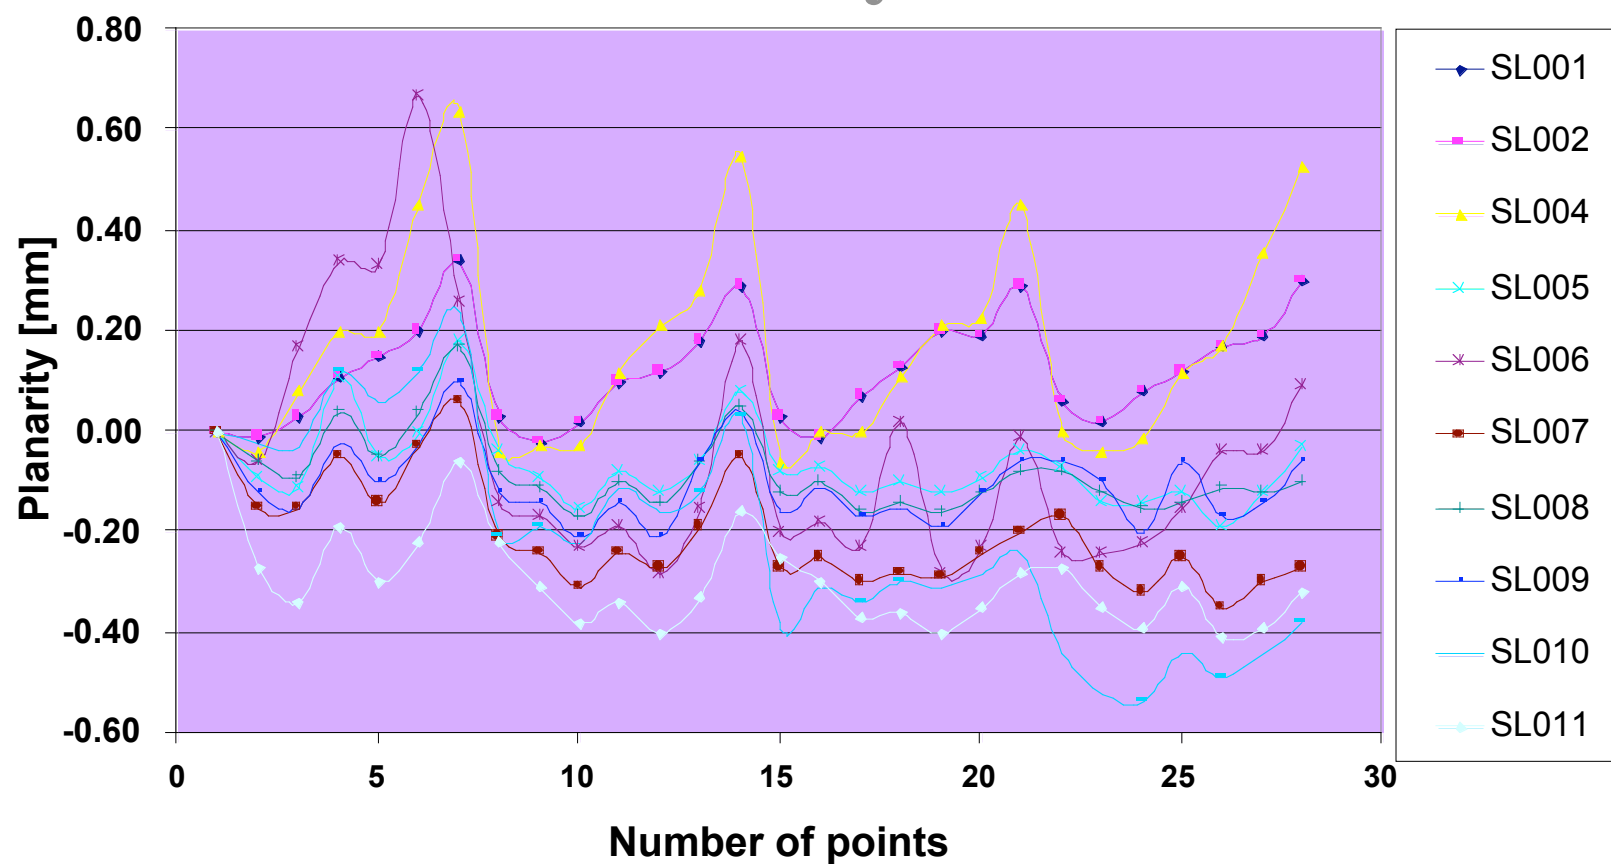
**Average planarity in latest SLs within 400 microns**

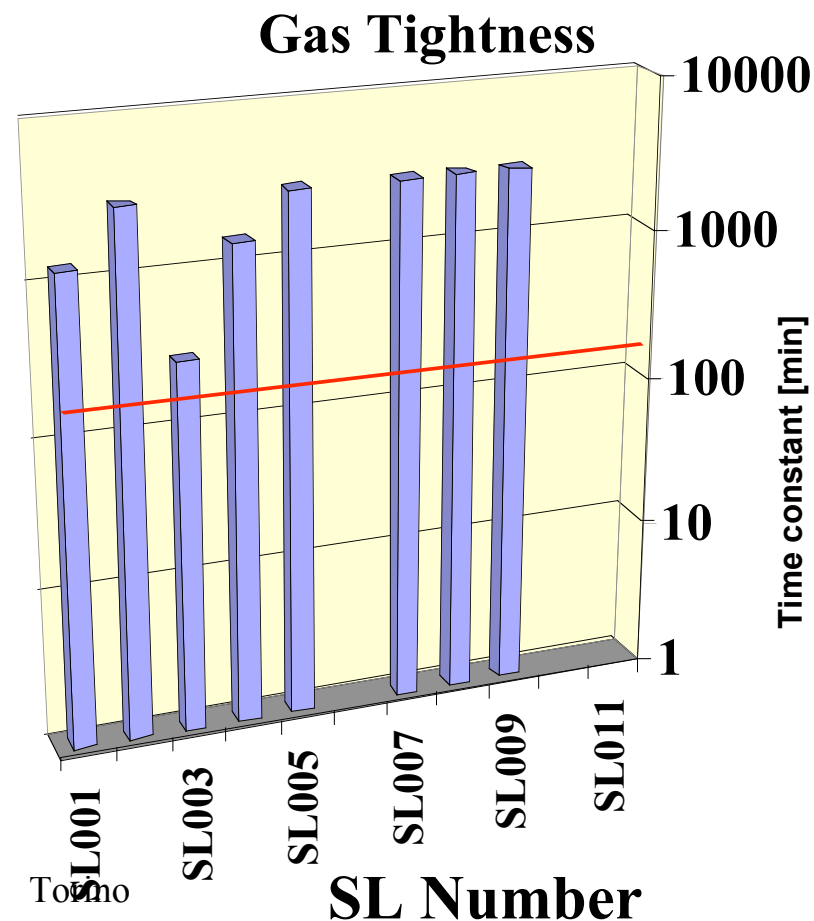
SL No.	t[ <i>min</i> ]	Additional Sealing
001	1322	Yes
002	Inf	Yes
003	296	Yes
004	1536	-
005	Inf	-
<b>006</b>	<b>Unglued the last plate</b>	
007	Inf	No
008	Inf	No
009	Inf	No
