# ISR reception and tests

Status report

**Jesús Puerta-Pelayo**  
**INFN Bologna**

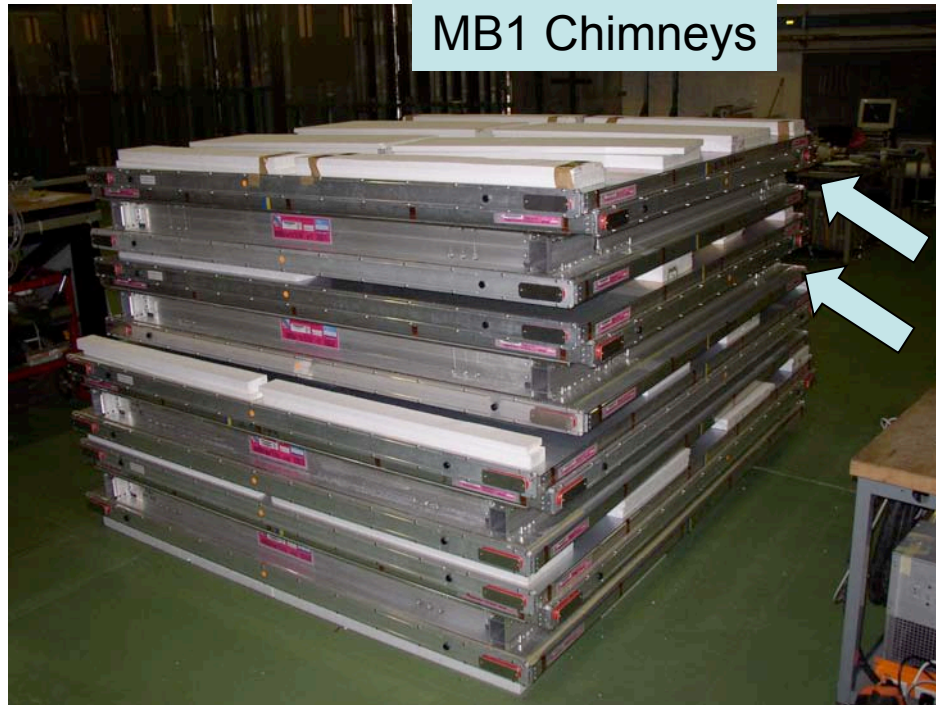
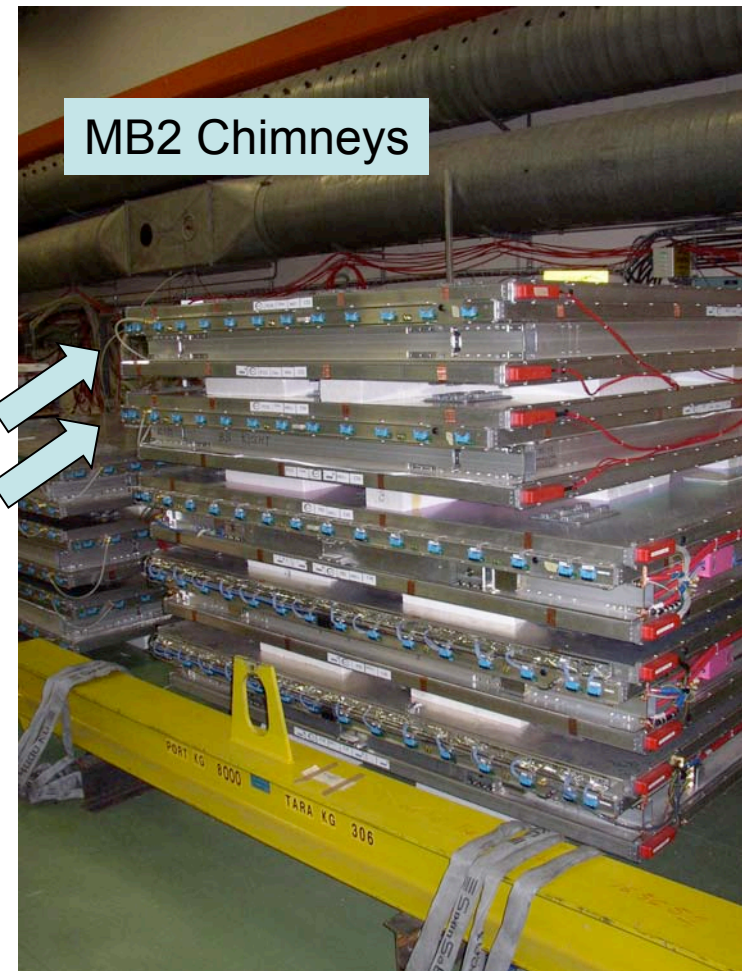
Chimney chambers already at ISR
