ISR reception and tests

Status report

Jesús Puerta-Pelayo

CERN

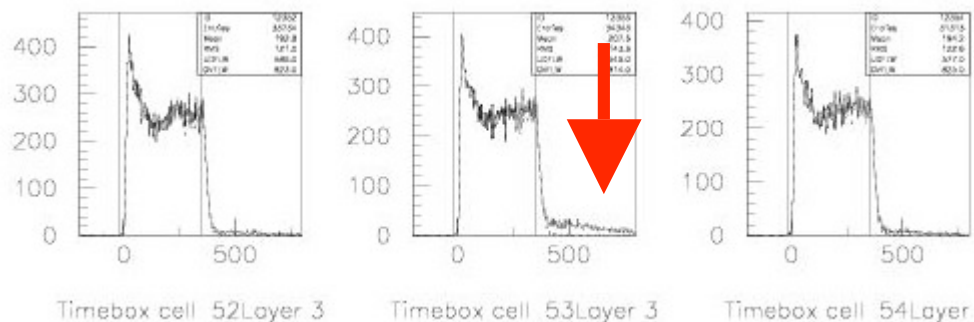
- ❑ Some bad connections were not observed at first cosmic tests because electrodes (strips / cathodes) were still charged, hence those cells were working properly. Problems arose after some time for self-discharging.

Chamber must be fully discharged before substitution
