ISR workflow

Tests status

CMS week September 05, DT session

Jesús Puerta-Pelayo, CERN-CMM

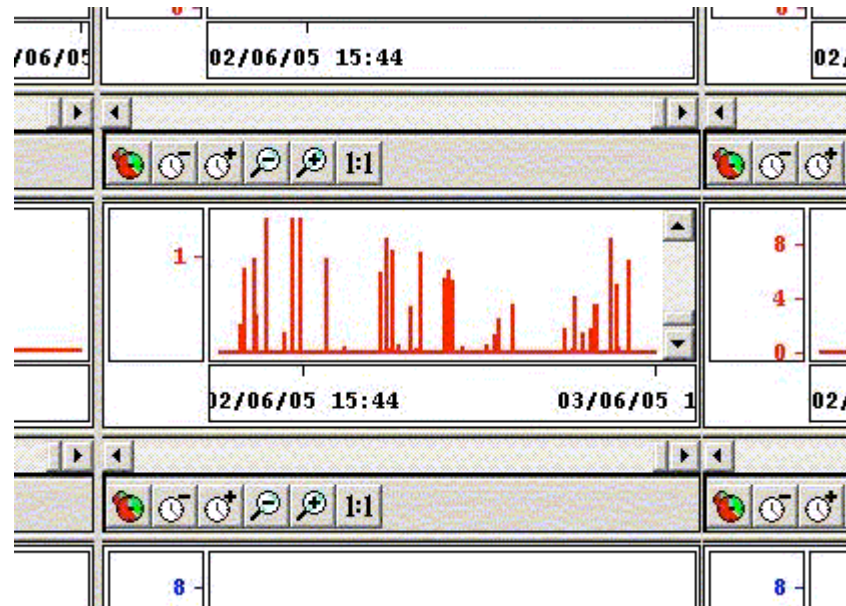
The achieve of a stable HV behavior is the most time consuming operation and the main source of delays in chamber certification.

Many problems appeared only after weeks under gas & HV.

“Grass-like” discharges are still present. In some cases even despite HV components substitution the problem didn't disappear.

Careful isolation and handling of components is fundamental

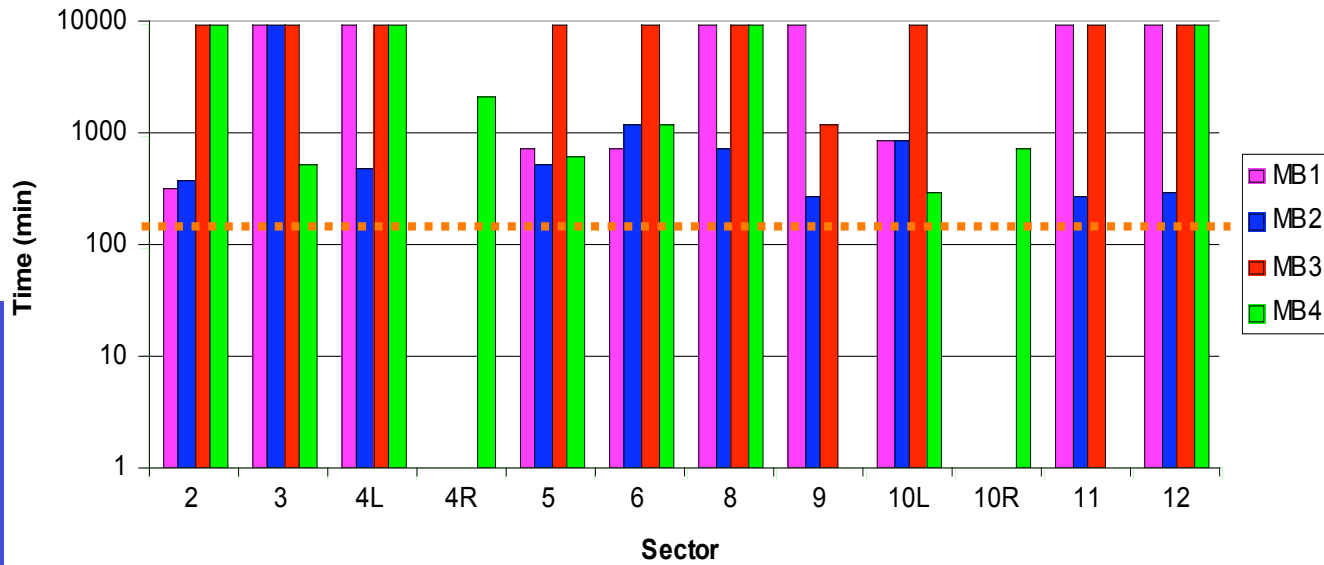
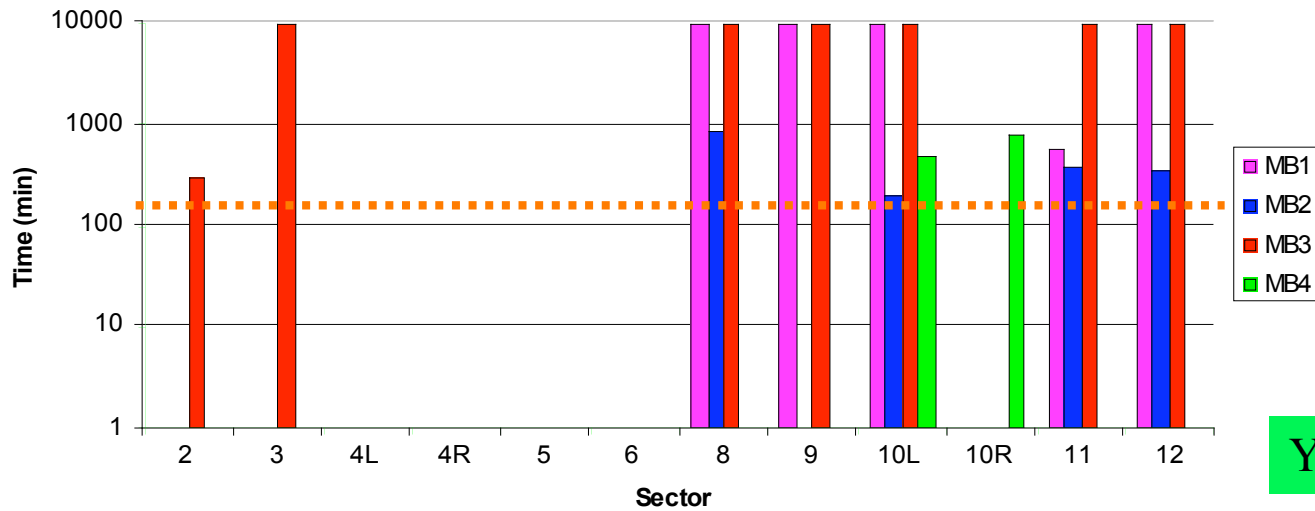
Gas tightness tests

Minimum time constant required = 120 min

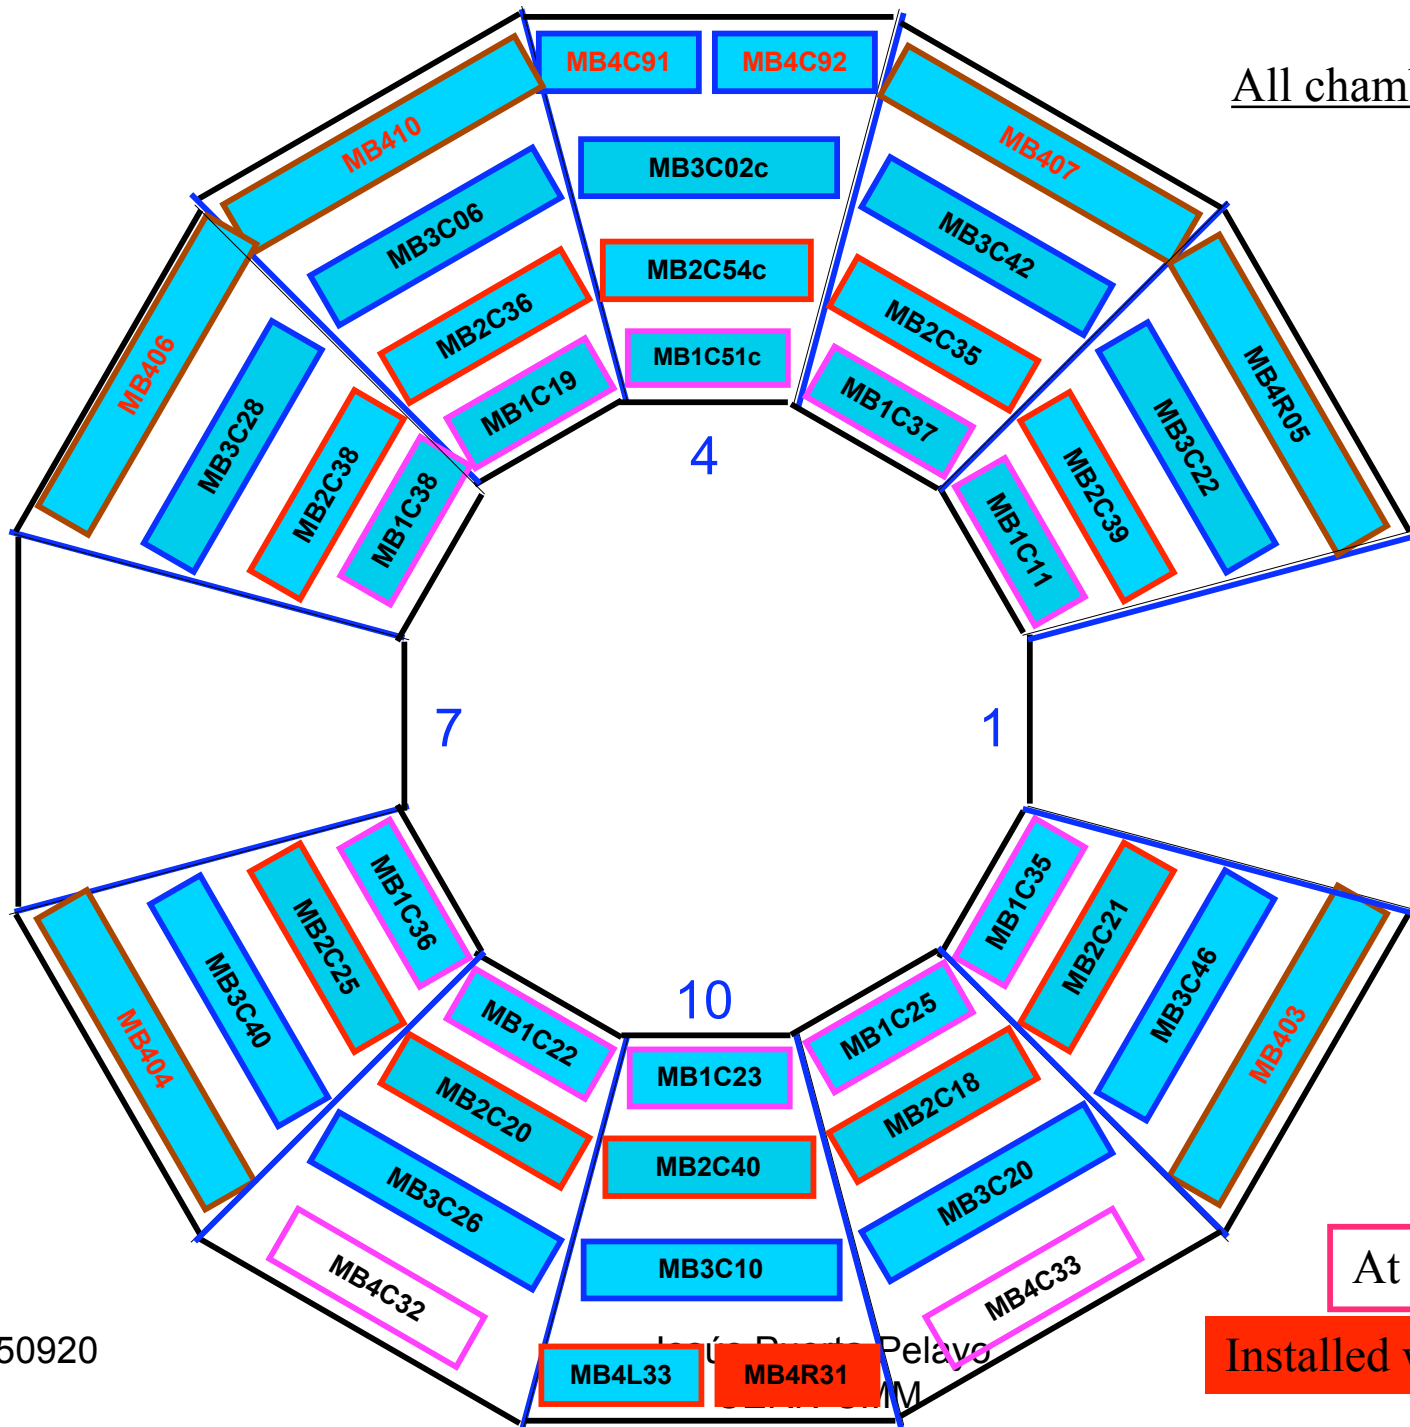
YB+1 status

- **Surface installation just finished last week with the last MB4s (again, no feet chambers installed yet)**
- **MB3** removed from YB+2 (MB3C10) was repaired (cell disconnected), HVB substituted and reinstalled in YB+1 after testing.
- One of the **MB4/10** (MB4/10C31) chambers was installed with HV problems. It will be repaired as soon as the gas flow at SX5 comes back to normality.
- One of the big **MB4** (MB4C10) had some gluing defects along certain cathodes of the upper plate in phi2. They induced noise and some mechanical problems. It was compensated by gluing a thick plate on top of the problematic region.
