## CMS Week 050619-23 Barrel Muon DT Session

### BMU Cooling Measurement, etc.

Hans Reithler / Aachen

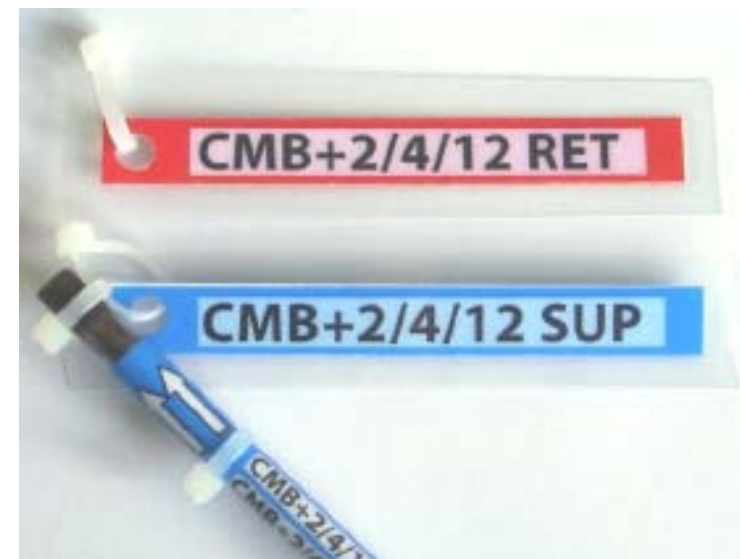
- Piping on wheels is partly different from general drawing: each second wheel has inlet and outlet of subcircuit (feeds two BMU stations) swapped.
- As far as the flow limiters are installed in accordance, and the circuit within the BMU stations are symmetric, this swap would not jeopardize the utilization of the circuit.
- To avoid possible problems when opening the cooling circuit for e.g. chamber maintenance, the addition of colored labels to indicate SUPPLY and RETURN were proposed.

Possible additional labels on cooling pipes

- Check the status of piping and marking on the wheels.
  - > Subcircuits indeed with reversed flow on YB+2, correct on YB+1,...
  - > Aluminum labels corrected. Pairs of identical labels left at few places; should be corrected meanwhile.
- Check how an eventual correction of the piping could be done and the implications on work and cost.
  - > Done. Feasible but costs precious time and money.
- Additional, colored labels to be implemented.
  - > Done, see example. Labels being mounted.
- Measure actual temperatures along the cooling subcircuit, to judge whether one can live with reversed flow direction.
  - > See next slides.

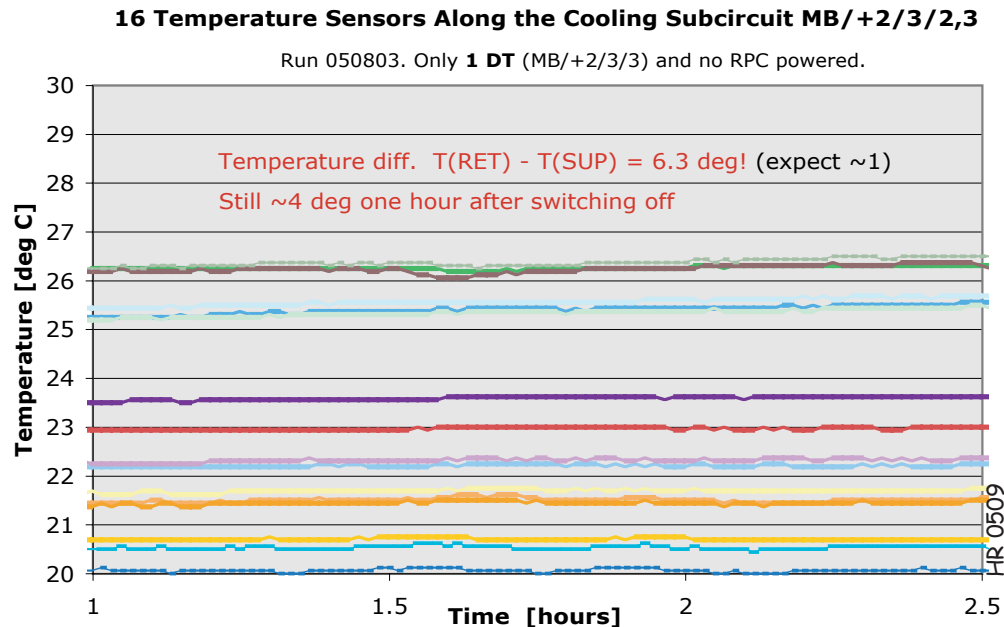
- Measurement 050803, only 1 MB3 powered (no RPC): cooling water warms up by  $>6$  deg (instead of  $\sim 1.5$  deg for 2 MB3+RPCs)!! ALARM! --> Check minicrate and cooling.

DT commissioning of MB3\_02\_03, 050803. Reach  $> 26$  deg on cooling water. Temperature on minicrate PCBs reaches  $\sim 42$  deg (expect  $\sim 34$  deg from former data; info from M. Zanetti).

- Minicrate: internal measurement also shows similar increase (reach 42 instead of  $\sim 34$  deg) on PCBs, but current remains normal. --> Problem originates elsewhere.
- Cooling circuit: find that this subcircuit has only 0.9 l/min (instead of 1.5; in open circuit). --> Bingo! ...but on 050805 the flow and the temperatures were closer to normal. Substituted the flow limiter.

- May encounter water flow problem(s).
- Need tool to measure water flow without opening the circuit. An ultrasonic flowmeter has been ordered by CERN.
- The built-in temperature measurement of the minicrate PCBs can warn about cooling problems. Use empirical reference values for this.
- The external temperature measurement was useful to discover and clarify the problem.

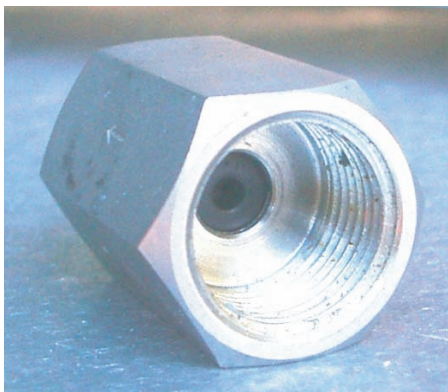
Flow limiter used. Is for 1.5 l/min and was designed to tolerate operation in magnetic field. (By Profi-Mess in Bremerhaven. Info from L. Isaksen)

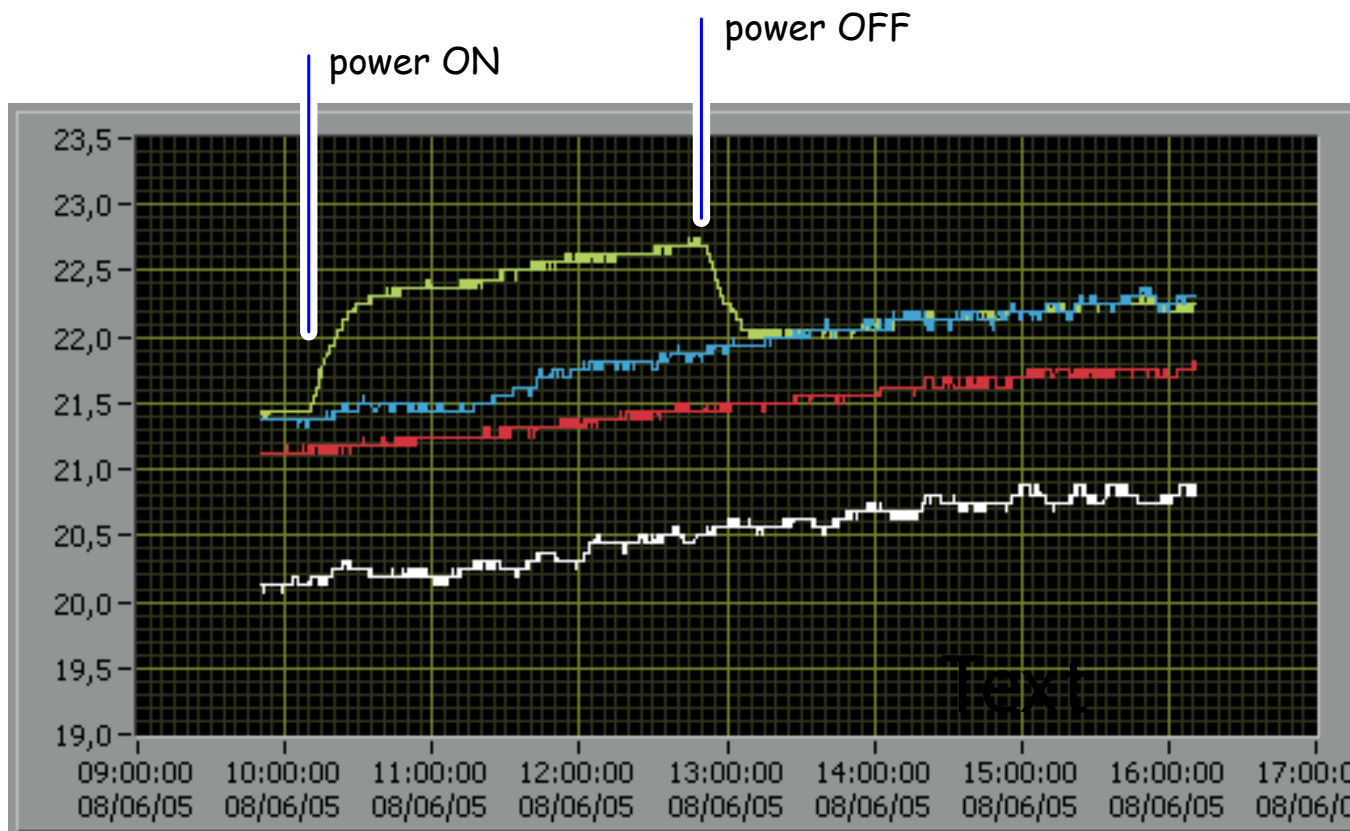
A cooling subcircuit with 2 MB2, but only ONE MB2 powered with LV; no HV.  
 White: hose at supply patch panel; red: hose between both MB2; blue: hose from RPC to minicrate at second MB2 (input to the minicrate powered); yellow: hose from this minicrate to SLphi1 (output from minicrate). Run 050806, powering MB/+2/2/3; no RPC. 23 A on +5 V (compare with 28 A for an MB3)

- Temperature of supplied coolant not very constant; ~0.8 deg increase in ~6 h, following ambient temp.
- Powering LV of **ONE MB2** DT warms coolant by ~0.9 deg.
- Current on +5 V: 23 A for MB2, 28 A for MB3 --> MB3 warms up coolant more.
- Temperature of coolant is settled within ~0.5 h.
- From "distributor" panel to chamber patch panel SUP see 1 deg temperature increase (ambient temp. 24.3 deg). Environment has thus quite an impact on temperatures.

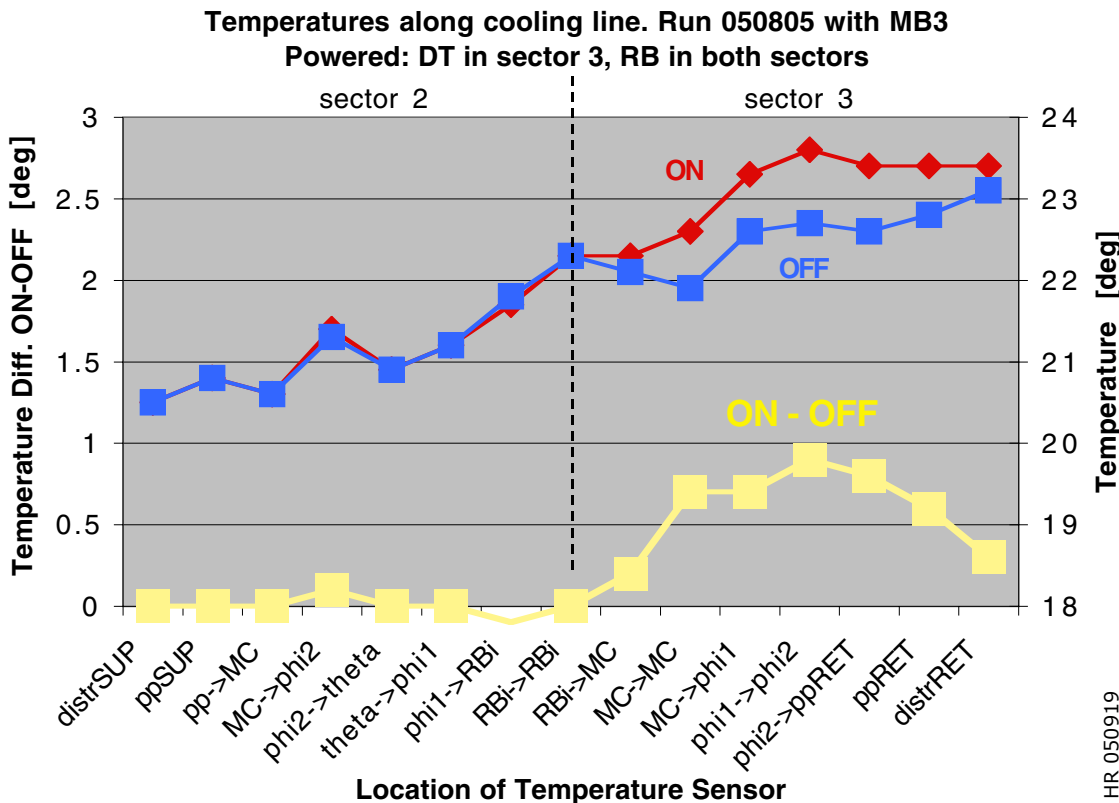
Fig. 2: Temperature vs. sensor, for power ON and OFF.

- Measuring cooling pipe temperature along cooling subcircuit of MB/+2/3/2,3. Powered one DT and both RPCs - Thanks to A. Colaleo, M. Maggi, M. Zanetti.
- Waited ~1.2 h for settling ON and OFF.
- Observe temperature increase RET - SUP of ~ 2.5 to 3 deg, but ON - OFF of ~1 deg.

- 1 DT heats coolant ~ 1 deg. Fine; about as predicted by ILK.
- RB heats very little, fine. Same heating at high data rates?
- Watch additional ~2.5 deg heating! Environment? Check.

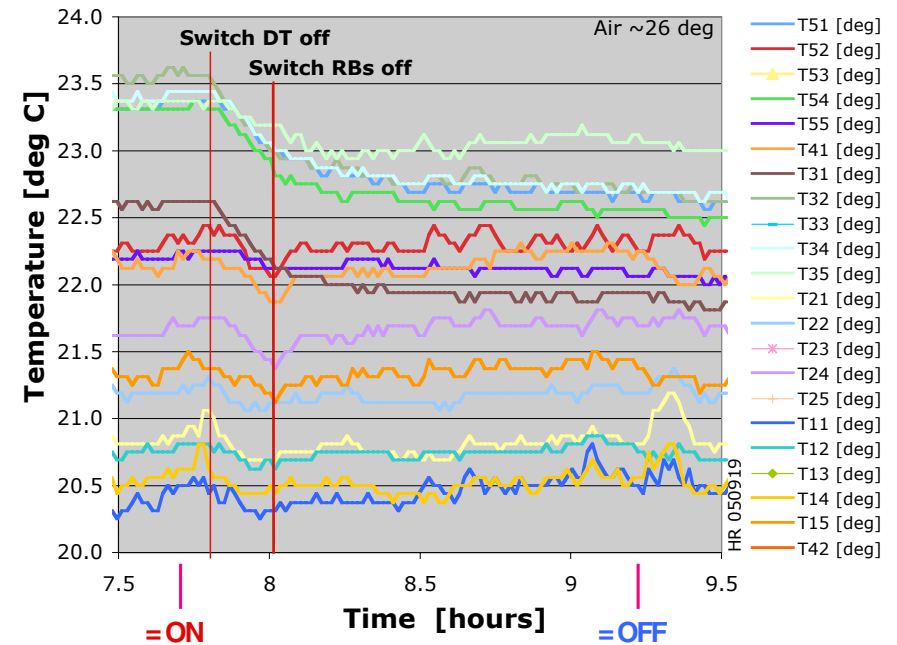
Fig. 1: Temperatures vs. time

16 Temperature Sensors Along Cooling Subcircuit MB/+2/3/2,3  
Run 050805, part 2. 1 MB3 DT (MB/+2/3/3) and 2 RB3 RPC powered.

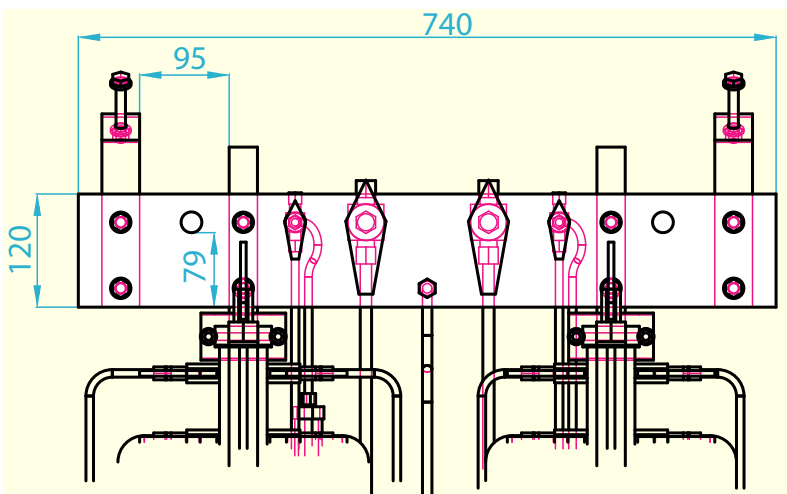
Panel at cooling distributor: several components but no marking available yet on the 30 panels.

● 30 large panels need to be marked; are mainly for HO & YB cooling... Who does it?
