CMS Week 051205-09  
Barrel Muon DT Session

Vd Chamber, HVC, etc.

Hans Reithler / Aachen

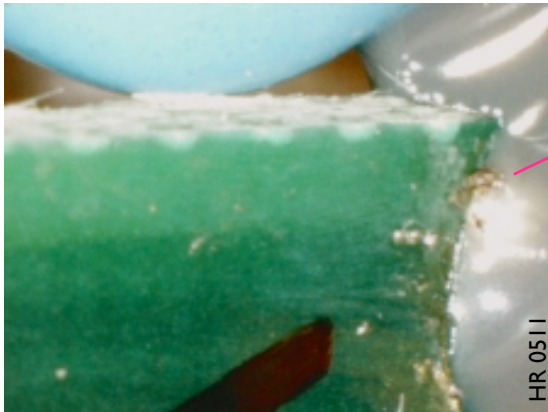
A 16 ch. High Voltage Coupling board "HVC".

- Last batch of ~380 HVCs (out of ~11000) assembled at Padova, then glued at Aachen and shipped to ass. sites.
- Found sparking (bad gluing) and no signal (spark gap short circuited) while using the first ones. Called batch back for systematic test.

nearly unprotected point under glue surface

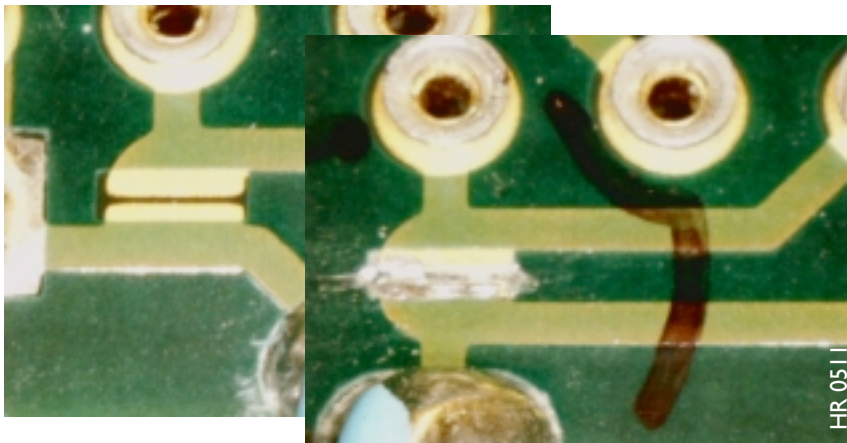
A bad gluing.

- Out of  $380 \times 16$  glued points, ~5 were bad. Corrected.

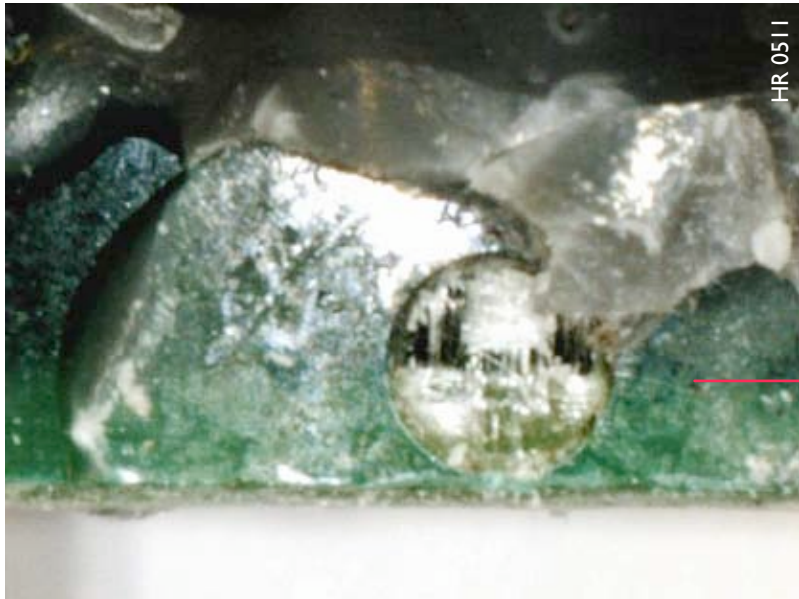
Fig. 4: Same rear face of the HVC, viewing orthogonally to the PCB. It evidences that the HV pad of ~1.3 mm diameter is located dangerously near the PCB border. The red line shows here where the GND starts in the inner layers of the PCB (darker area).

The PCB border is quite rough, the viscous glue may fail to moisten it and allow for HV current.

● To cure this problem, increase the distance between HV leg and PCB (see next slide).

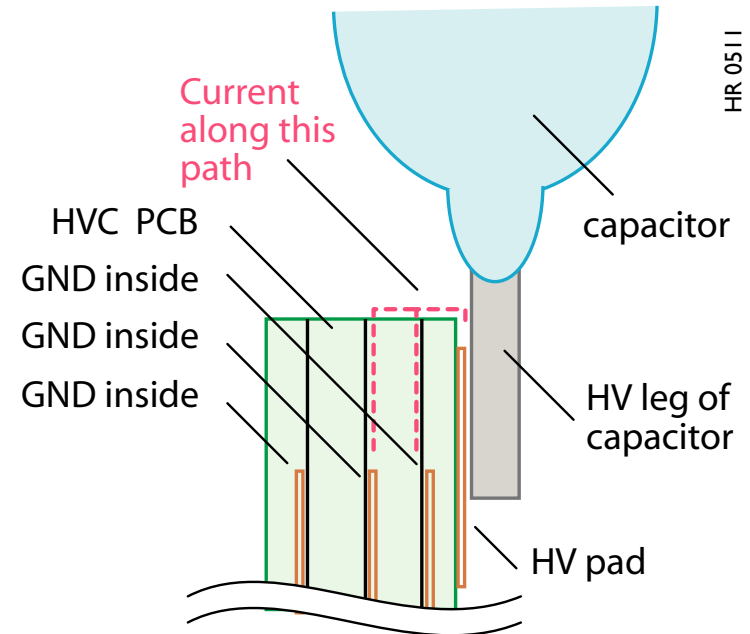
Fig. 2: Sketch illustrating the weak point: current may flow from HV pad to inner PCB layer, as shown in this enlarged cross-section of the border.

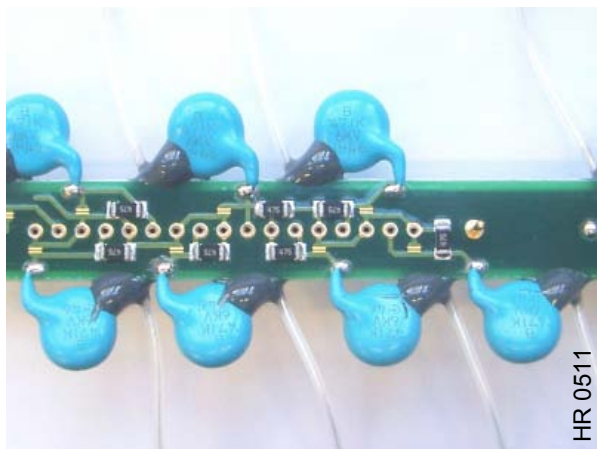
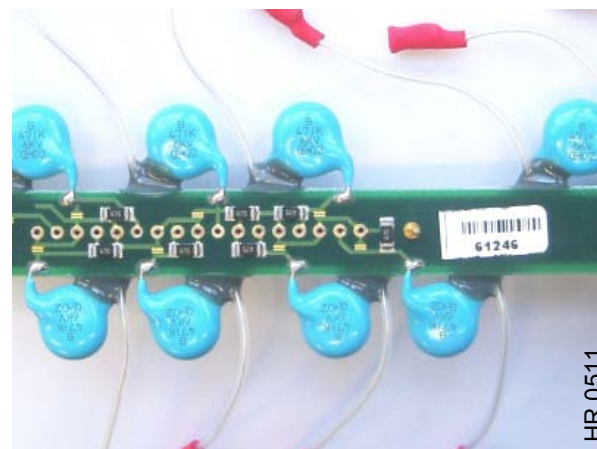
An HVC with (left) and without (right) current. At the left the HV leg of the capacitor (covered by glue) comes closer to the PCB border.

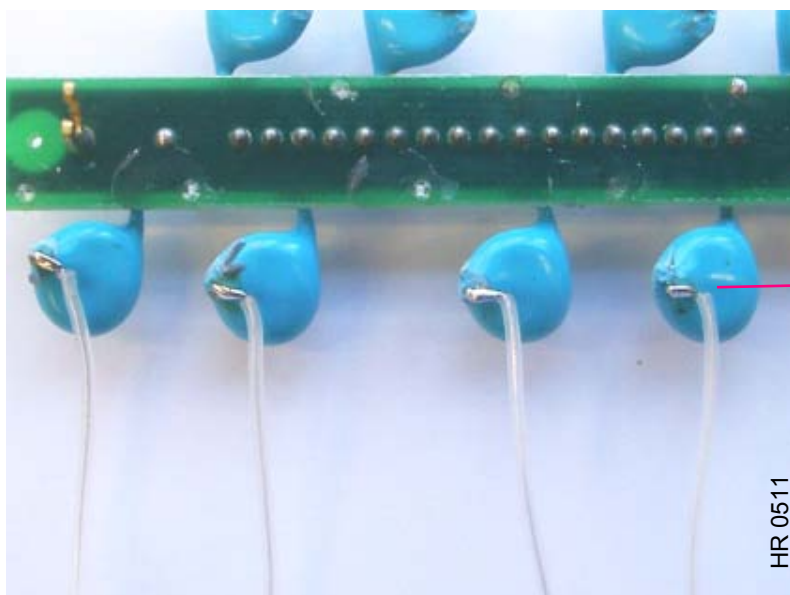
A modified HVC, prior to gluing.  
The HV wire from the anode is kept far from the PCB border; there is no HV pad on the PCB anymore, ensuring a large HV safety margin.

- First 12 HVCs were successfully modified and tested: no current at 5 kV.
- The potential risk of this batch is high. Should also modify not only the 53% bad HVCs.
- The modification is time consuming (~45 min/HVC). Can some lab participate?

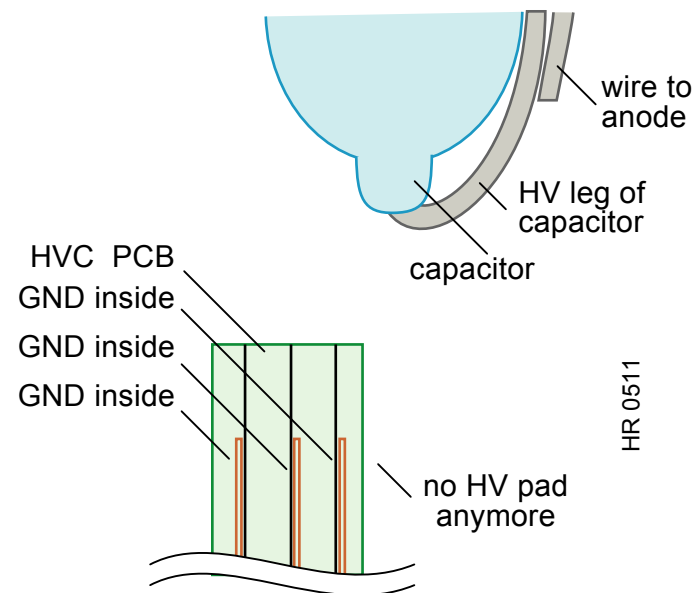
Sketch illustrating the cure: the HV leg of the capacitor is bent away from the PCB (the signal leg of the capacitor, not shown, remains soldered to the other face of the PCB). For clarity, signal leg and glue are not shown.

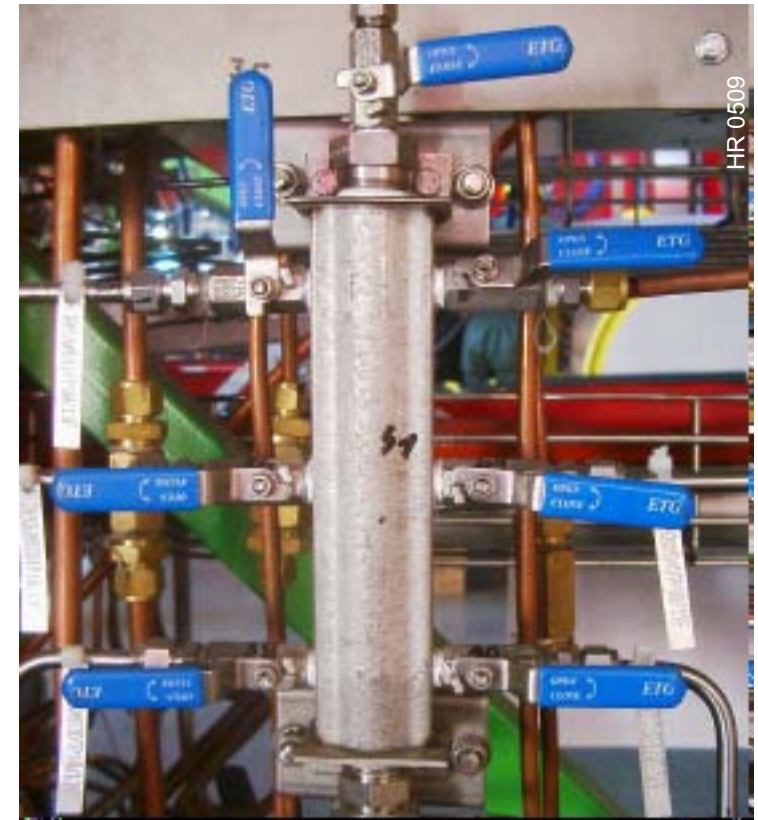
- Recently observed "accidents" with gas and cooling valves:
  - ~ 3 cooling valves found at changed status next day (August)
  - Gas valve at rack exit found closed (...thus sending the gas through the safety valve. October)
  - 3 gas quick connectors found disconnected after a couple of days (November).This partial list evidences that there is some problem.

- For the cooling valves, check whether the handle can move by its own weight. For the gas valve and the quick connectors this is excluded because too much force is required.

Cooling valves around a distributor.

- Conclude: it is very recommendable to install some sensors permitting to check that the valves are at their nominal position.

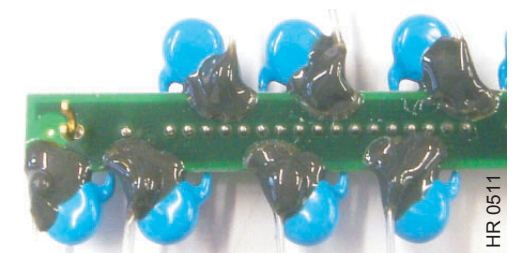
First HVC upgraded.  
(Can use a bit less glue)
