DT Chamber Commissioning

Kerstin Hoepfner, RWTH Aachen & CERN CMM
For the commissioning team

Commissioning Procedures

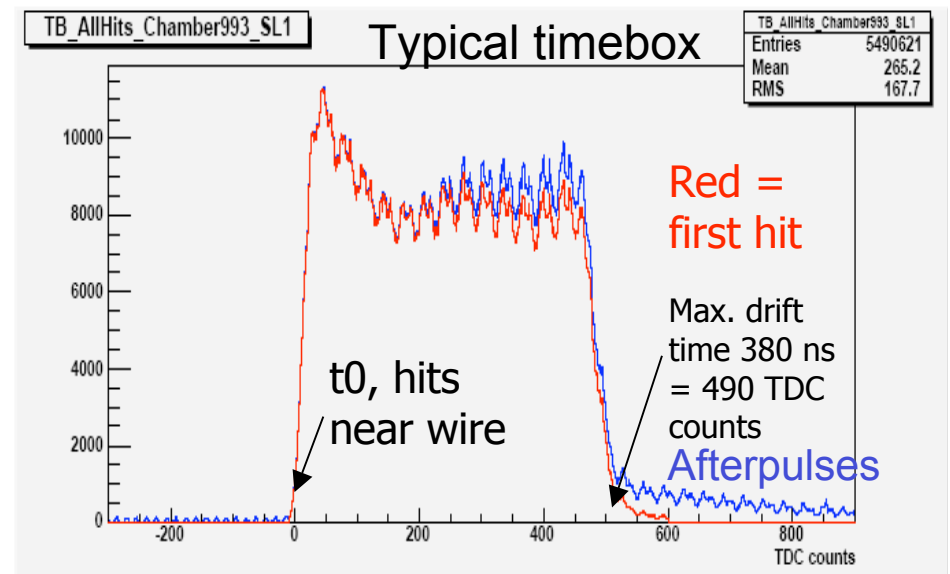
Timebox diagnostics: head: 0-190 counts, belly: 190-320, tail: 520-640

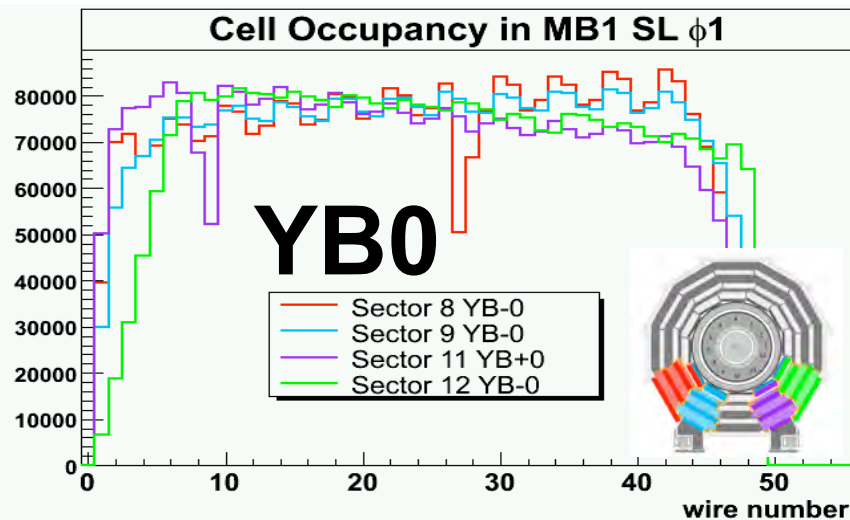
The occupancy decreases steadily due to shielding of HB/solenoid, more so for strongly inclined sectors.

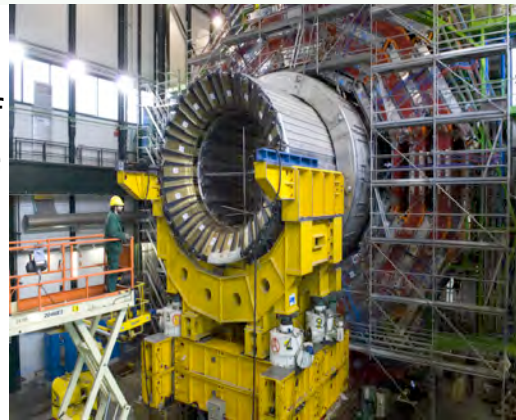
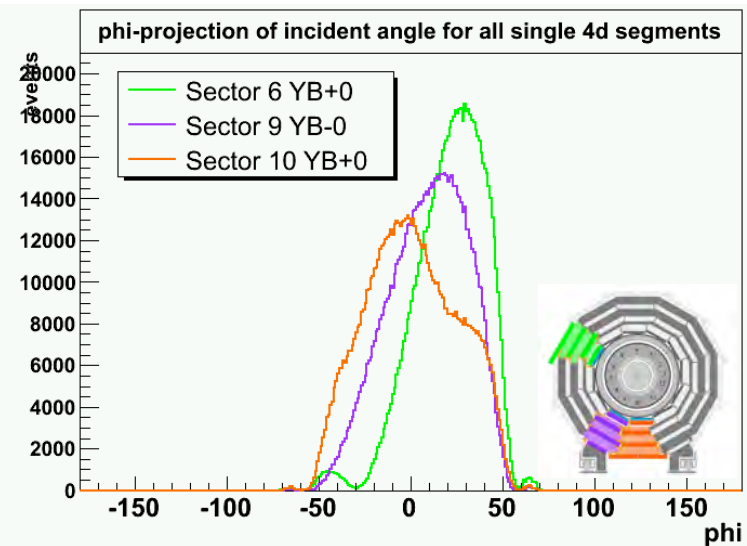
Strongly inclined chambers (S06) cover less track angles.

For S10 as a horizontal chamber one would expect symmetric distribution. But the MB1 S10 is not centered and thus shielded asymmetrically by the solenoid/HB

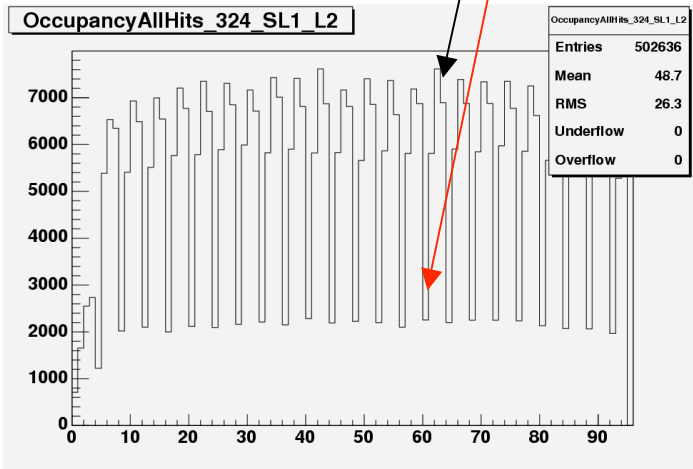
Analysis of MB4 YB+2 in inclined sectors showed strong pattern in occupancy.

Cells with a distorted TDC spectrum, distributed according to a **regular pattern**. Occupancy drops in the cells with distorted time boxes

Reason: angular acceptance of BTI was not sufficient to cope with the large shift between both phi SL (2 cells = 8.4 cm) in MB4. TRACO did not correlate segments between two outermost BTI.

Fixed by increasing angular acceptance (Pierluigi)
