# RPC readiness for Installation: ISR test activity

A.Colaleo- Aachen Muon Week 28-30/4/2004

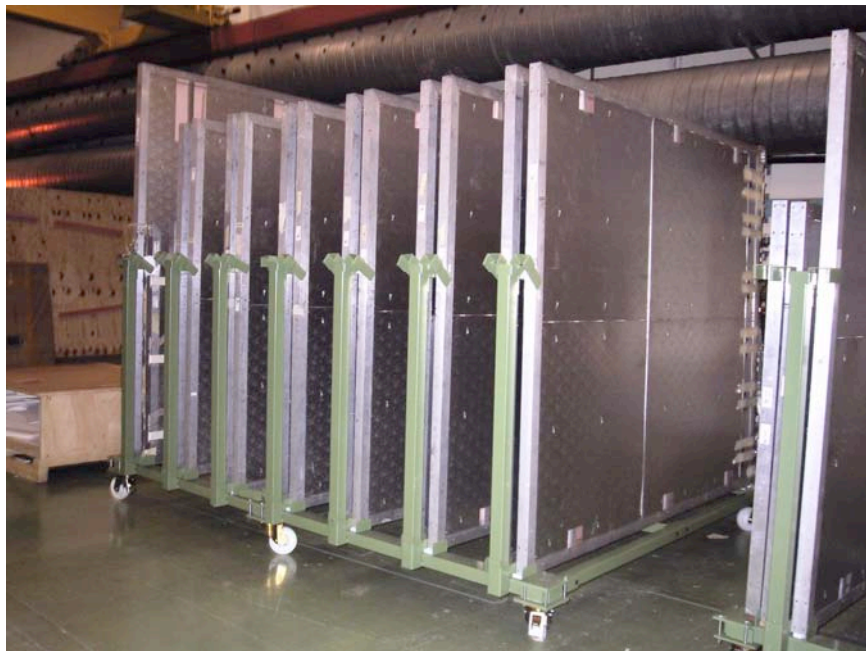
**11m X 7 m  
CHAMBER STORAGE AREA**

Foreseen 160 chambers for the end of year

We have put wheels on all our stoking trolleys in order to move them easily in dedicated storage

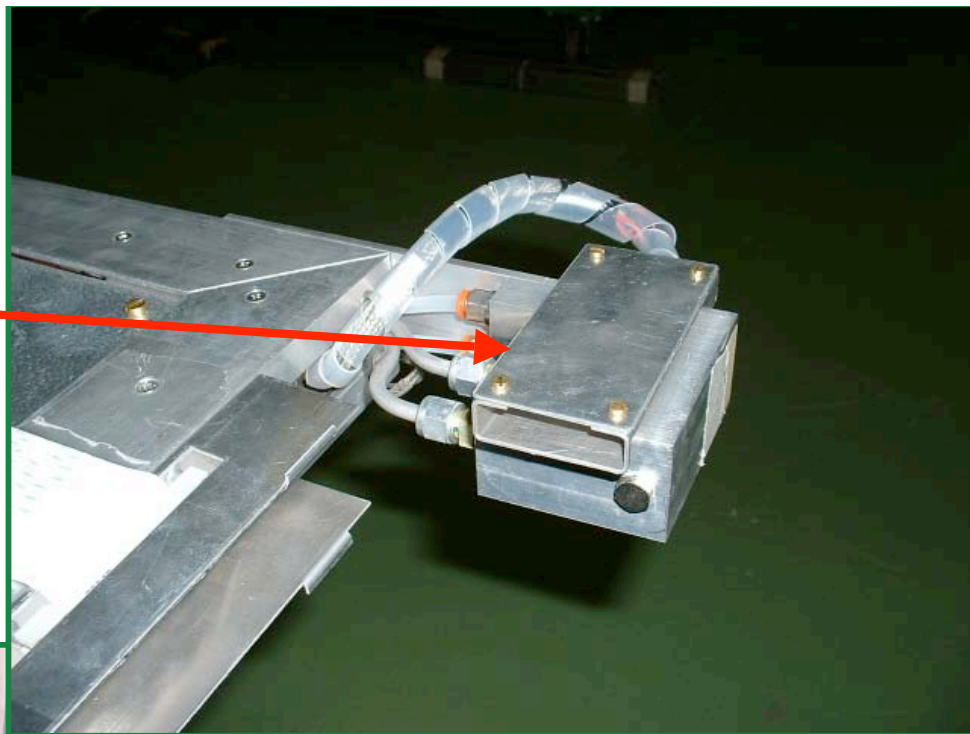
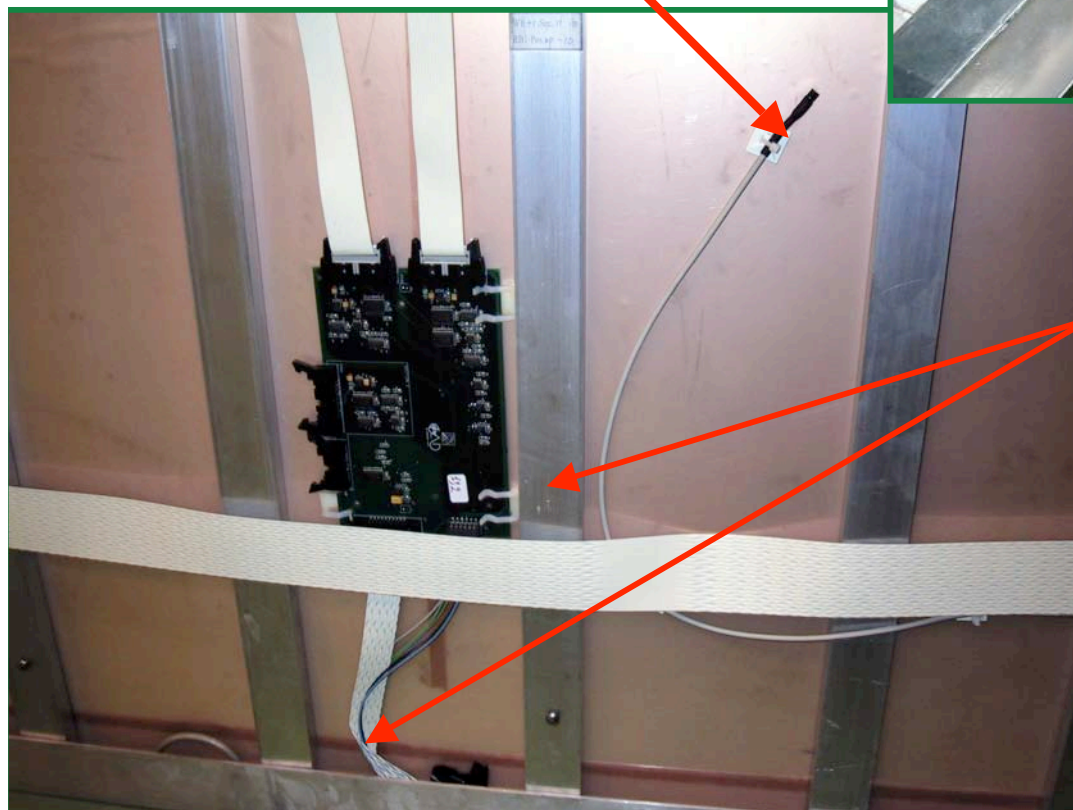
- HV final connectors on some chambers
- Temperature Sensors

- Control board - cable often need to be changed after the transport.
- Found 2/65 chambers with disconnected signal cables

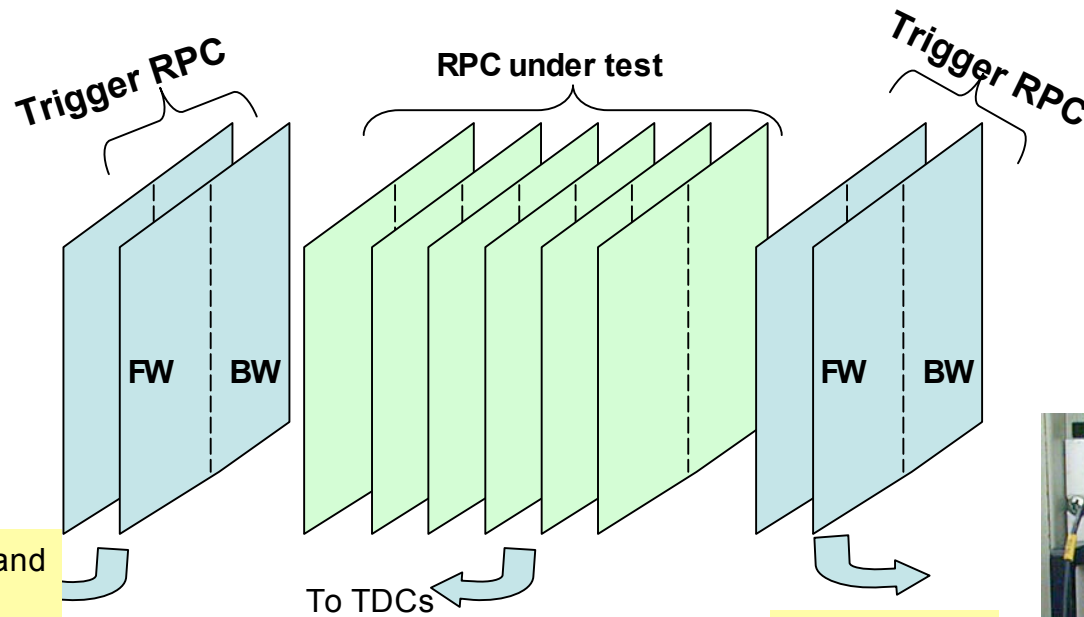
- 132 SIGNAL CABLES → 11 or more chambers can be tested at the same time
- The RPC performances will be checked by triggering with cosmic rays.

The 8 home made NIM modules are interconnected with I<sup>2</sup>C bus driven by the Special Board

To TDCs and Trig. logic

To TDCs

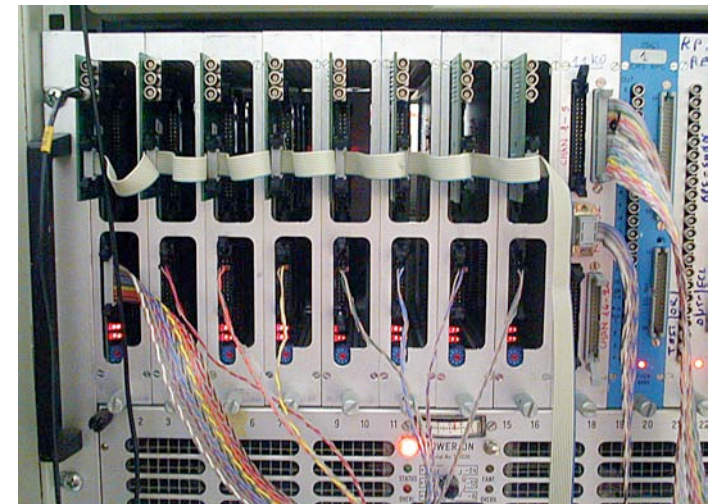
## NEW NIM Module

- OR of 96 strips on NIM and LVDS
- Mask noisy channels
- Majority level selectable on the front panel
- NIM Trigger output - NIM Veto input

System ready in May

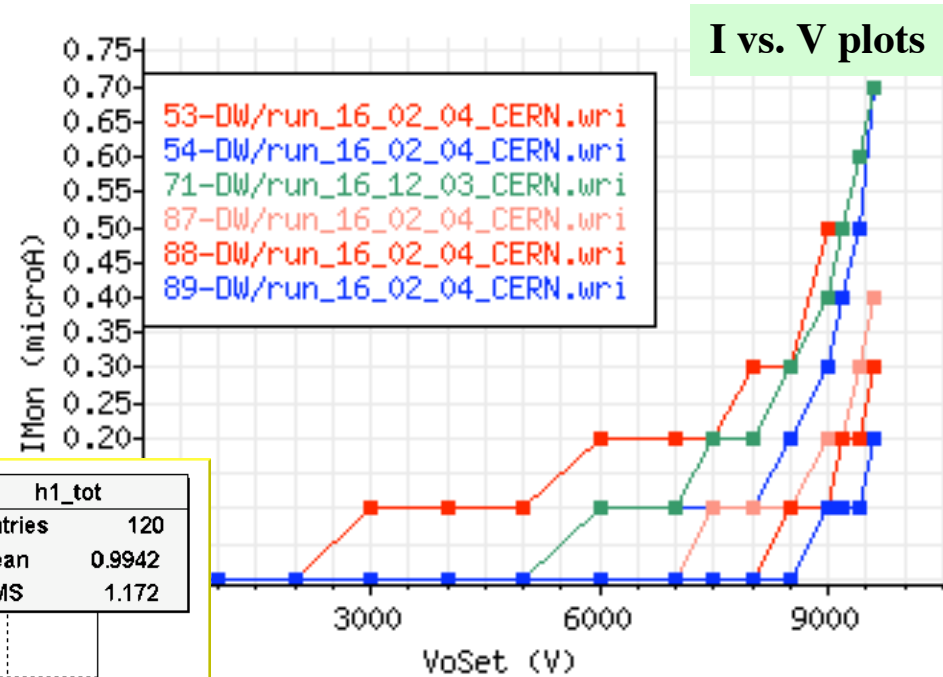
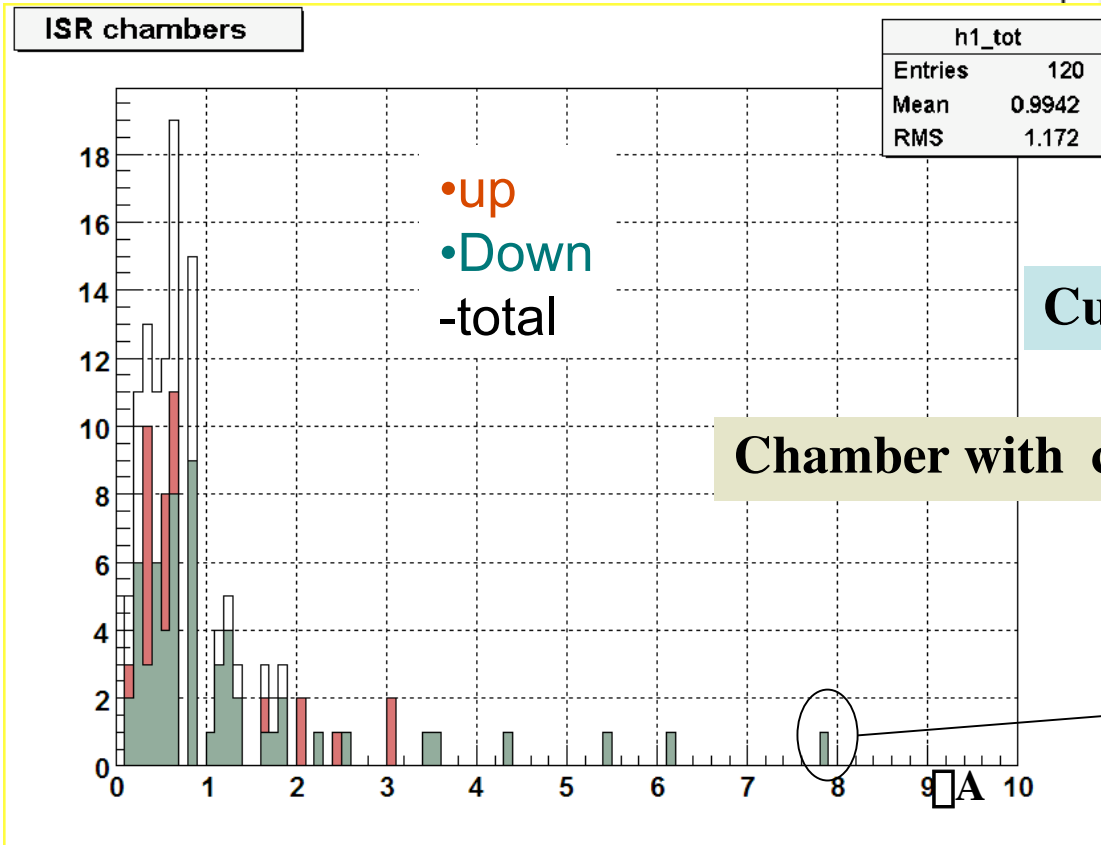
Current@9400 V

- I vs. V plots during the tests
- Current stability for ~15-20 days
- Chambers suspicious have been monitored for > 1 month

Chamber with current/layer > 10  $\mu$ A are rejected

Chamber ID 102: suspicious!  
Long time monitoring...

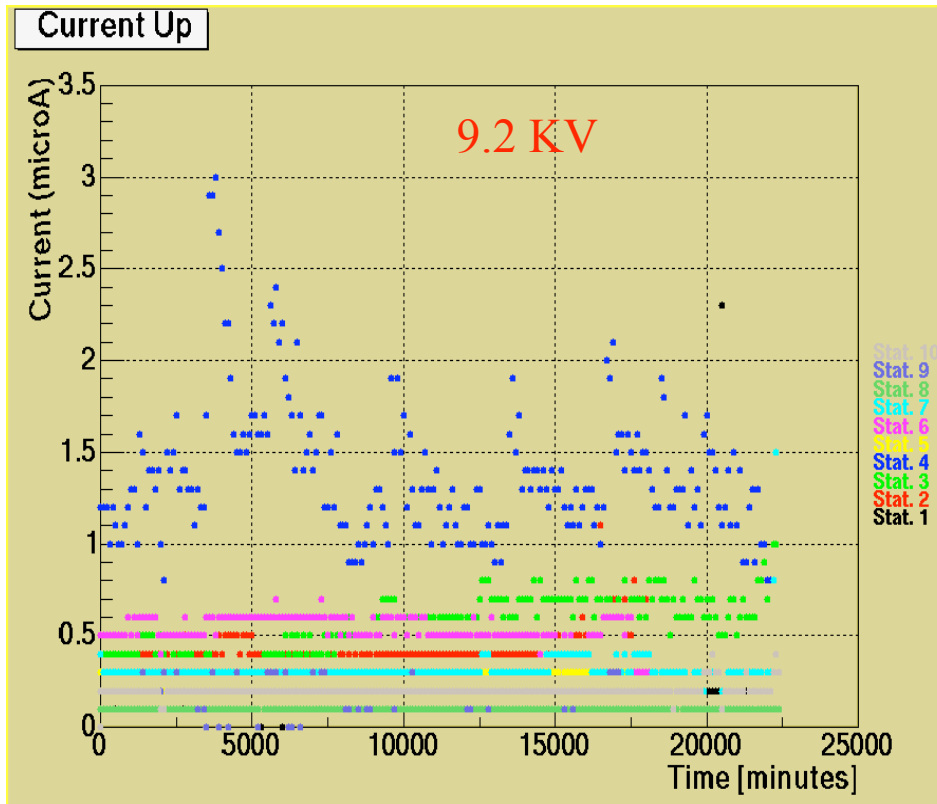
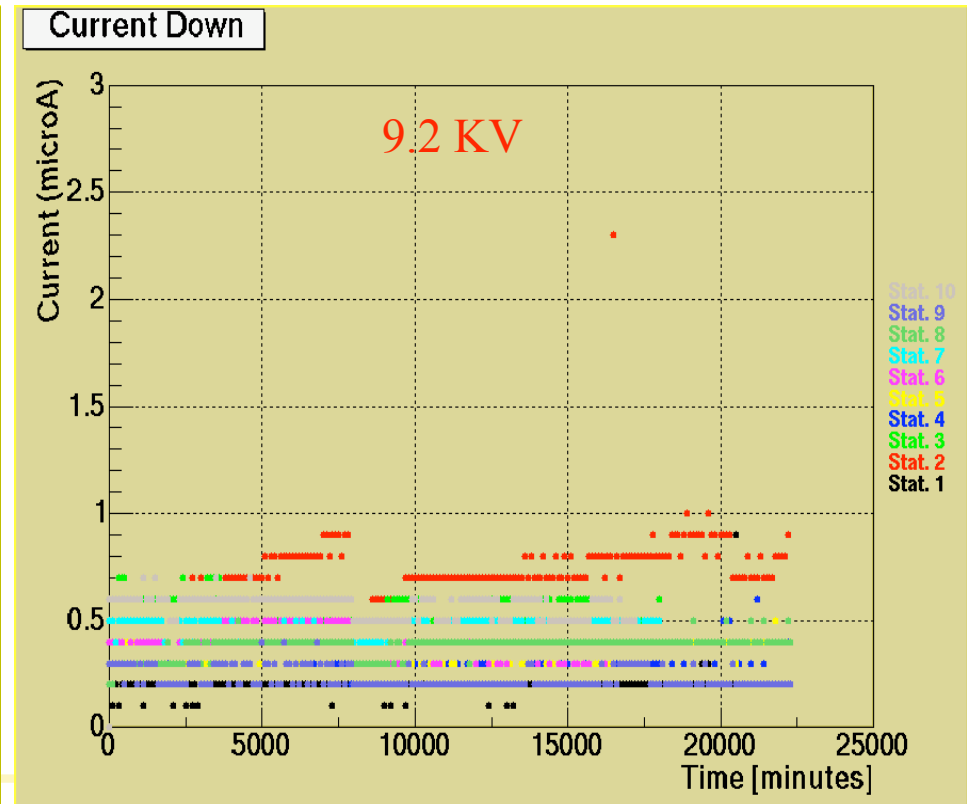
Monitor the current stability @ 9200 V vs time for at least 15 -20 days

On the test trolley for about 1 month

10 Chambers: LAYER UP

10 Chambers: LAYER DOWN

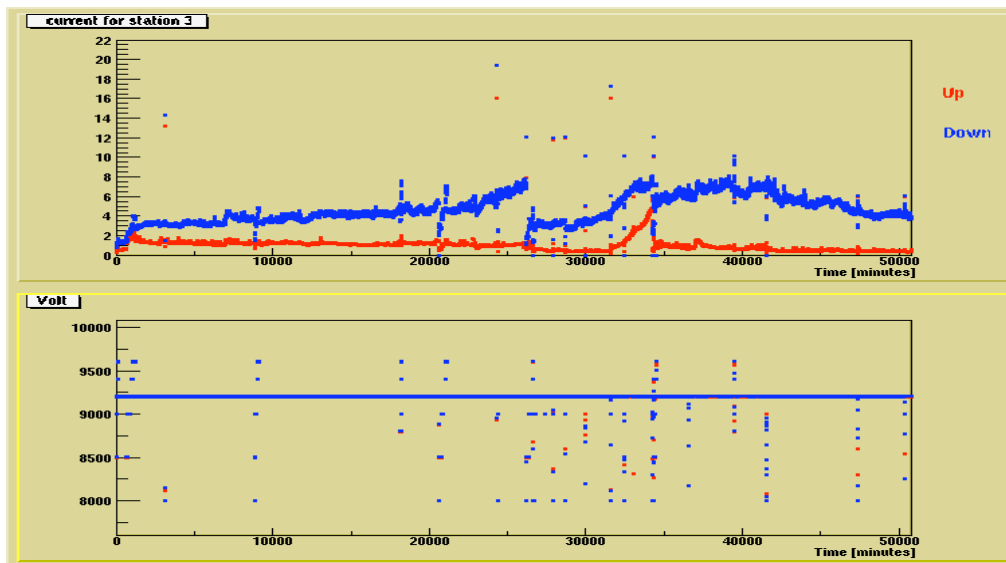
5 rejected for steady increasing of current : chID 98 57 58 61 120

**Suspicious:** HV was switched ON too early

**New procedure since december:** flush with final gas mixture for at least 5 day before switching ON the HV.

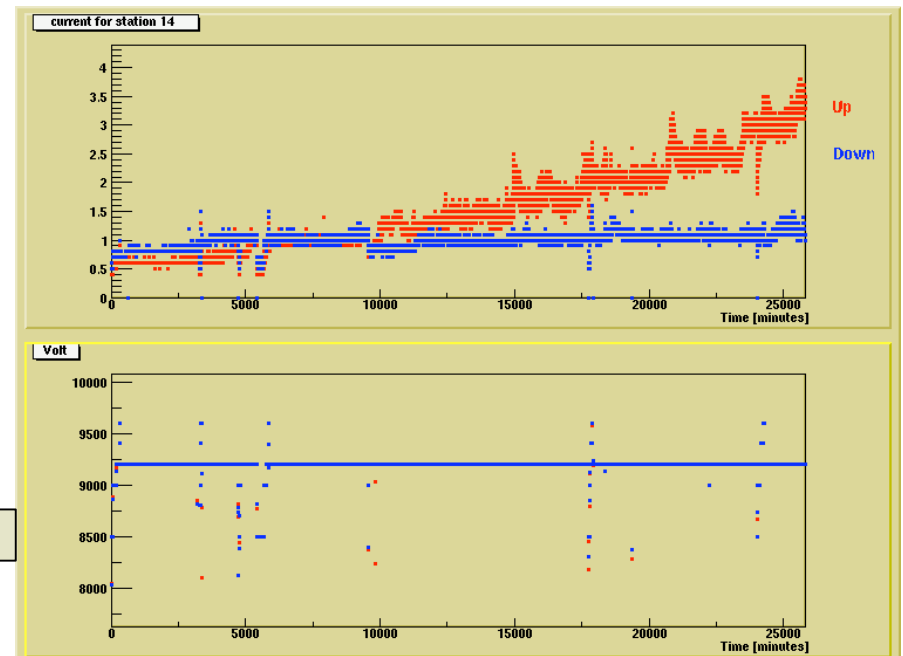
ChID 102 under test since Nov.

Long term test OK

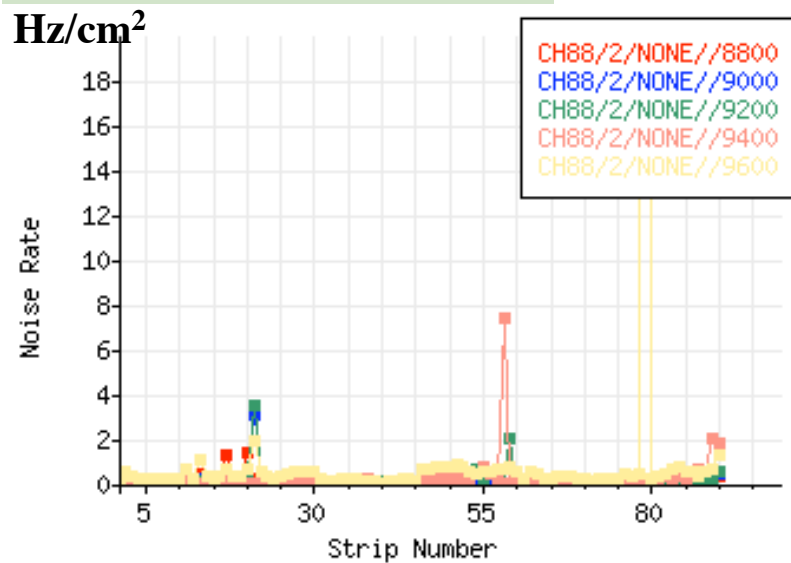
Hit rate profiles chID 88 between 8.8-9.6 kV

Random trigger runs in single and double gaps

- Hit rate profile: noise, dead strips
- Average noise rate by cluster counting

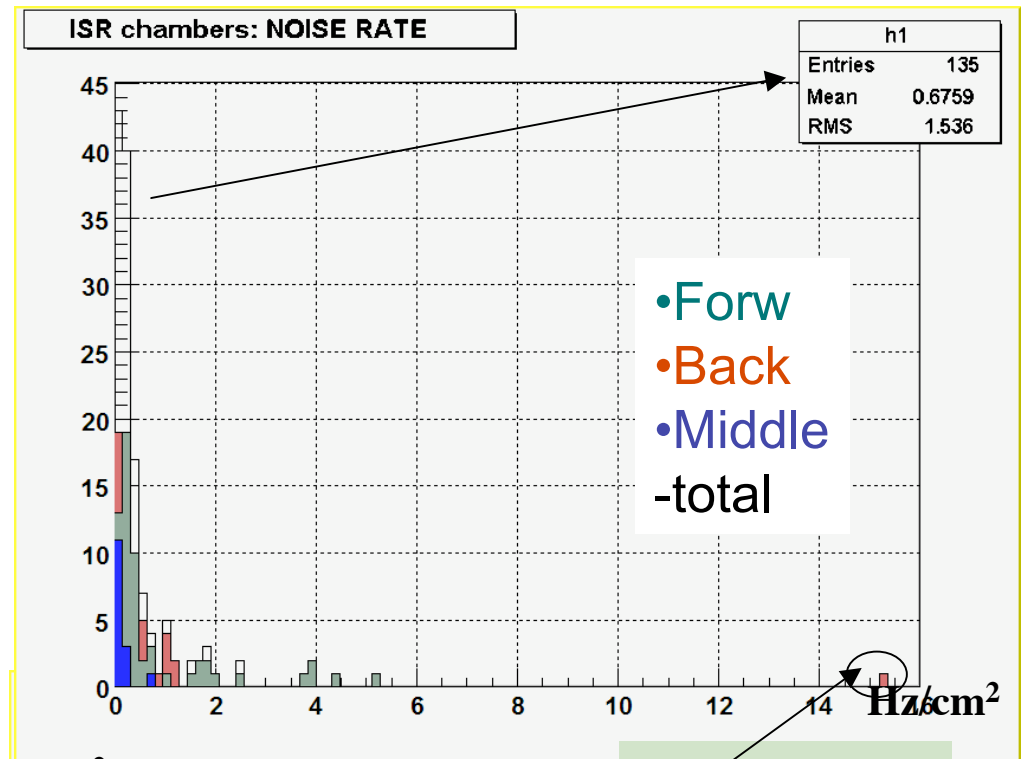
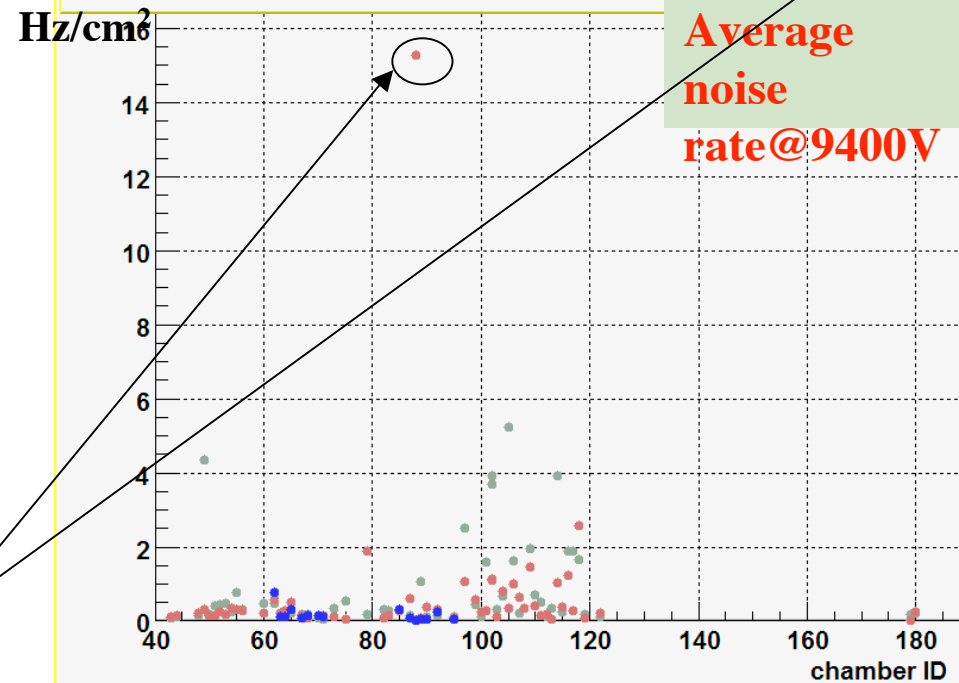
Single run with few, not continuously, noisy strips are accepted

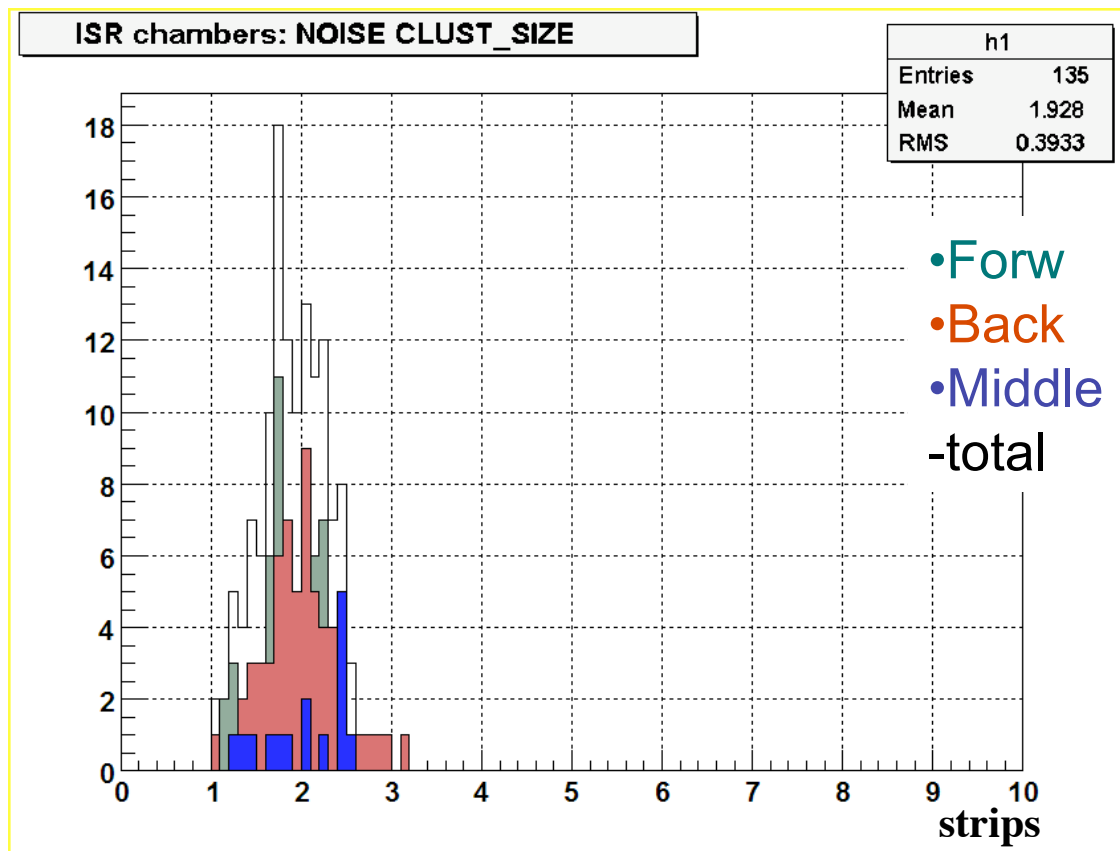
## Random trigger runs: cluster size in noise events

60 Forw + 60 Back + 15 Middle

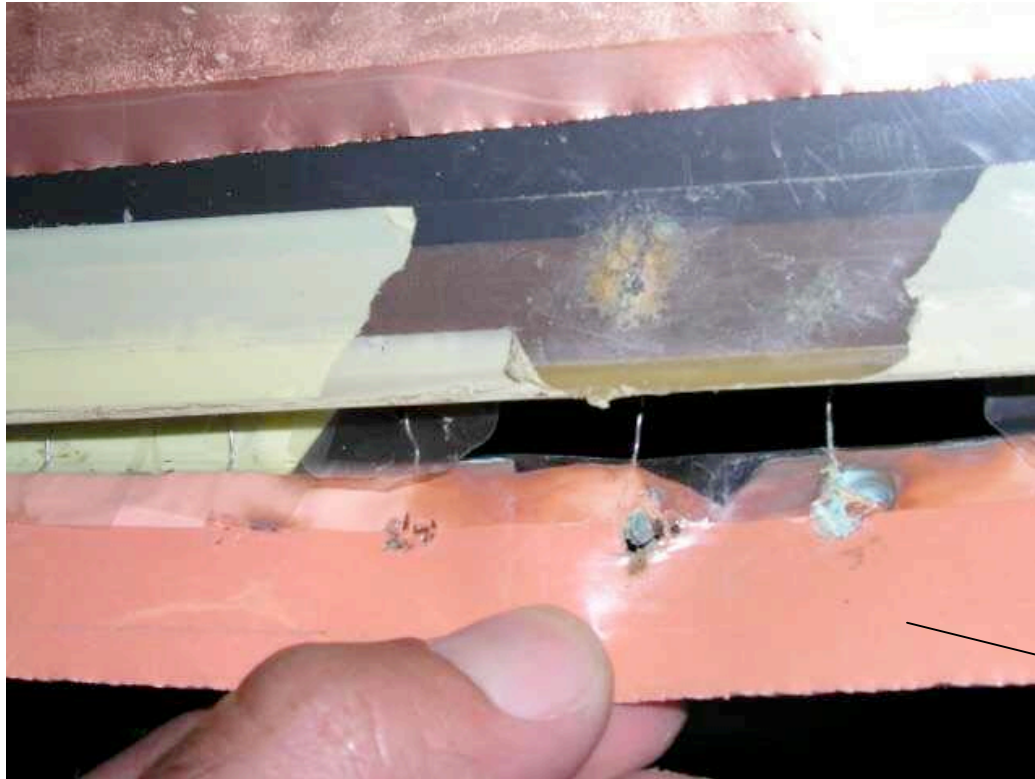
**Known problem in first production chambers.**

**Discharge** found between the gap edge and copper ground plate. Bad soldering of the termination resistor.

An additional “C” made of PET has been added in all new production chambers

→ Copper ground plate

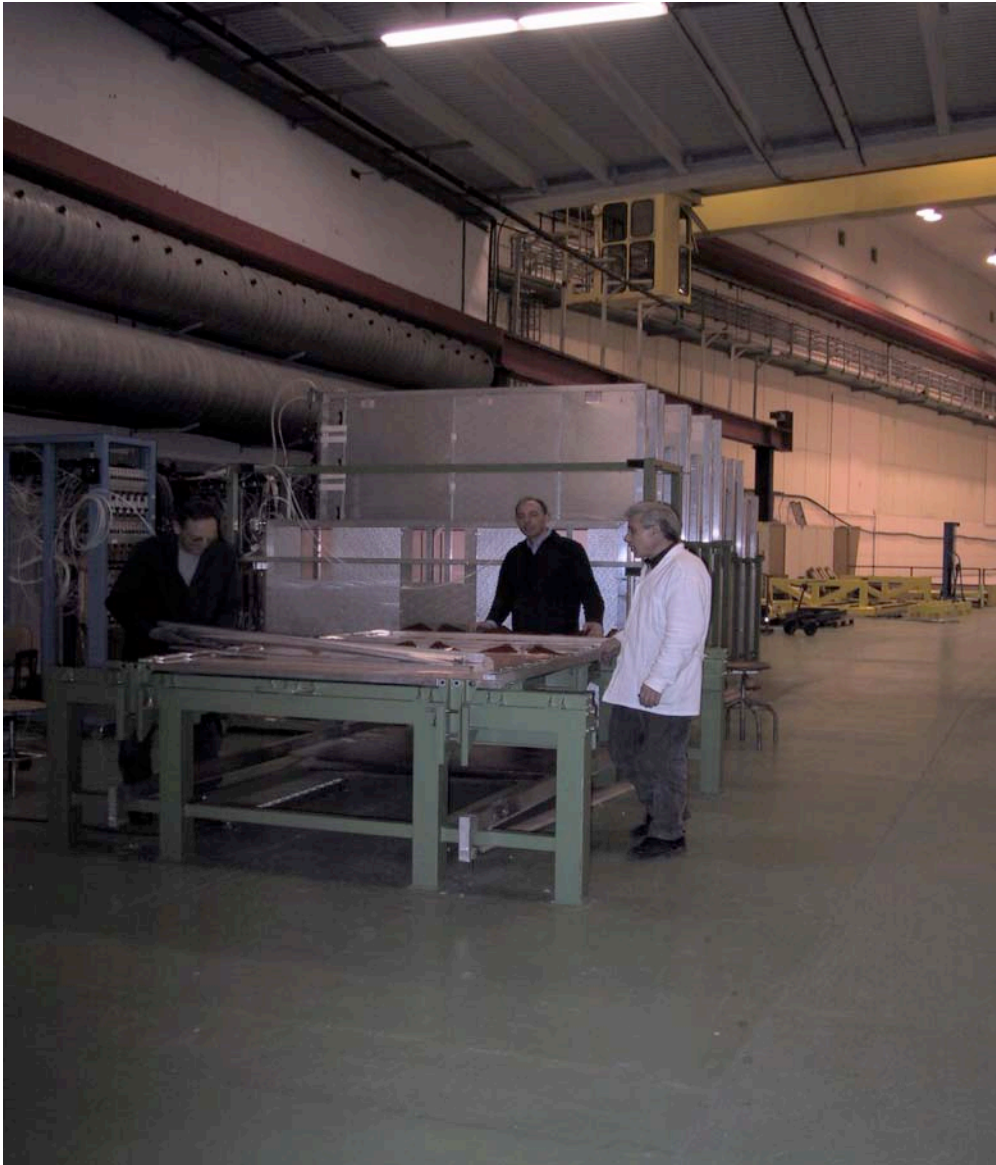
**20 RB3 chambers have been dis-assembled, sent in GT for the modification and re-assembled at ISR**

New gas “custom T junctions” in polycarbonate have been also inserted during the reassembling

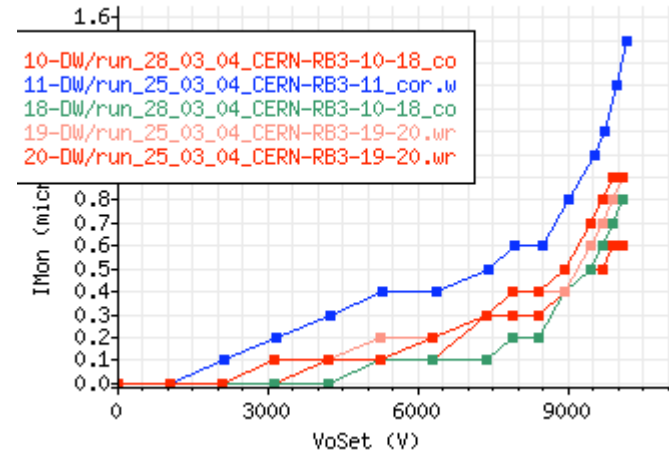
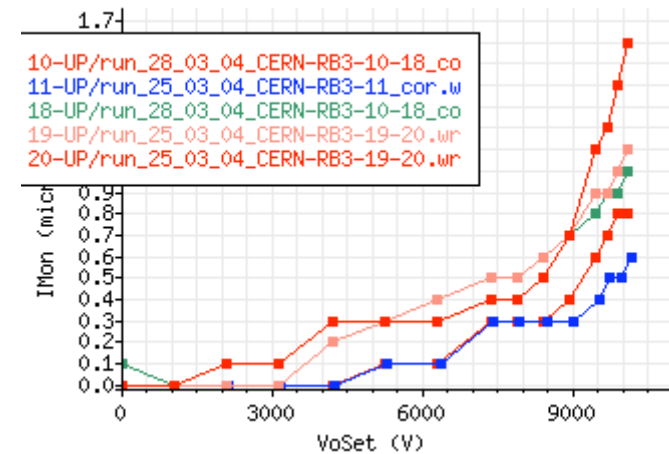
## Fast tests on the 20 assembled chambers

At ISR:

- LV+ CONTROL BOARD CARD
- I vs V plots

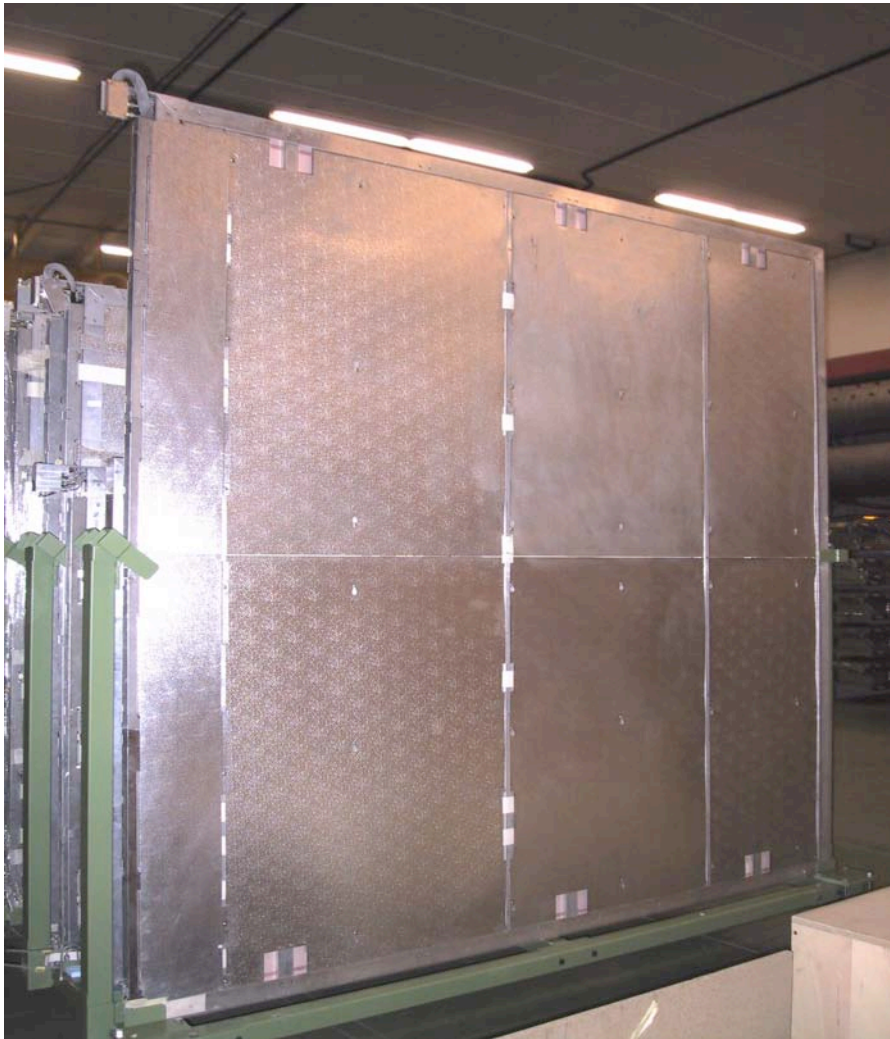
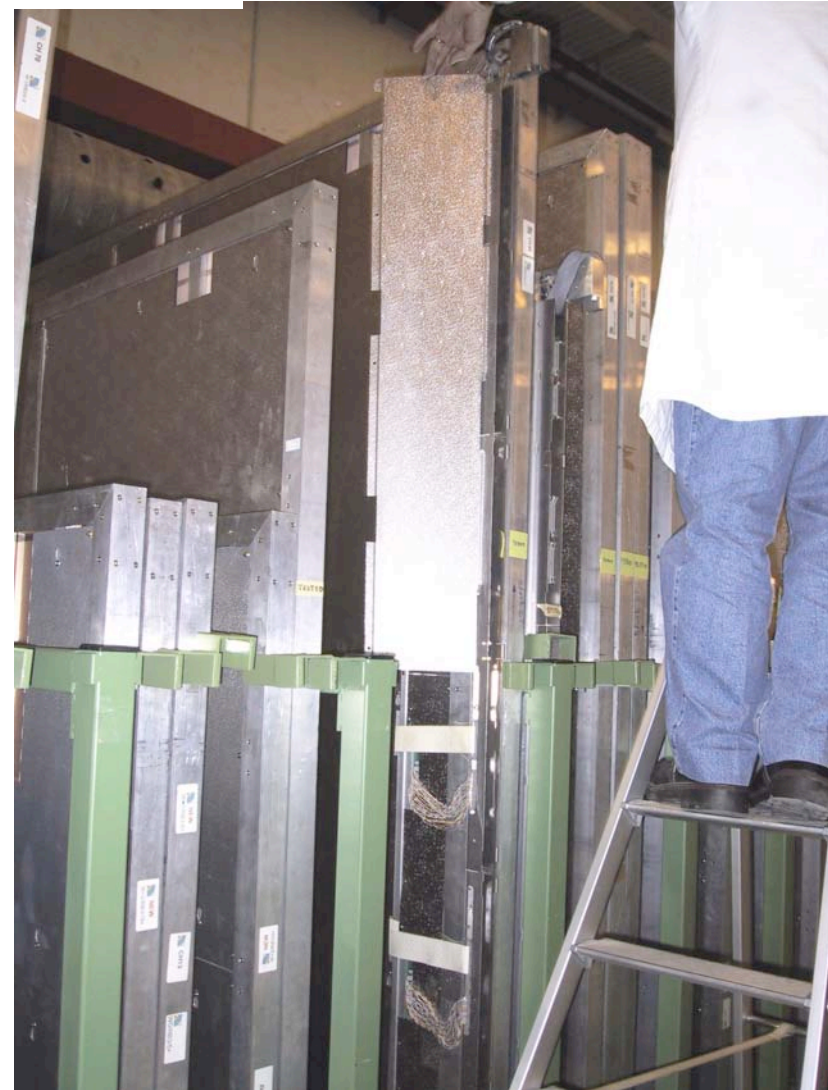
Chamber passing the tests are **ready for installation**

- Grounding straps
- Cable covers

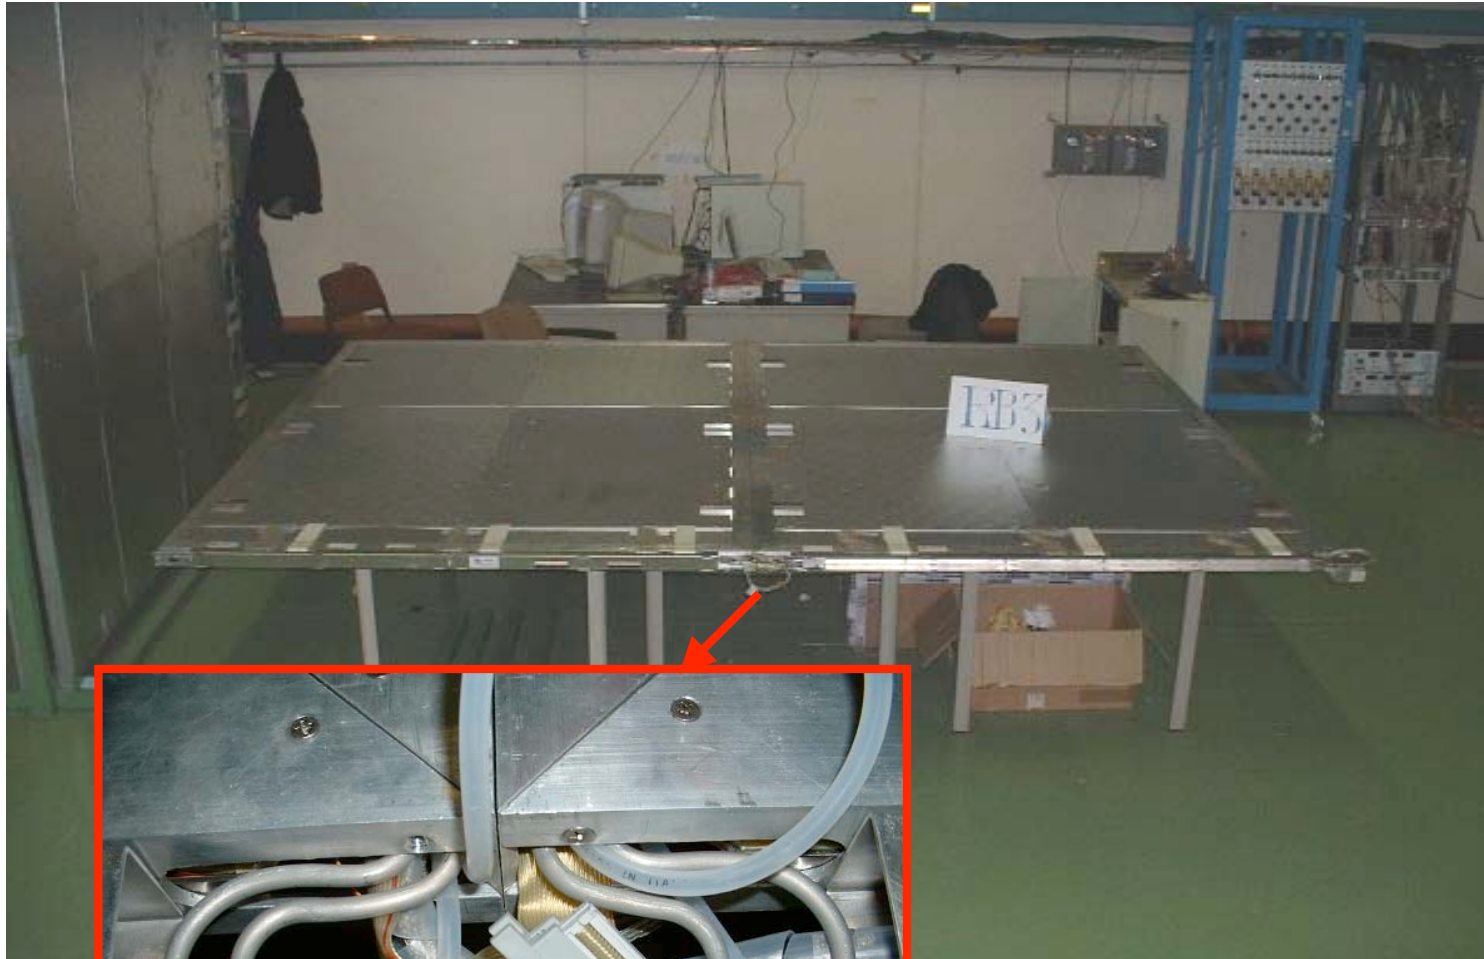
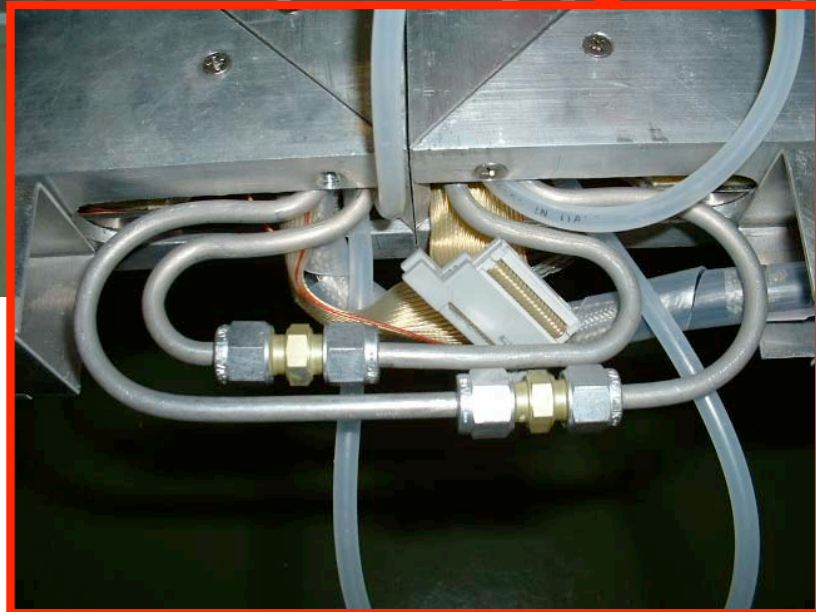
- Cooling system test with final connectors

**The two RB3 will be jointed (gas & cooling pipes, LV cables) on the MB3**

**Full RB3: jointing zone  
gas and cooling pipes**

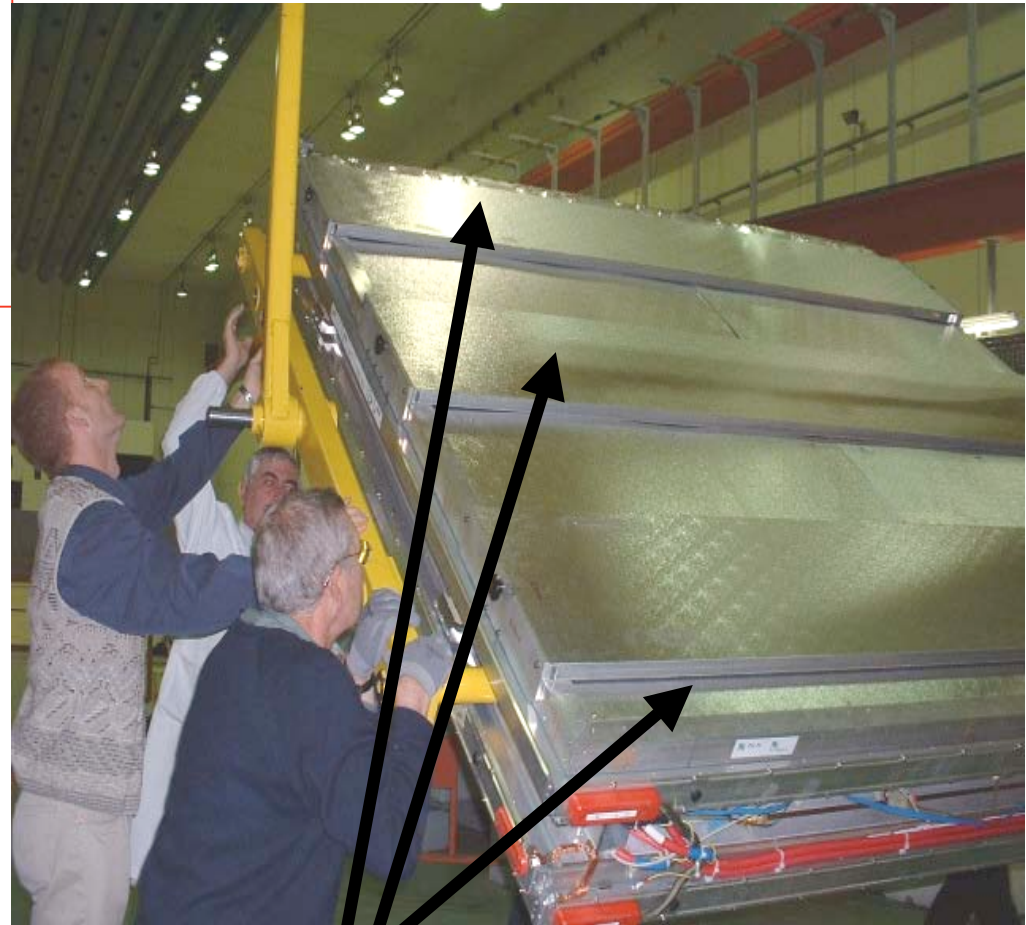
- 1) Posizionare e agganciare RB OUT su DT dopo aver preventivamente fissato le barre di trazione sulle barre precaricate.

- 2) Dopo aver ruotato la stazione di 180°, posizionare e agganciare RB IN su DT. Montare pannelli di contenimento delle barre precaricate.

- 3) Ruotare la stazione di 90°. Trasportare alla zona di montaggio.

**3 compensating planes needed for each RPC-DT-RPC system (MB1-MB2-MB4 stations)**

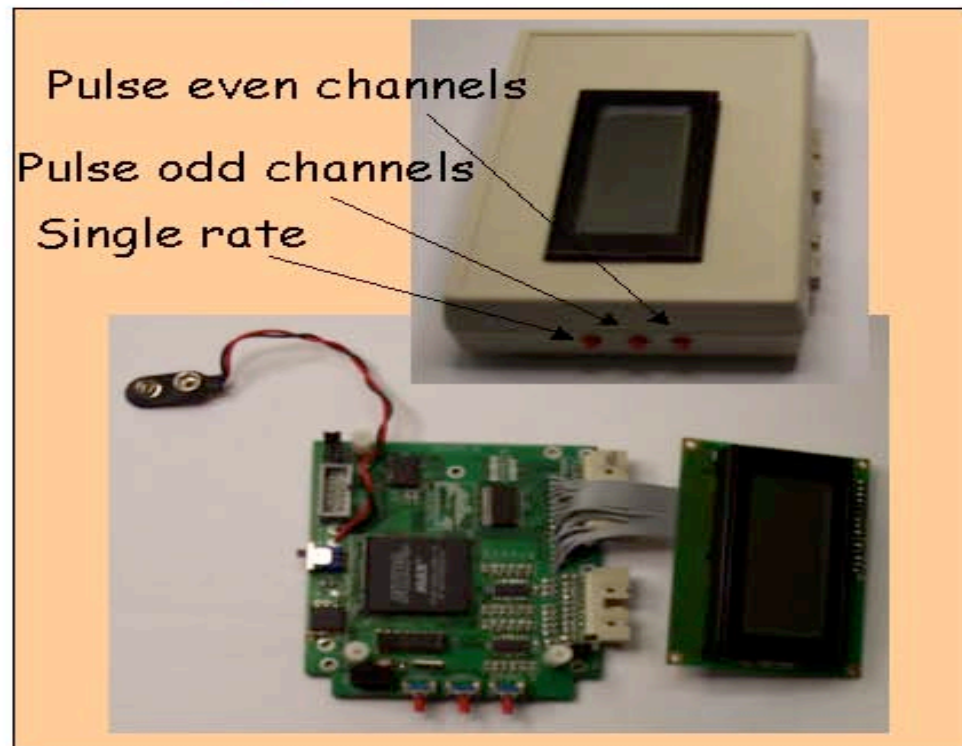
- **Strip connectivity and FEBs**

288 channels frequency-meter  
realized by Naples group:  
Fast test of all the electronic  
channels of the chamber.
