# RPC readiness for Installation: ISR test activity

A.Colaleo CMS Week 8-06-2004

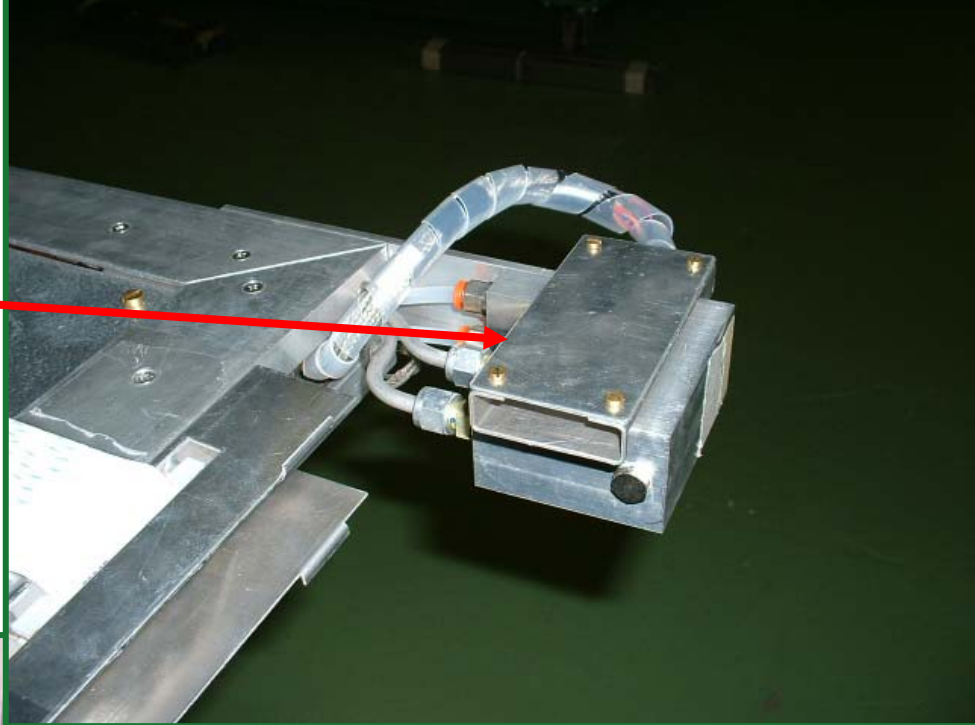
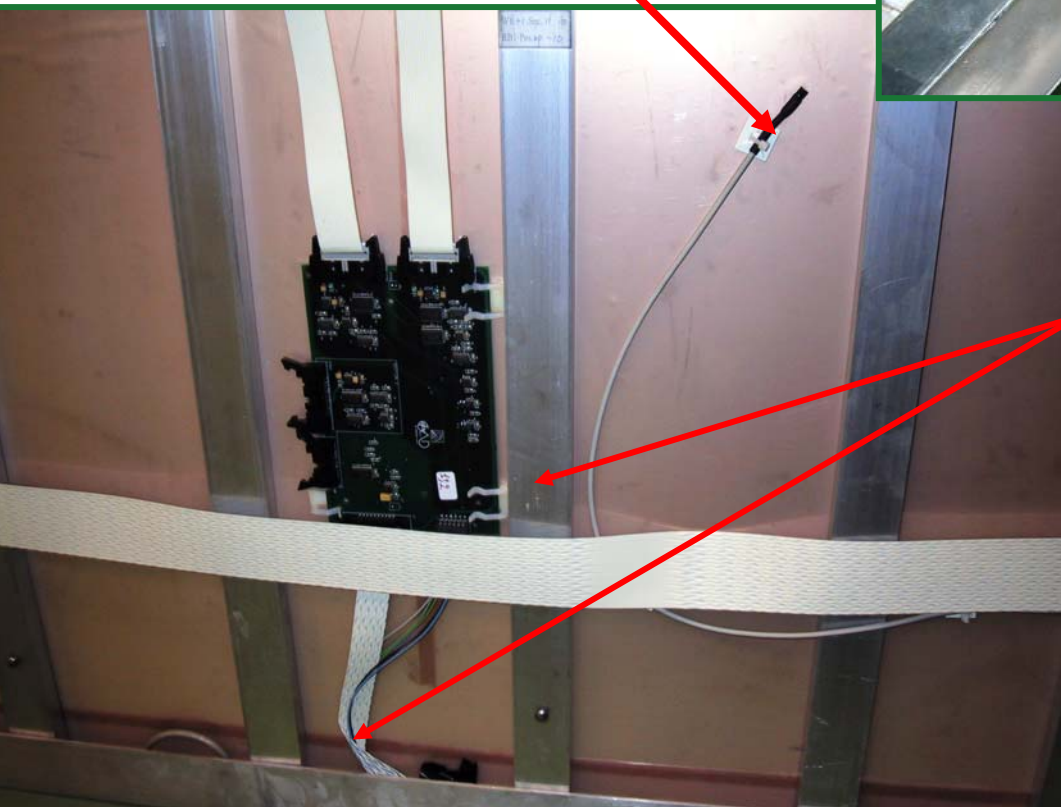
## Work on chambers arriving at ISR

- HV final connectors on some chambers

- Temperature Sensors

- Control board - cable often need to be changed after the transport.
- Found 2/76 chambers with disconnected signal cables
- 3 FEBs changed

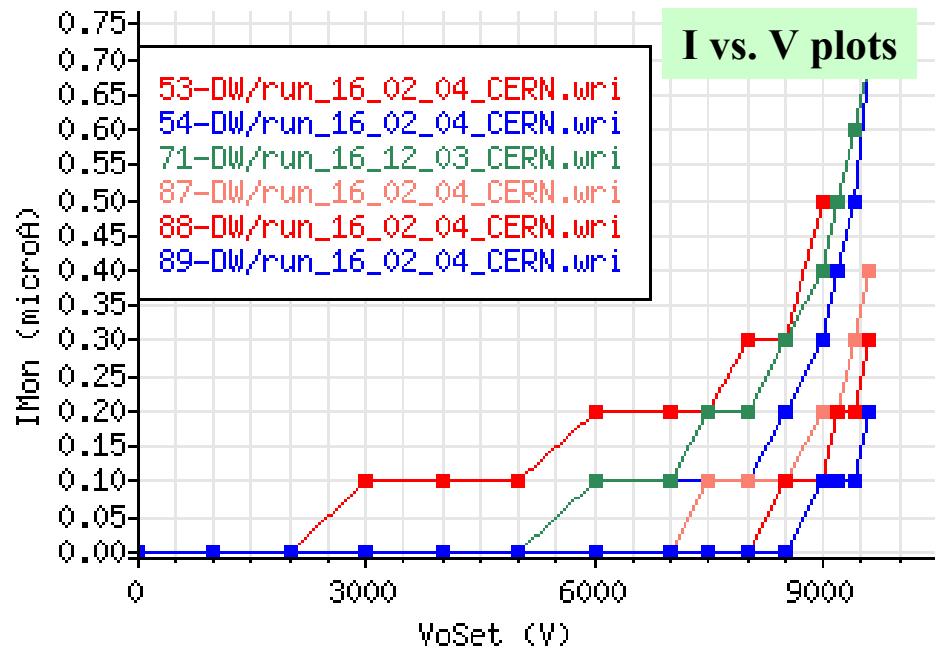
# Results: Currents

- I vs. V plots during the tests
- Current stability for ~15-20 days
- Chambers suspicious have been monitored for > 1 month

**Current@9400 V**

**Chamber with current/layer > 10 μA are rejected**

**Chamber ID 102.  
Long time monitoring , recovered and accepted**

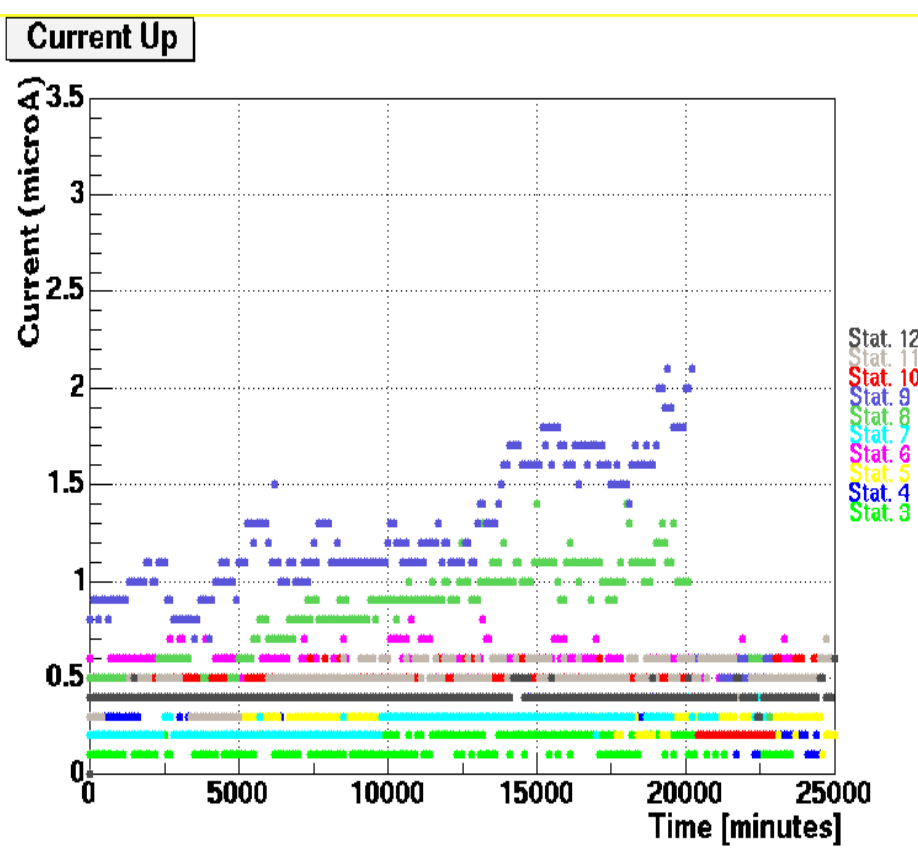
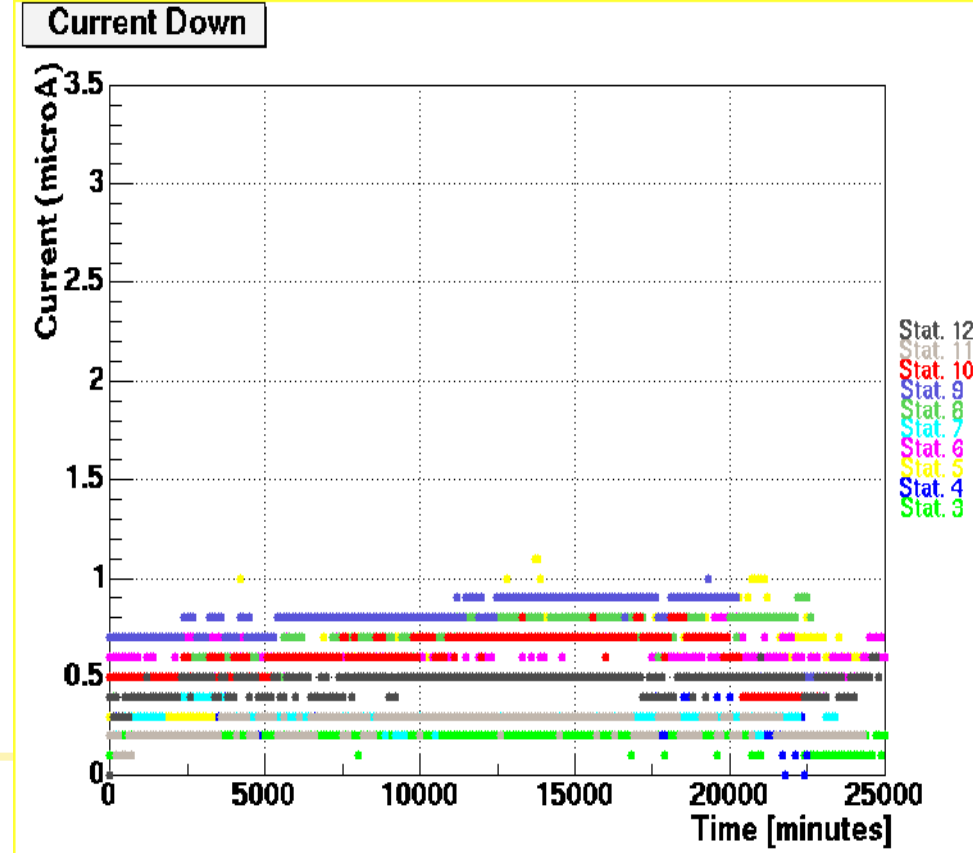
Monitor the current stability @ 9200 V vs time for at least 15 -20 days

On the test trolley for about 1 month

Last Chambers: LAYER UP

Last Chambers: LAYER DOWN

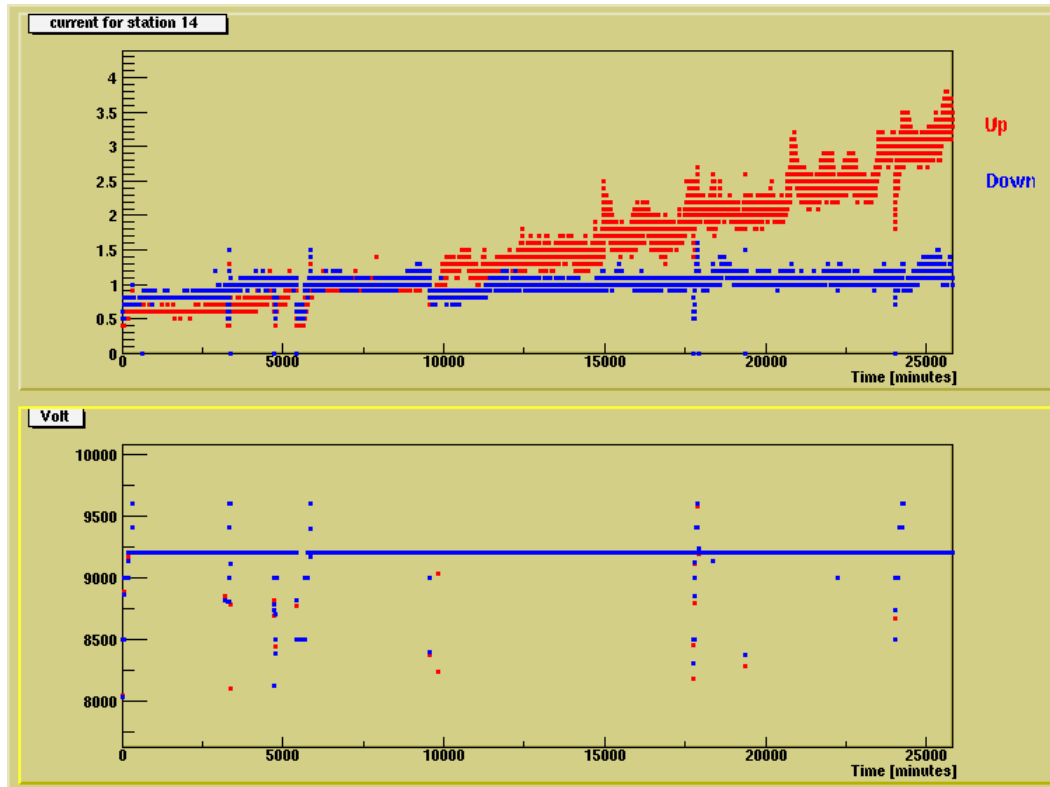
5 rejected for steady increasing of current : chID 98 57 58 61 120

ChID 50 now under observation

Recovering procedure: HV off for ~1 month  
slowly increasing of HV

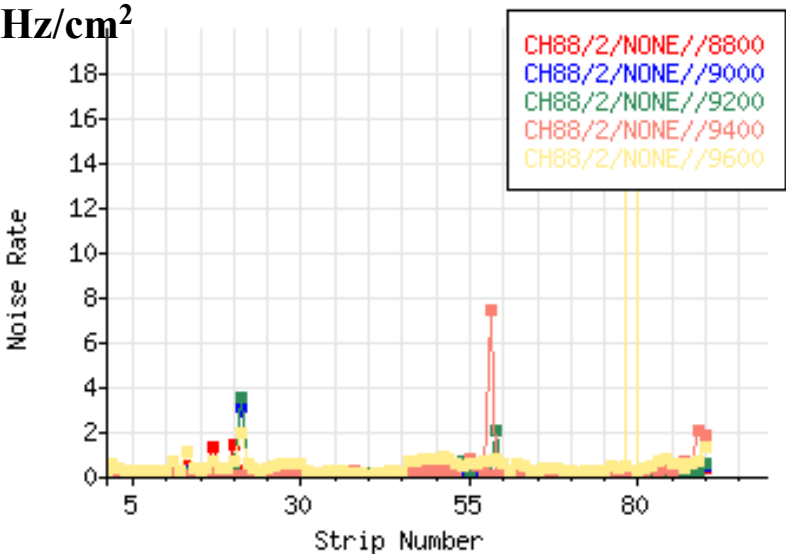
Hit rate profiles chID 88 between 8.8-9.6 kV

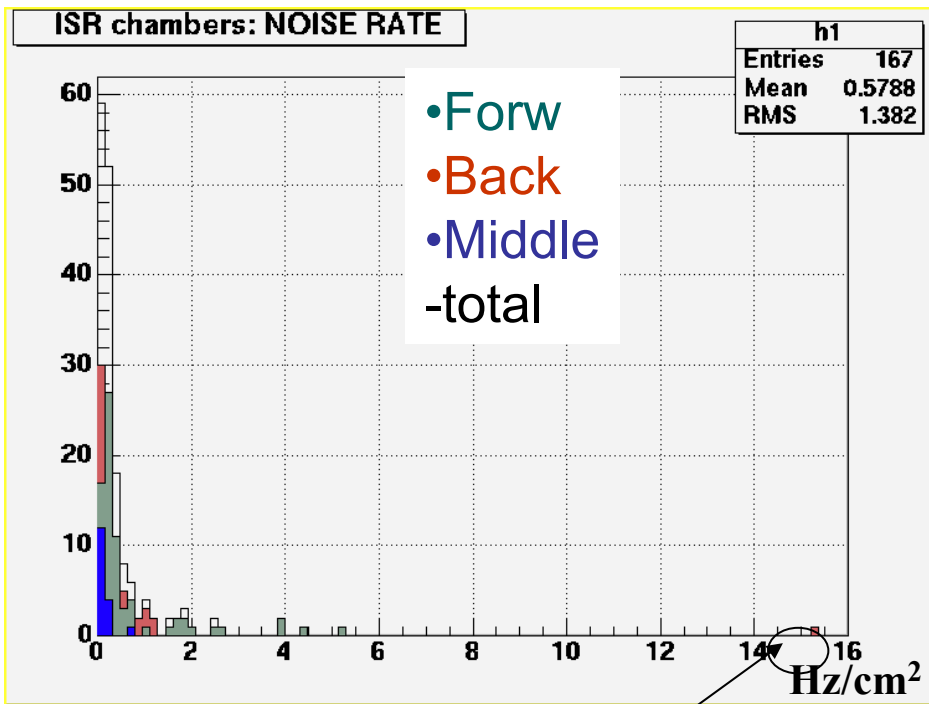
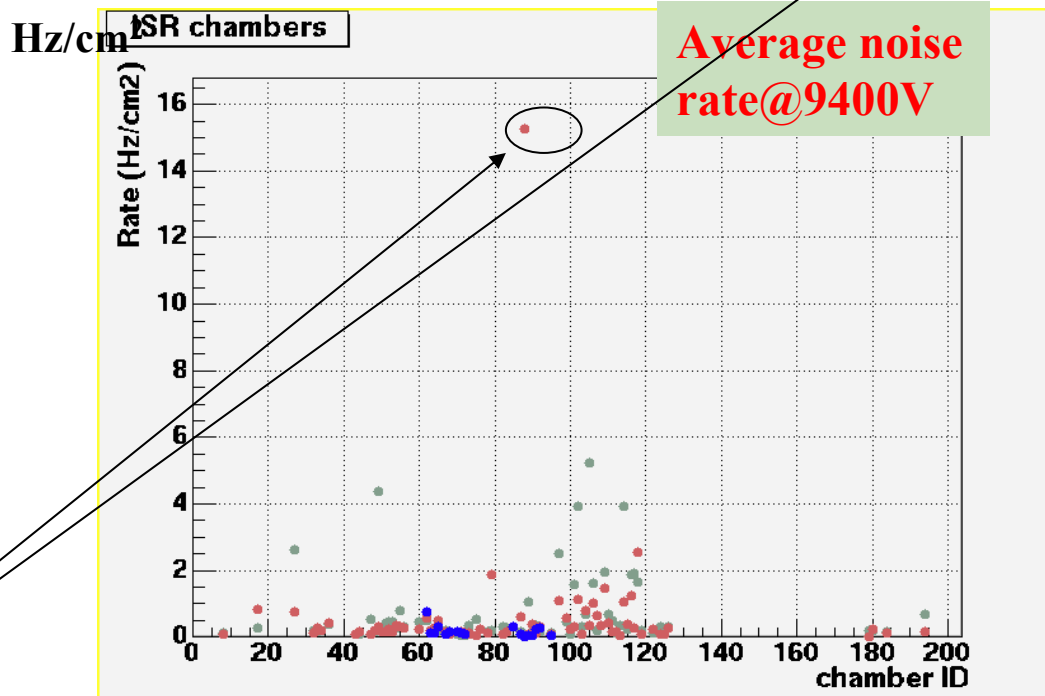
Single run with few, not continuously, noisy strips are accepted

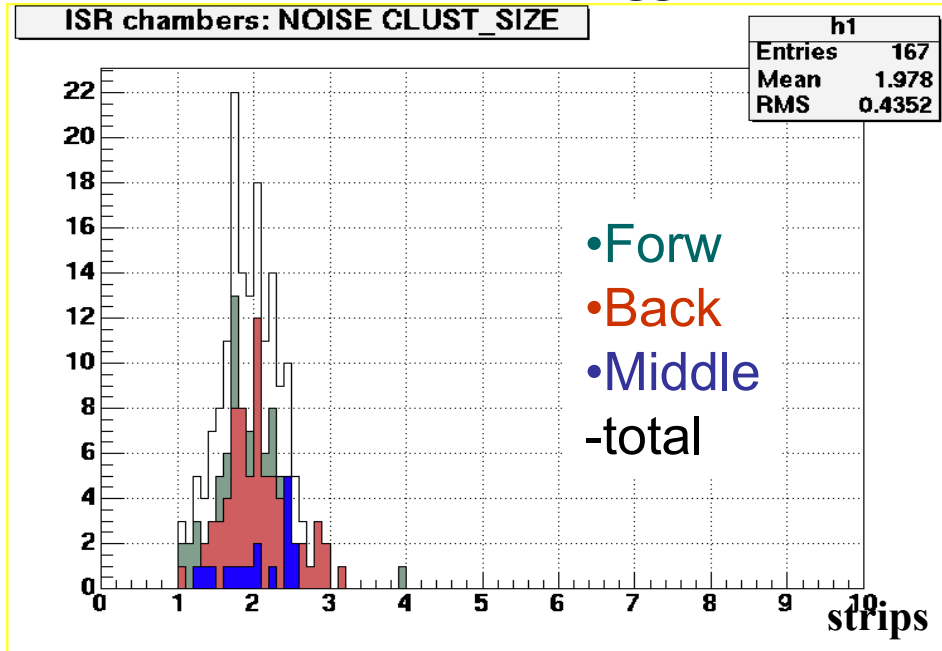
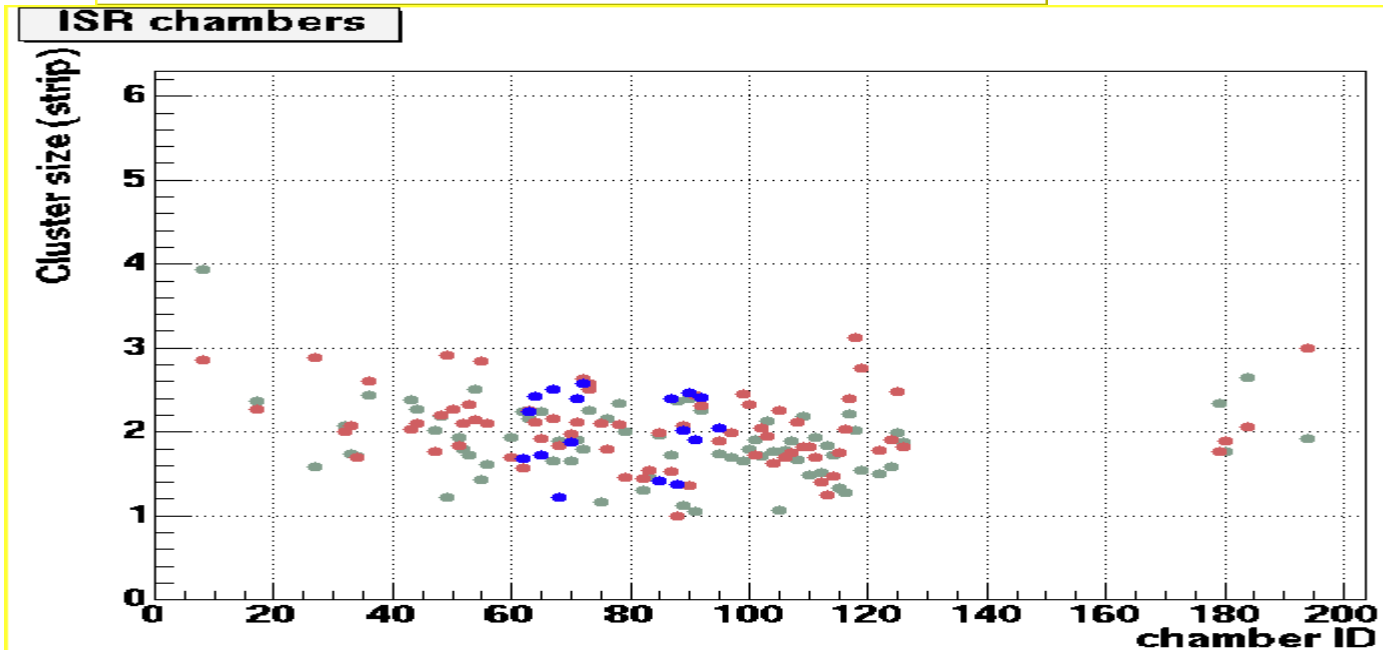
## Random trigger runs: cluster size in noise events

75 Forw + 75 Back + 17 Middle

Mean cluster size < 2 strips

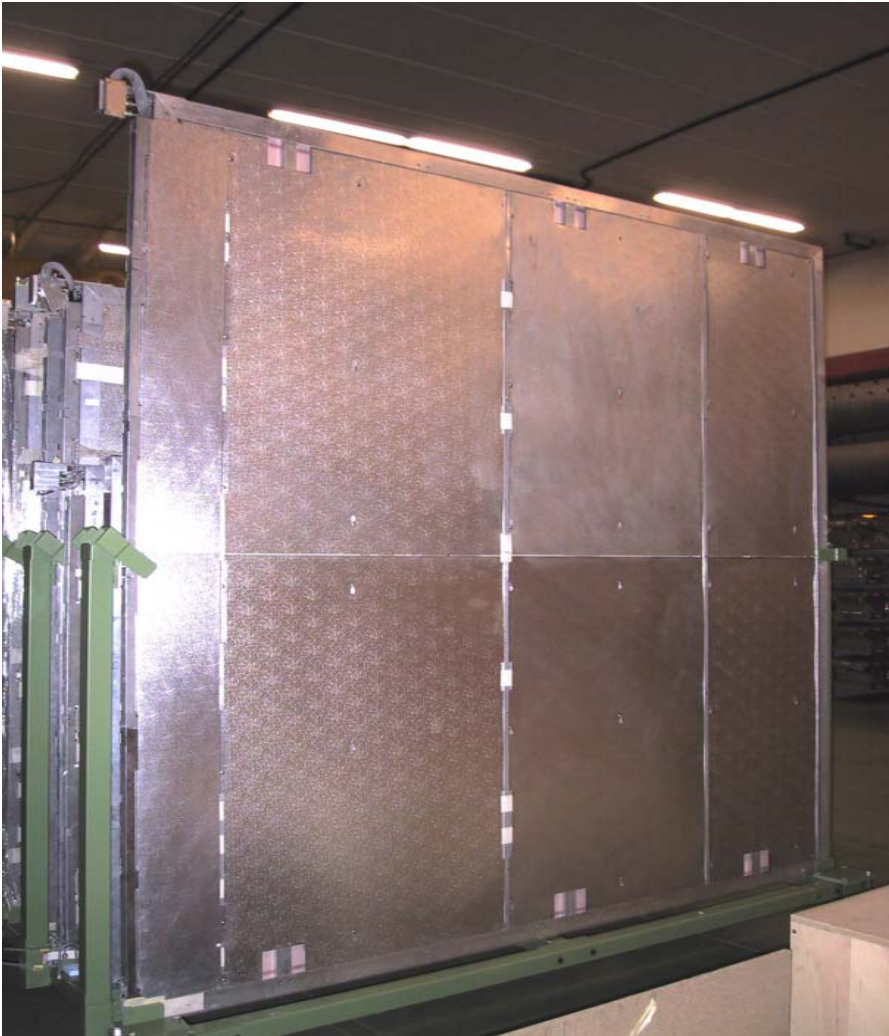
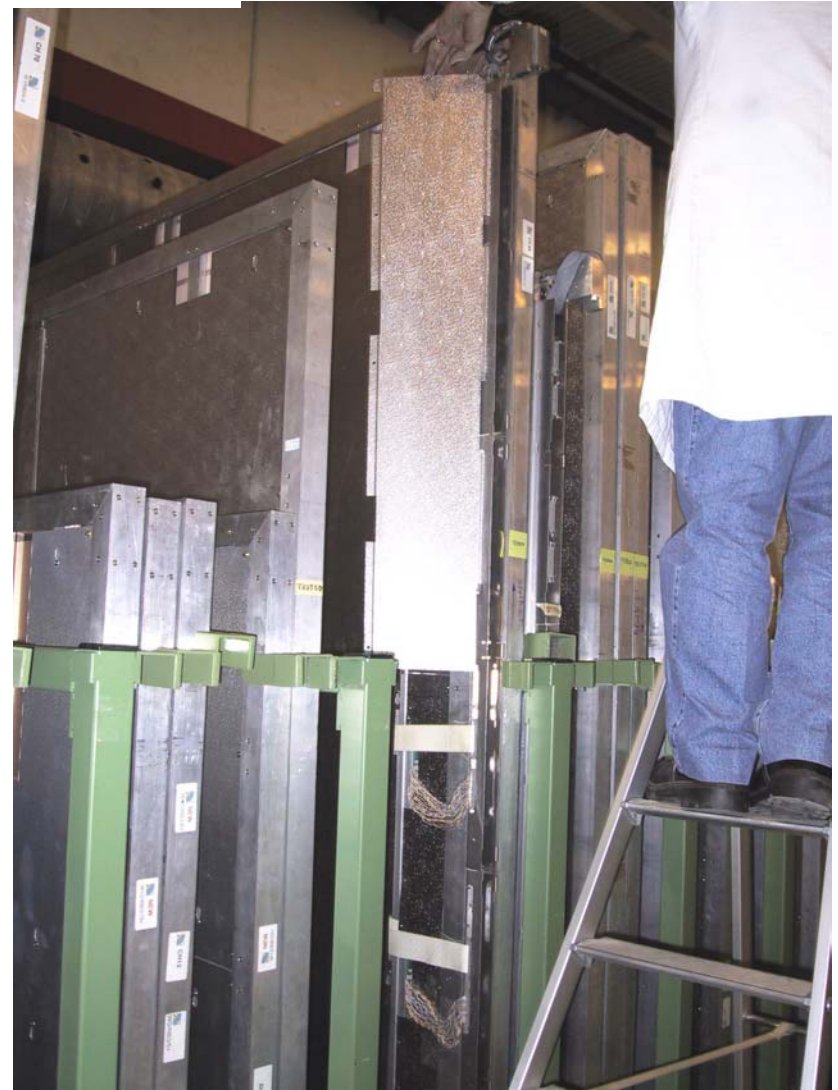
## Final work before coupling

- Grounding straps
- Cable covers

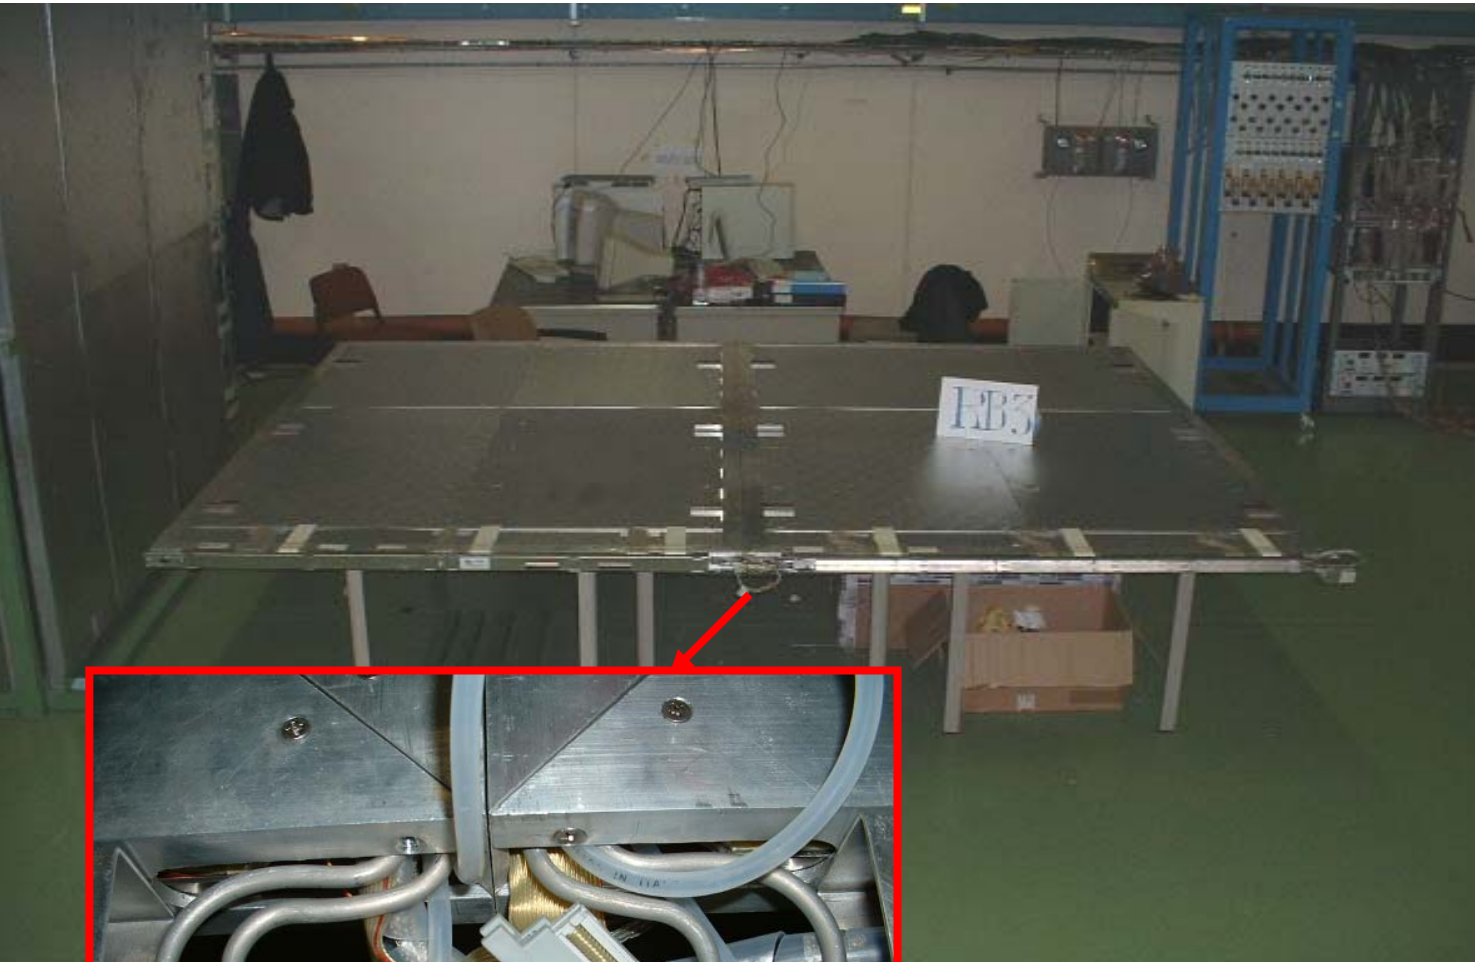
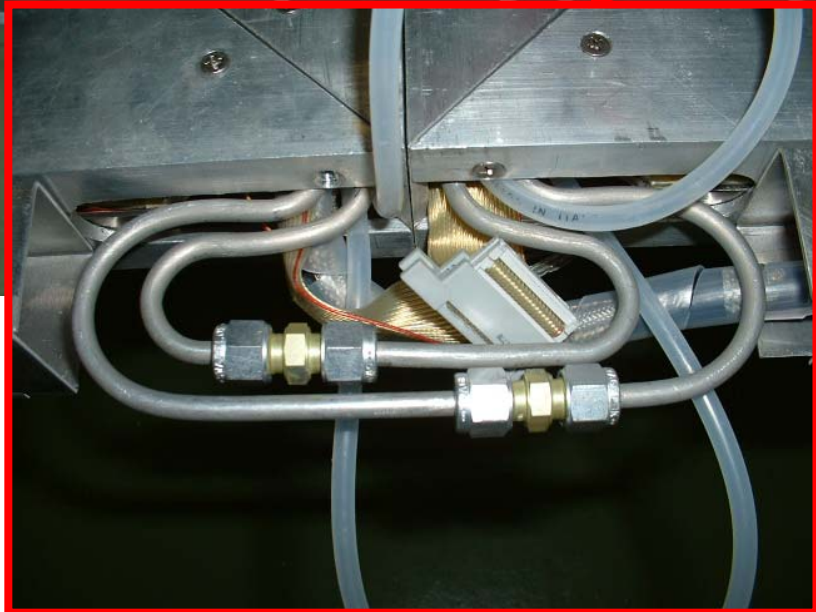
- Cooling system test with final connectors

**The two RB3 will be jointed (gas & cooling pipes, LV cables) on the MB3**

**Full RB3: jointing zone  
gas and cooling pipes**

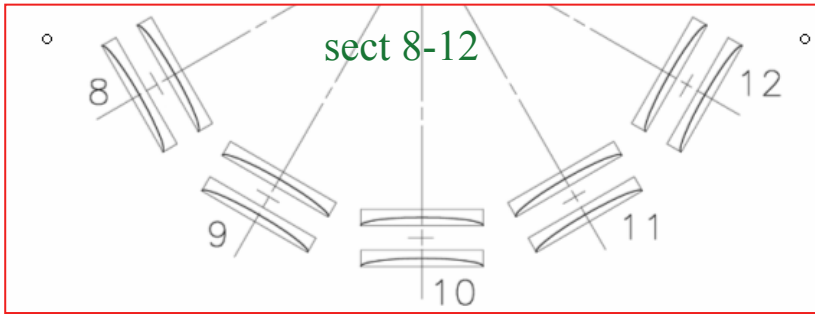
# RPC coupling to DT and pre-load compensation

## 1st step

- 1) Posizionare e agganciare RB OUT su DT dopo aver preventivamente fissato le barre di trazione sulle barre precaricate.

## 2nd step

- 2) Dopo aver ruotato la stazione di 180°, posizionare e agganciare RB IN su DT. Montare pannelli di contenimento delle barre precaricate.

## 3rd step

- 3) Ruotare la stazione di 90°. Trasportare alla zona di montaggio.

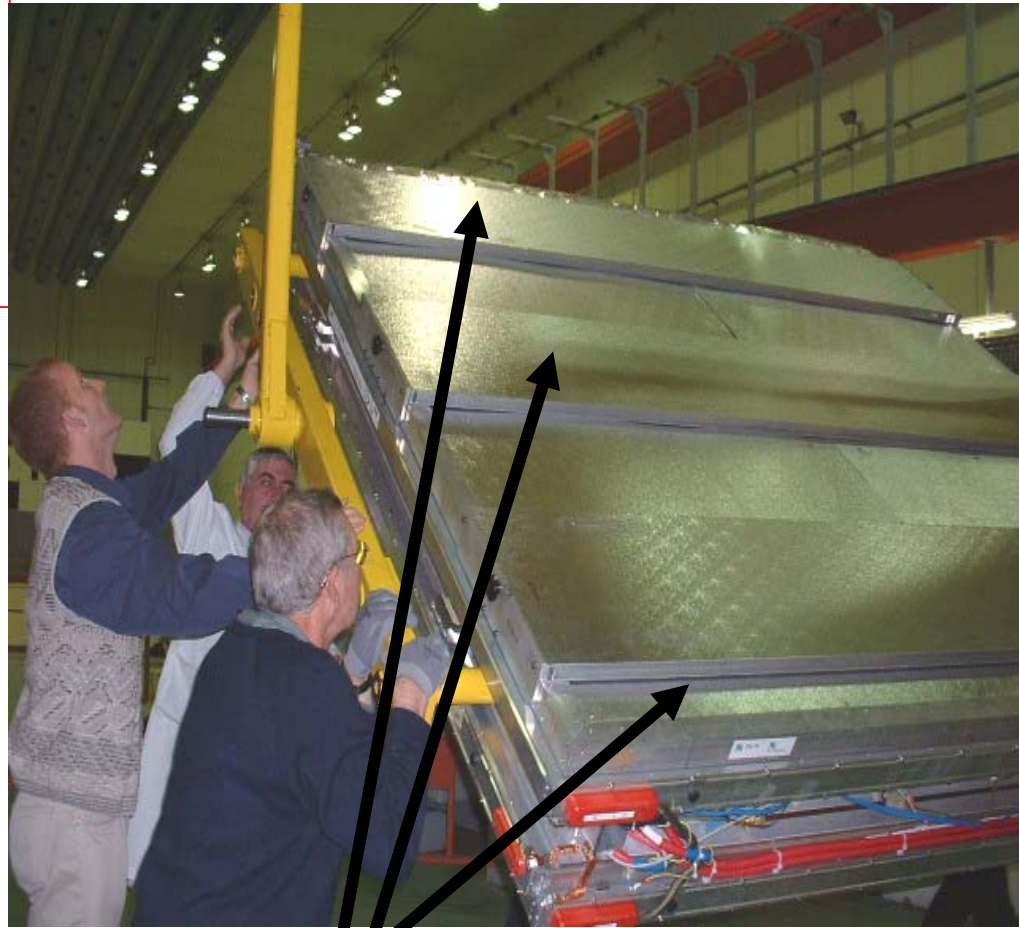
**3 compensating planes needed for each RPC-DT-RPC system (MB1-MB2-MB4 stations)**

**24 compensating planes available for RB2 chambers**  
**24 planes for RB1**  
**24 planes for RB4** } **Arriving on 9 June**
