# ISR Work Progress Report

CMS Week June 2nd 2003

A. Benvenuti  
INFN Bologna

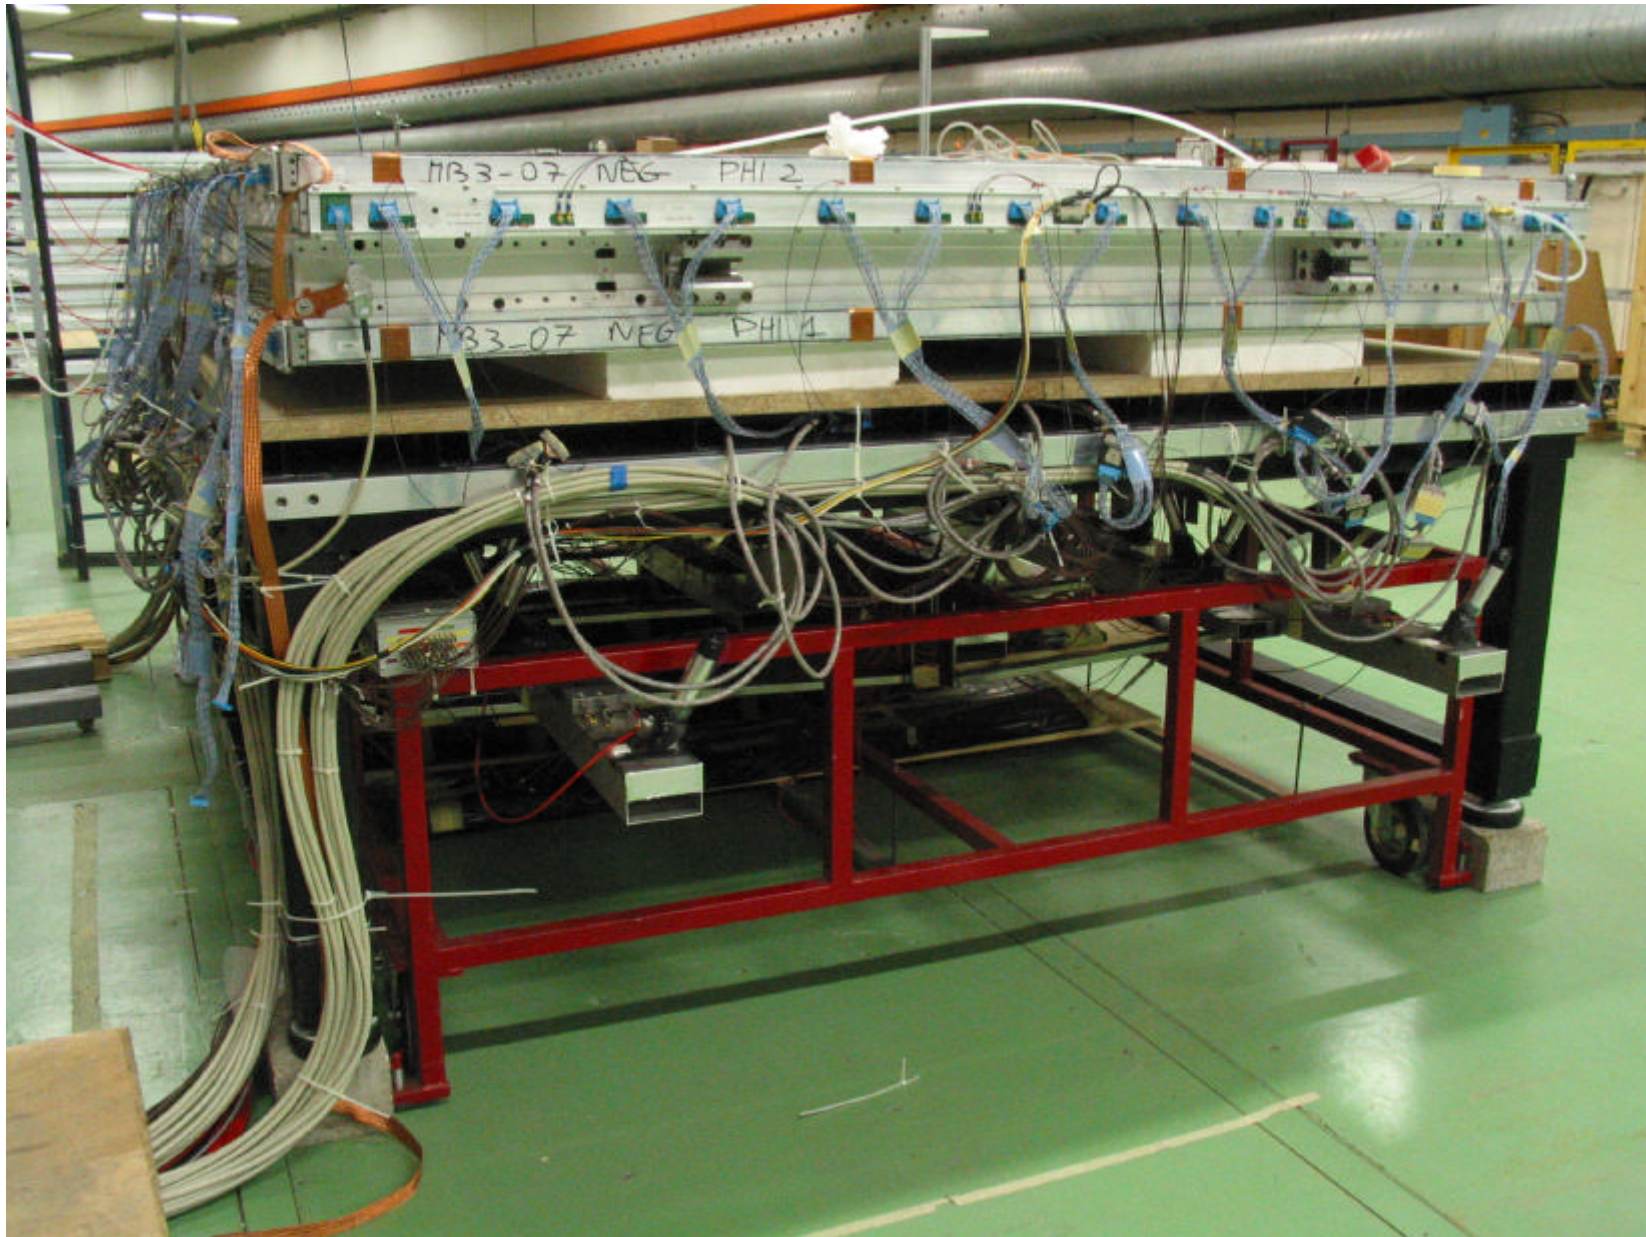
On Alignment bench

- ▴ Chambers with DCS problem
  - ▴ Front-end board problem
- SL must be opened to fix problem

Chamber can be moved with simple supports through the alignment passages  
Cabling and access to front-end much easier/faster
