ISR Work Progress Report

CMS Week December 9th 2003

A. Benvenuti
INFN Bologna

ISR Status

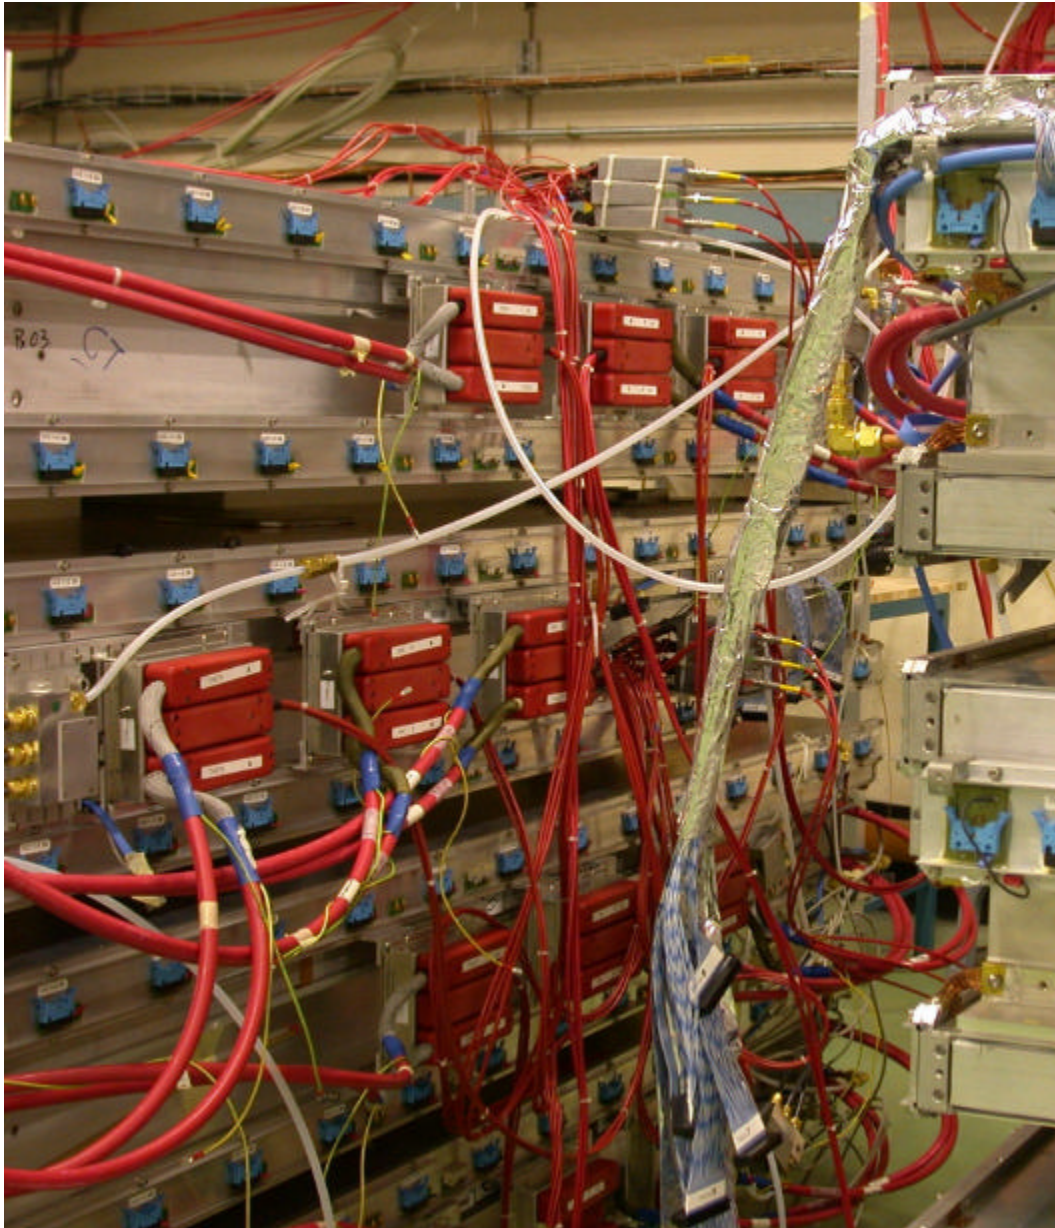
HV Test System

The HV from the CAEN Sy127 is distributed to six connectors with a home made box.

Without Patch Panels one distributor box is needed for one chamber and **ALL pins are connected to HV.**

With HV PP one distributor box is connected to 2 chambers, **ONLY used pins are connected to HV.** It is also possible to connect the chambers to the final HV system.
