ISR Work Progress Report

CMSWeek,
CERN June 8th 2004

A. Benvenuti
INFN Bologna

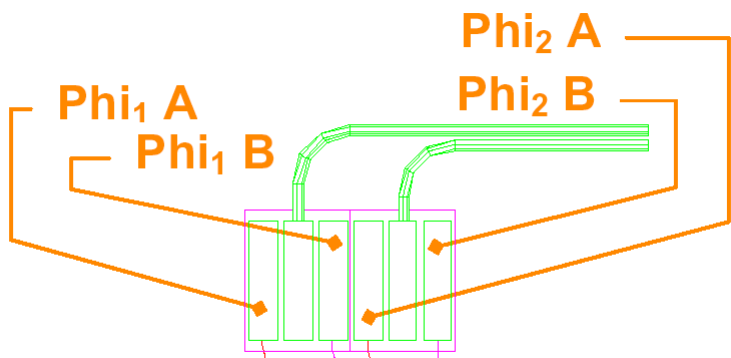
Cable type		L _{cable} ¹ [mm]	L _{outer} ² +0 – 50 [mm]
Phi₁ A	HVC 4 04	α	4330	1450
Phi₁ B	HVC 4 05	α	5640	1470
Phi₂ A	HVC 4 04	α	4330	1450
Phi₂ B	HVC 4 05	α	5640	1400

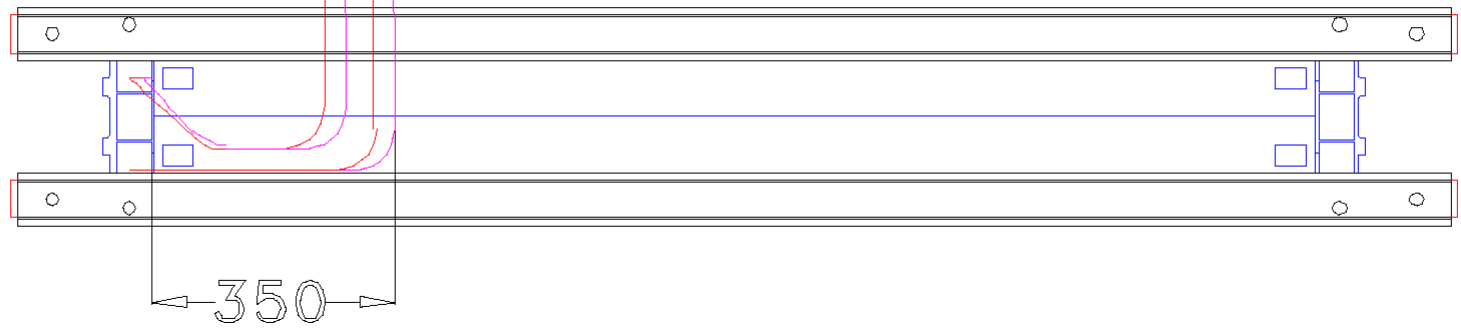
Gas Manifold Carter

Test with MiniCrate
and final cables
needed to be sure
that all fits.
