# ISR reception and tests

Status report

**Jesús Puerta-Pelayo**  
**INFN Bologna**

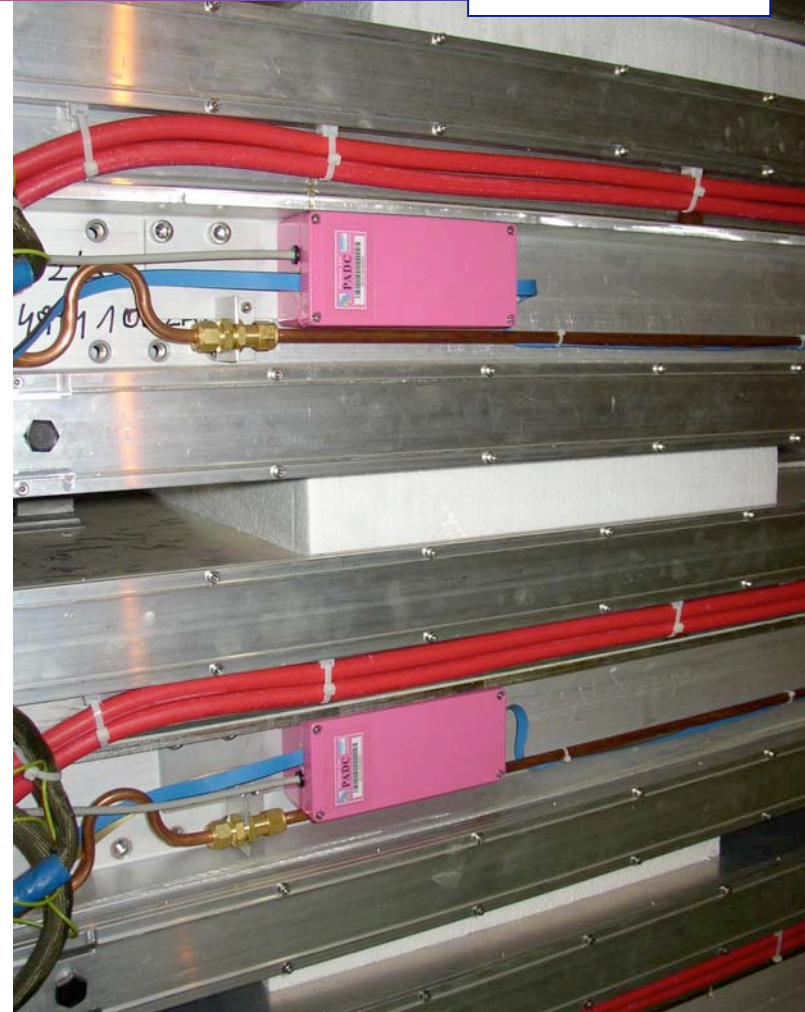
- ❑ Chambers for wheels YB+2, YB+1 and YB0 equipped with PADCs.
- ❑ HV cables, gas piping, gas manifolds in almost all aligned chambers.

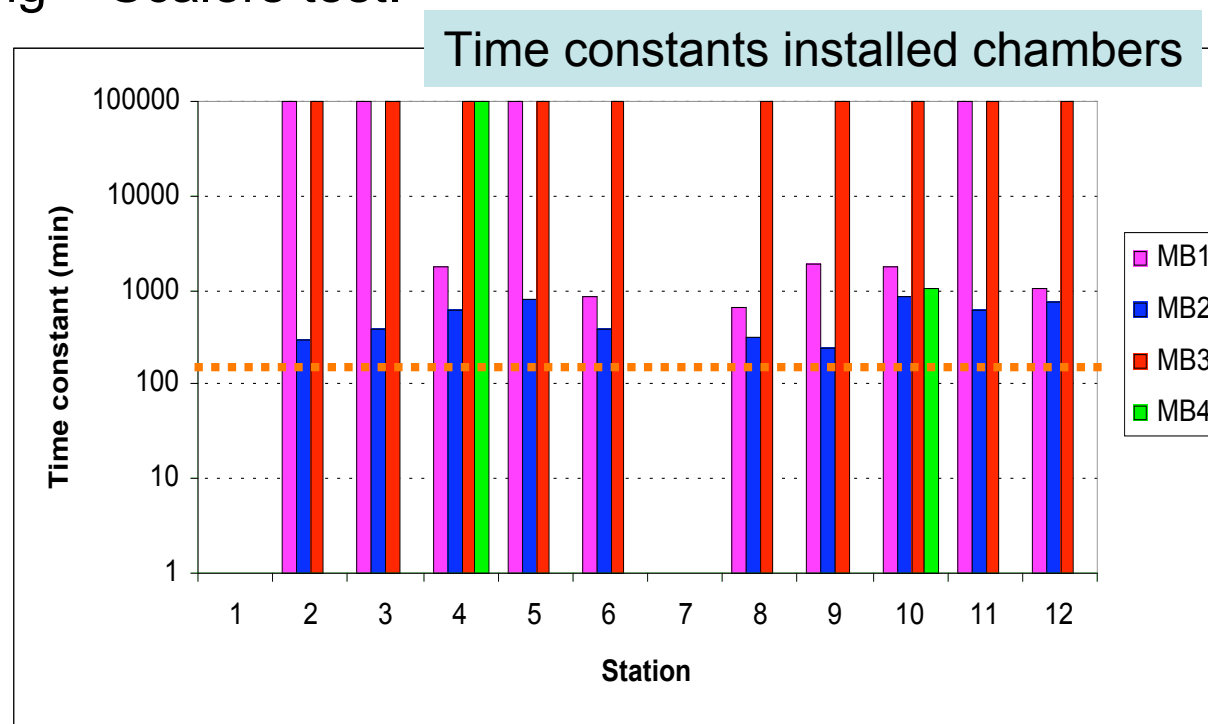
1. Regular trending of HV behaviour.
2. Last certification with cosmics.
3. Theta FE cabling + Scalers test.
4. Gas tightness test (after eventual reparations) with gas manifolds.
