DT Chamber Commissioning

Kerstin Hoepfner, RWTH Aachen & CERN CMM
For the commissioning team

Commissioning Procedures

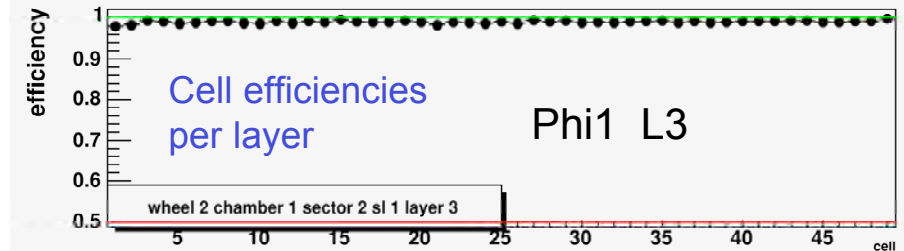
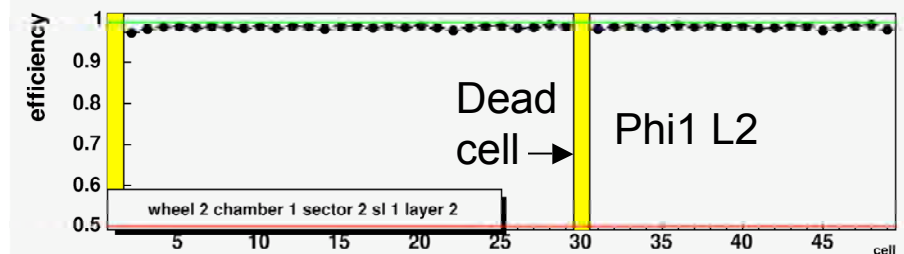
Local Cell Efficiencies

- Efficiency of good cells is usually better than $\sim 99\%$
- Some examples (other layers look the same)

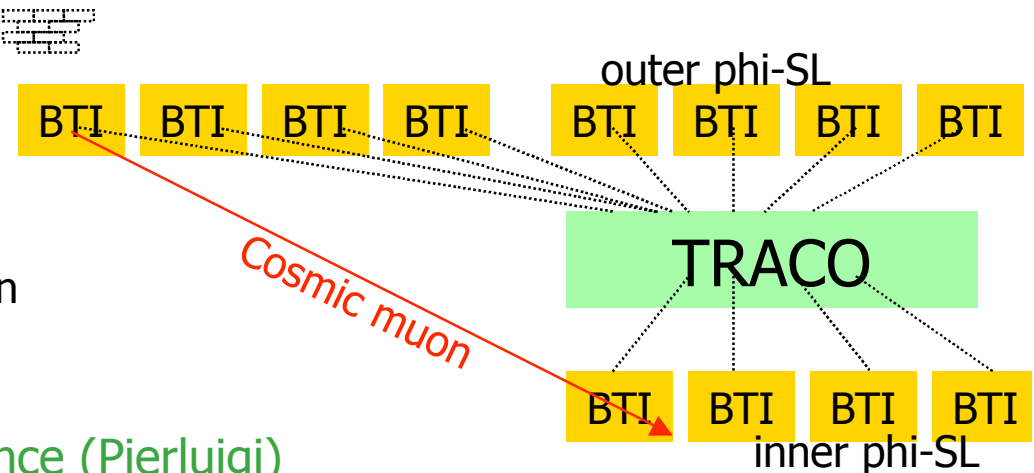
Reason: angular acceptance of BTI was not sufficient to cope with the large shift between both phi SL (2 cells = 8.4 cm) in MB4. TRACO did not correlate segments between two outermost BTI.

Fixed by increasing angular acceptance (Pierluigi)
